Erosion and Stability of Till Cliffs
on the Holderness Coast

This thesis is submitted in fulfilment of the requirements
for the Degree of Doctor of Philosophy
in Geotechnical Engineering

Iain Robertson

University of Newcastle upon Tyne
Geotechnical Engineering

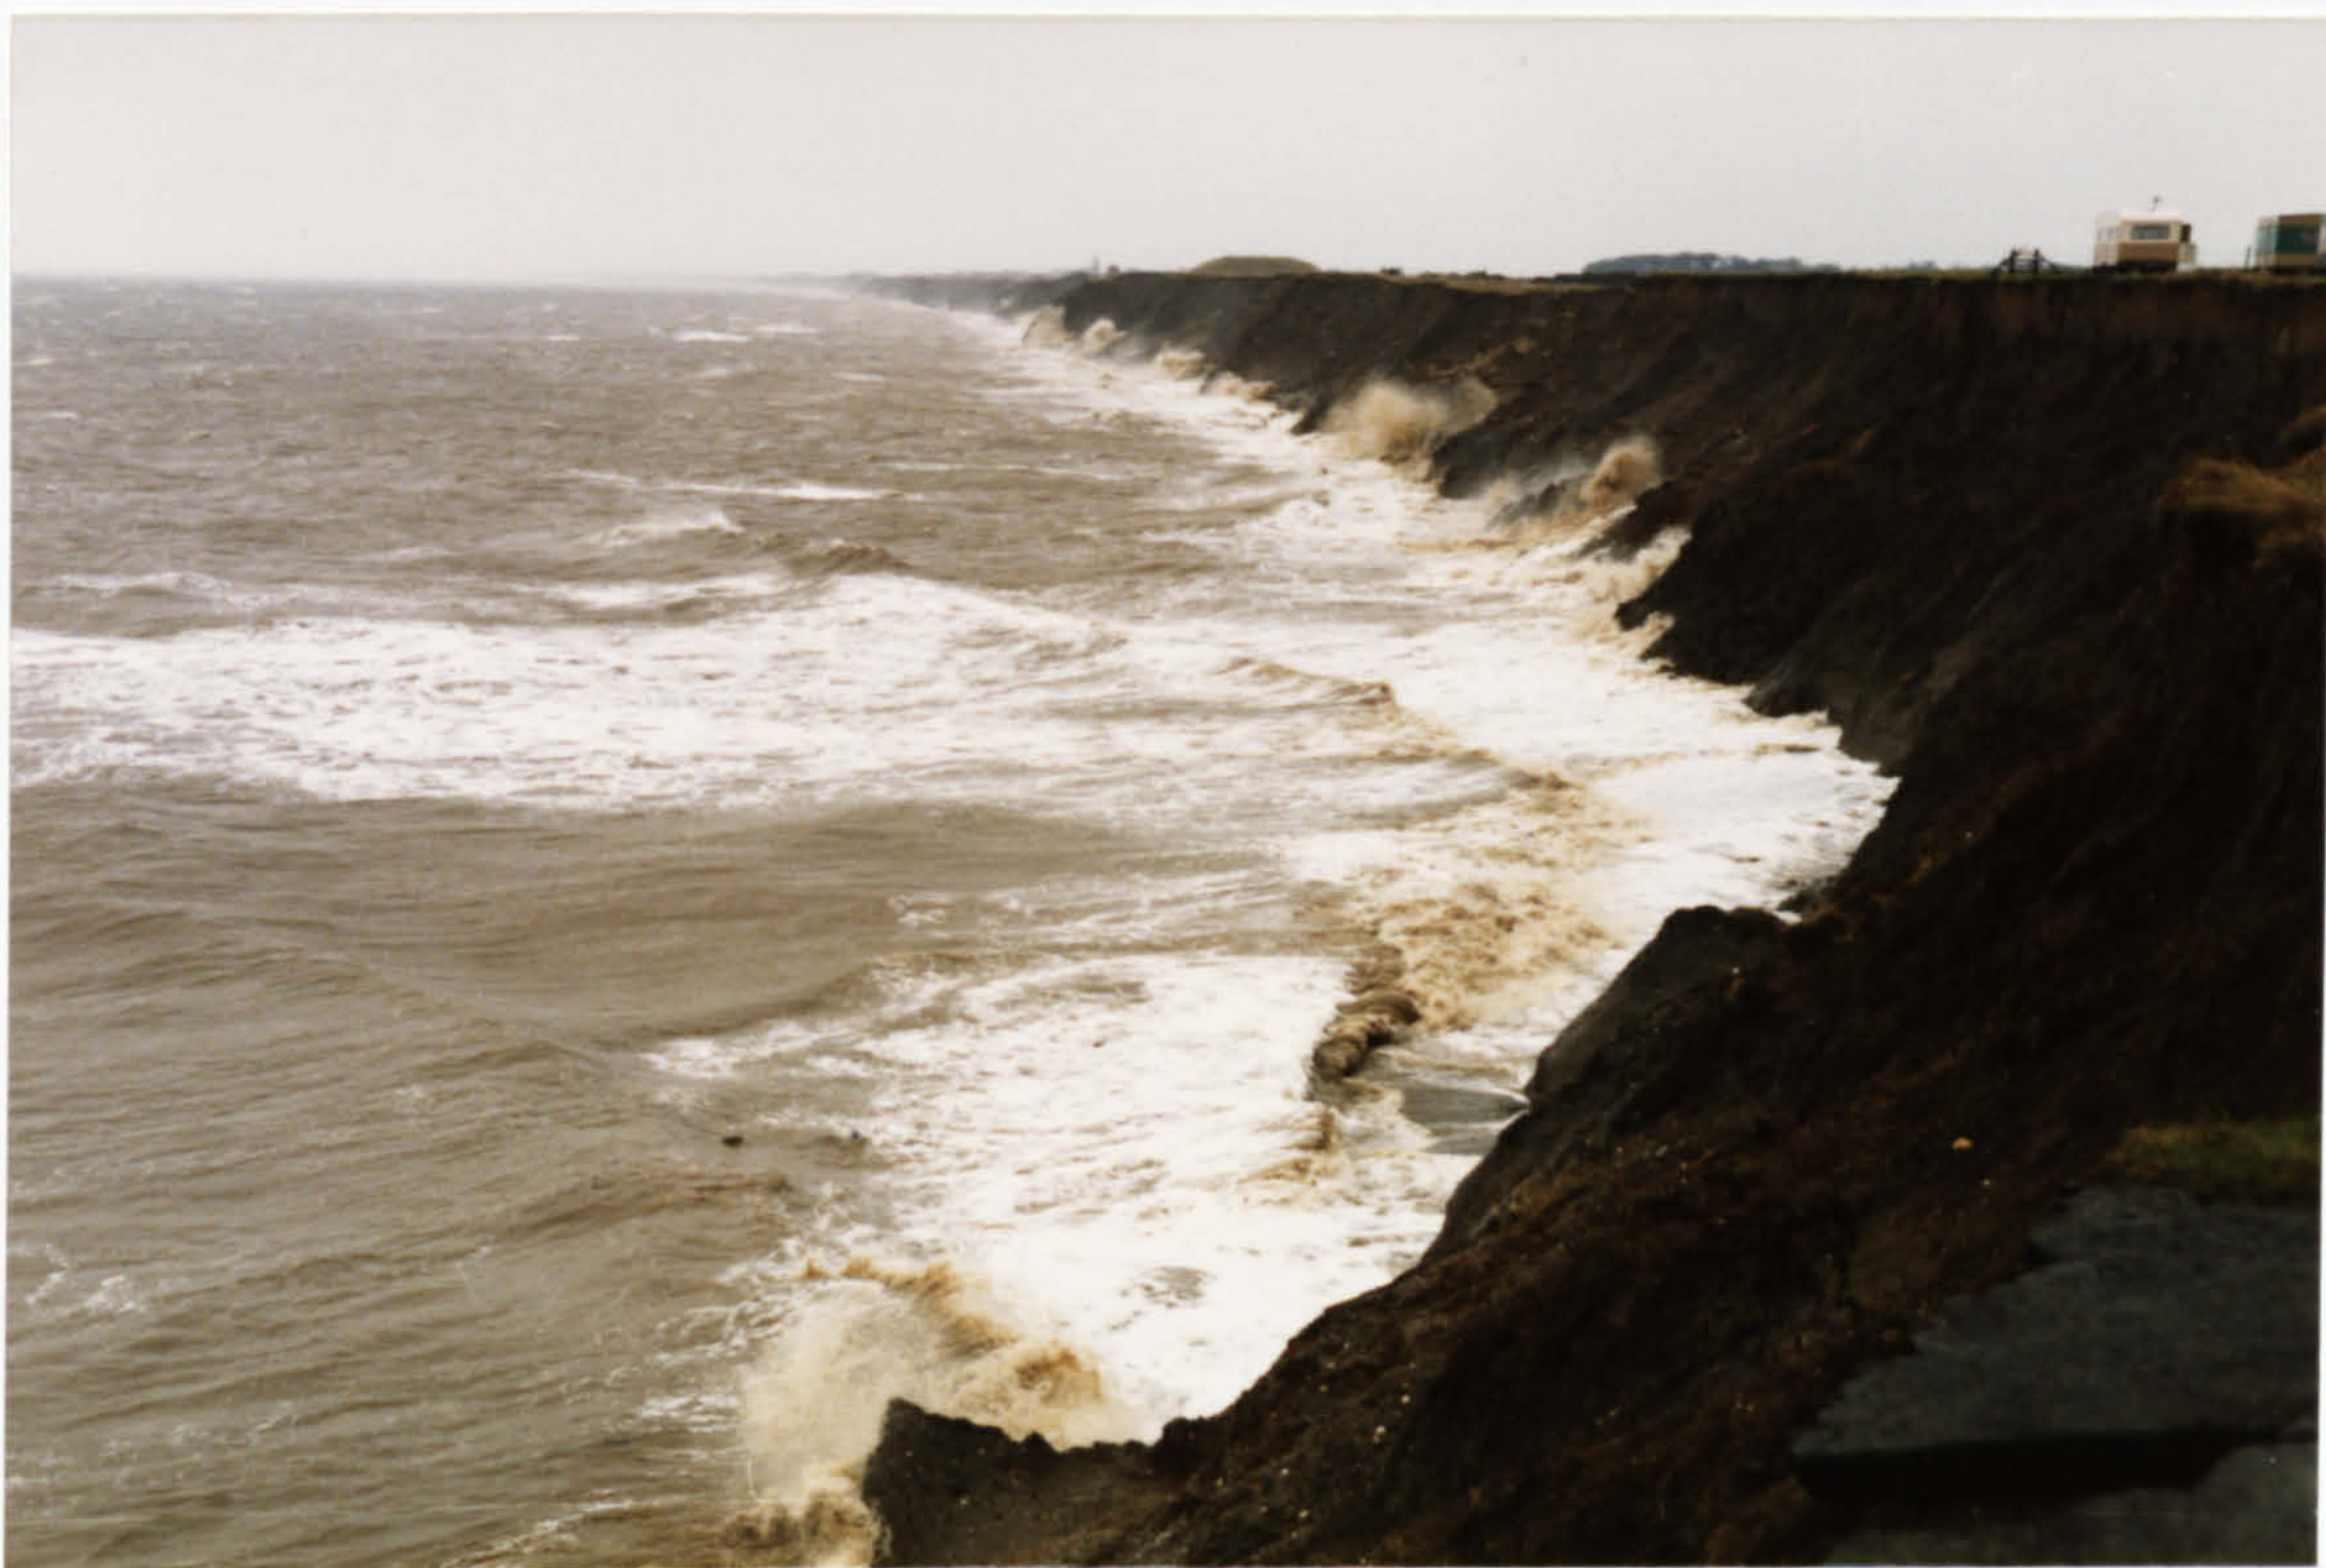
Figure 1.2

The Holderness coast south of Hornsea, with high energy wave conditions during a March storm

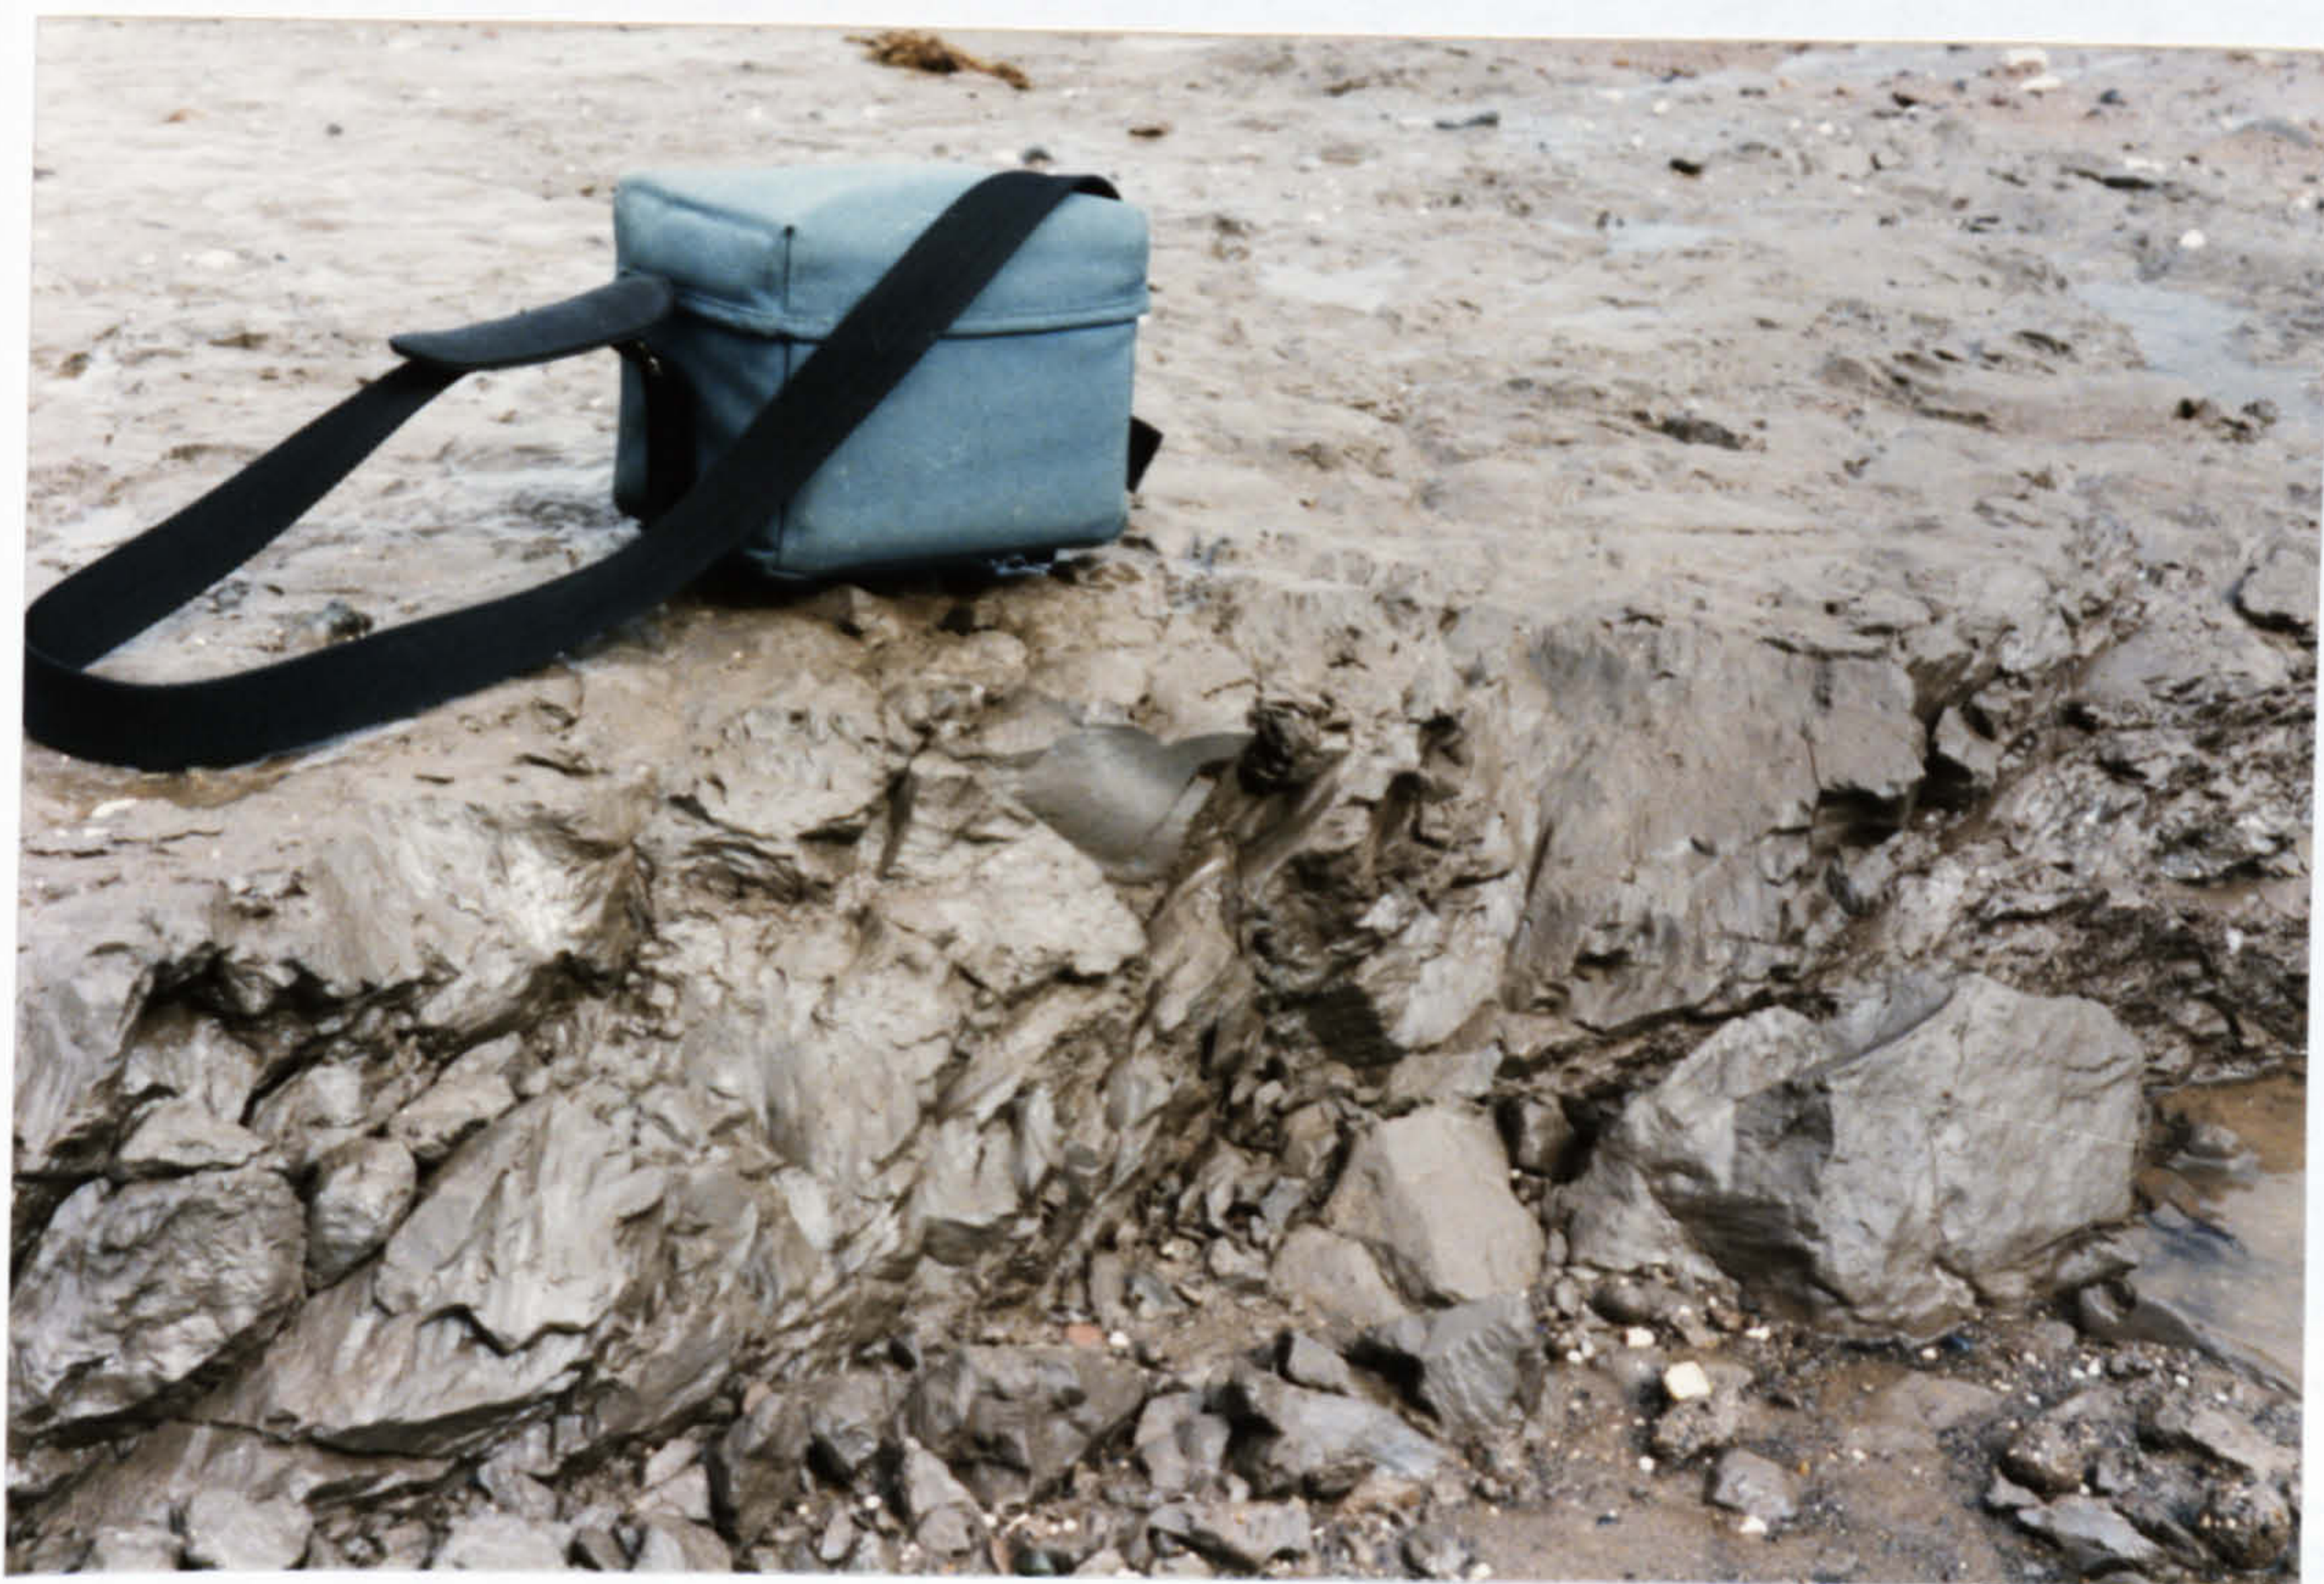
Figure 3.7

In areas where "stone-free" clay layers occur near the cliff foot, the failure surfaces of the slips often appear to be partly within them, giving the slips a flat sole (see Figure 3.23). The slips are base failures with the toe emerging in the foreshore, between 5 and 30m from the cliff foot. The toe is often marked by a low ridge, arcuate in plan, visible when the beach is removed. Sheared "stone-free clay" is sometimes exposed at the ridge (see Figures 3.7 and 3.8). The cliff morphology is of long degraded slips, often multiple and of low slope angle ($20-30^{\circ}$), and continuous along the coastline for several hundred metres (see Figures 3.8 and 3.32). This contrasts with other areas where slips are separated by areas of "till cliff". A description of the main areas affected by "stone-free" clays is given in Appendix C. These include the B.R.E. cliff study site at Cowden where recent work has shown the strong influence of this soil type on the mode of failure (Butcher, personal communication). Complex failures, consisting of three blocks were found to occur.

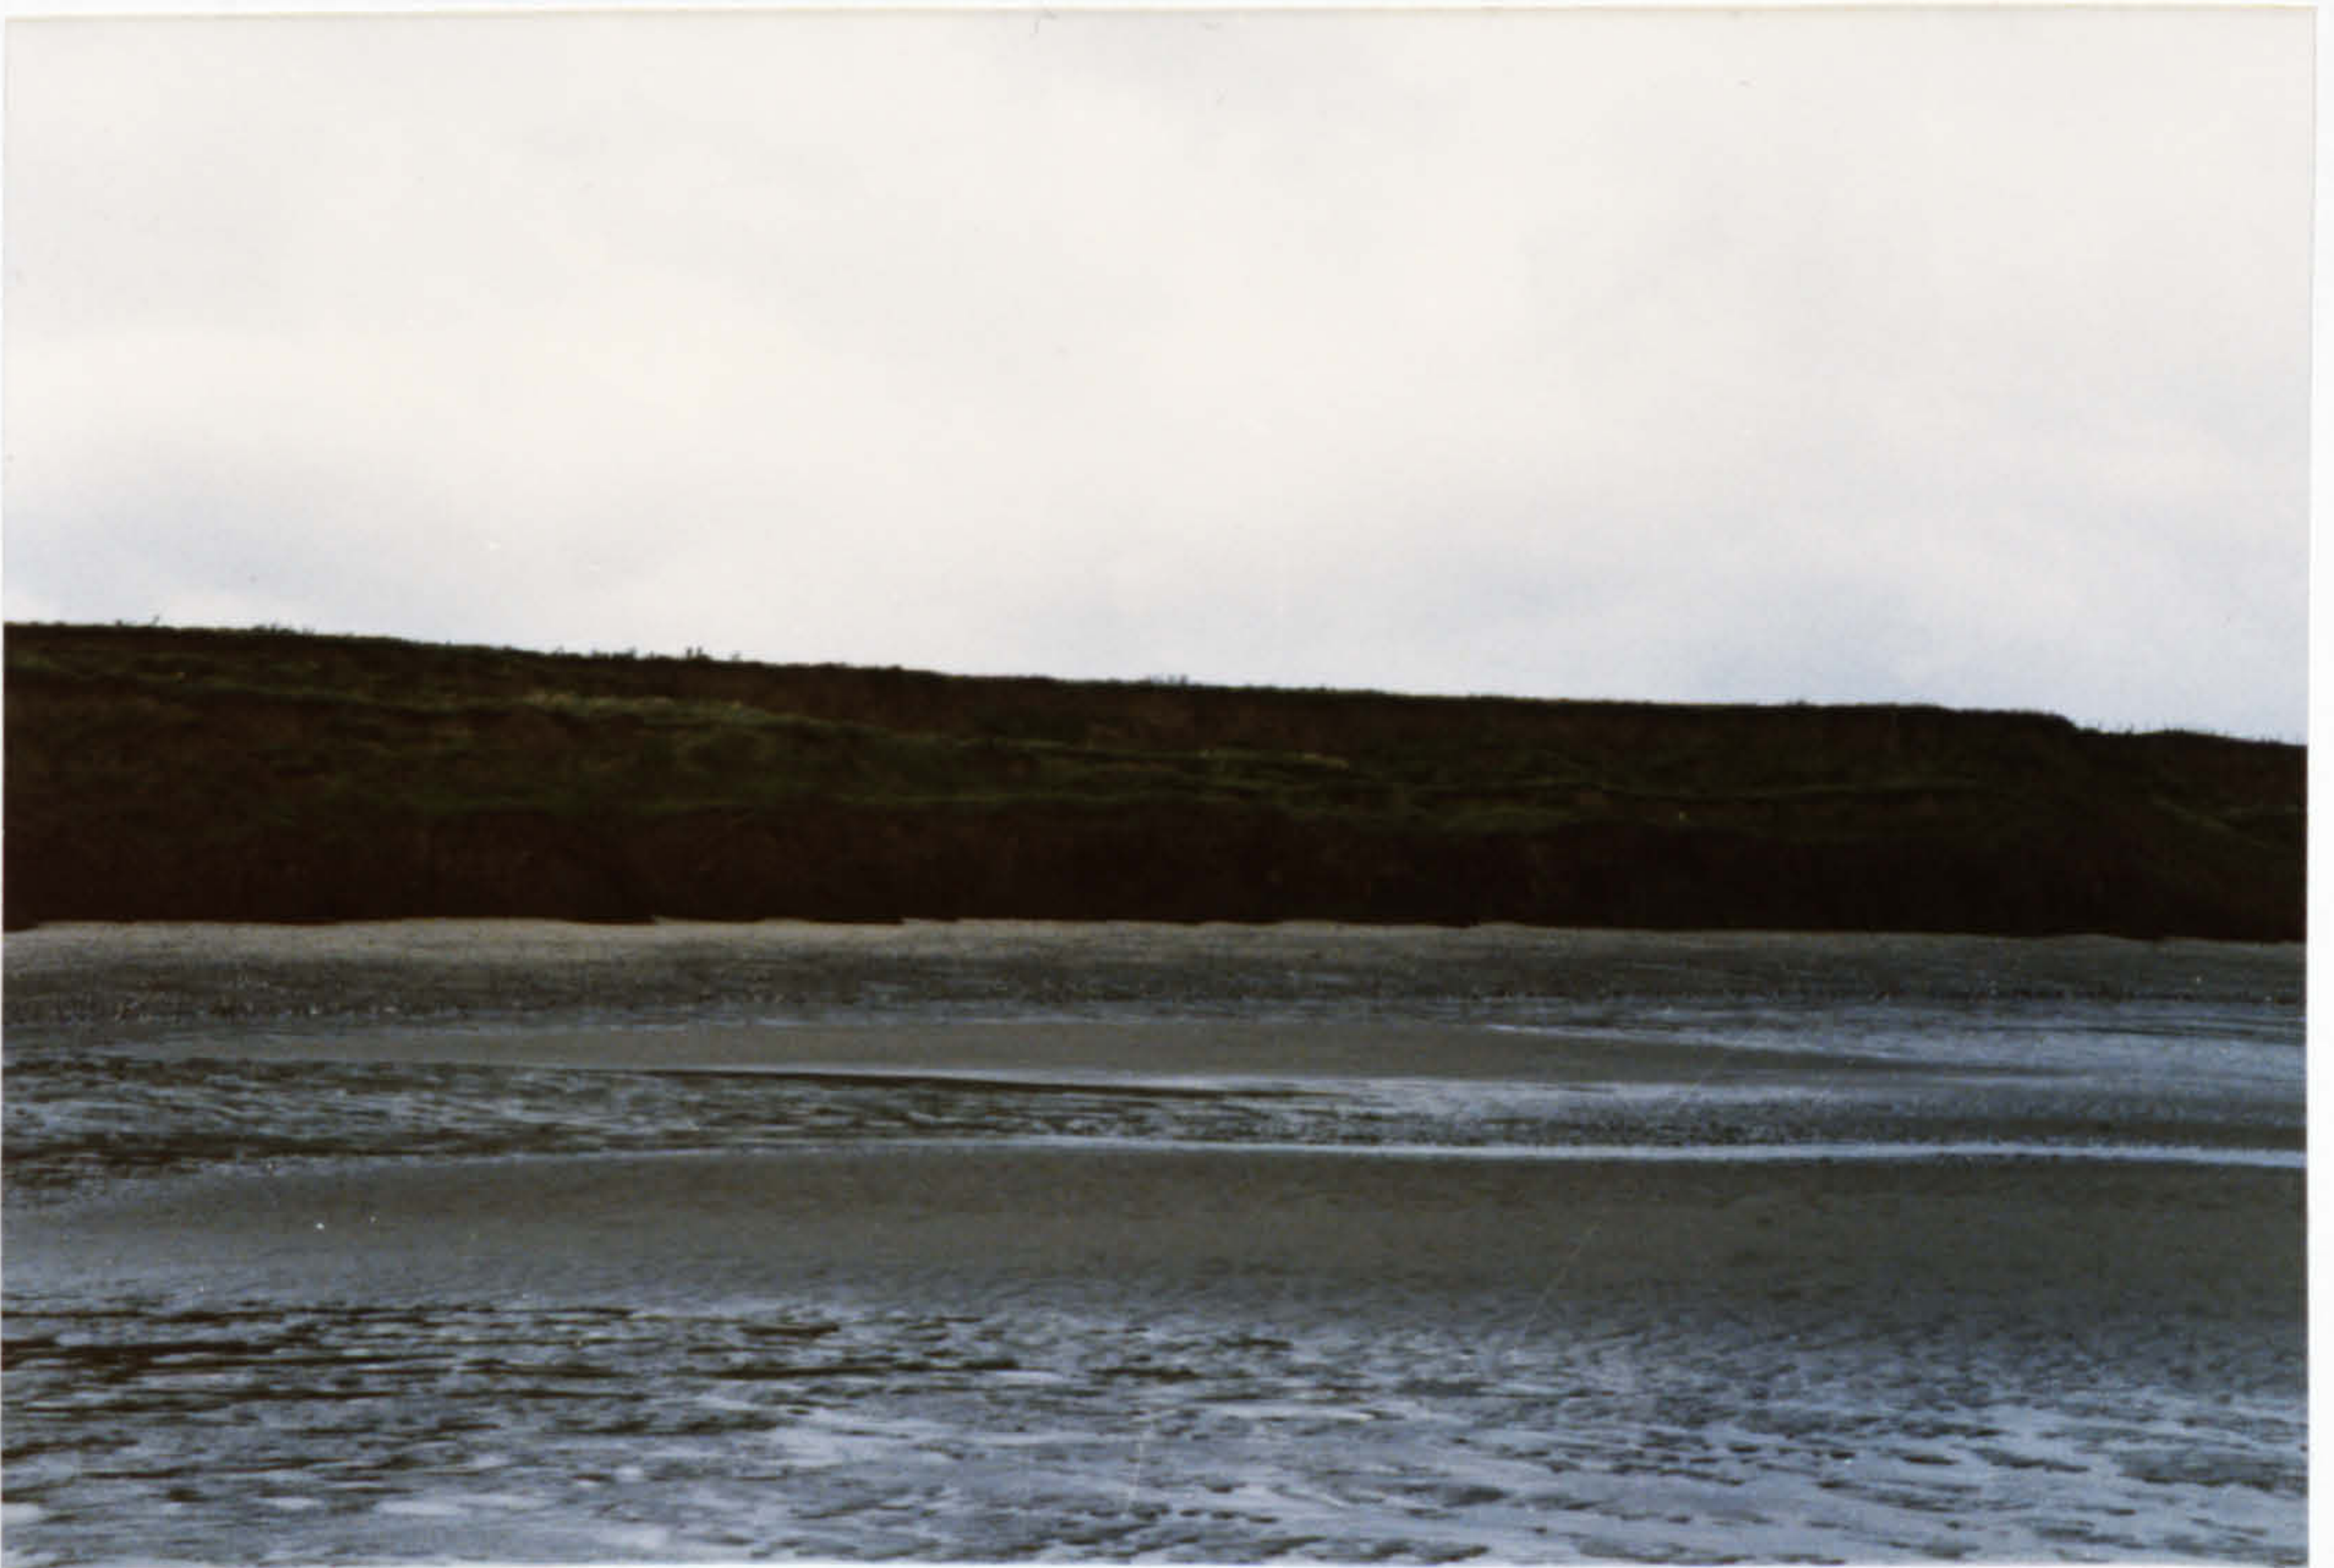
Figure 3.8(b)

Recent slip influenced by the presence of "stone-free" clay. Note two ridges in the foreshore, marking the toe of the present slip and a previous one.

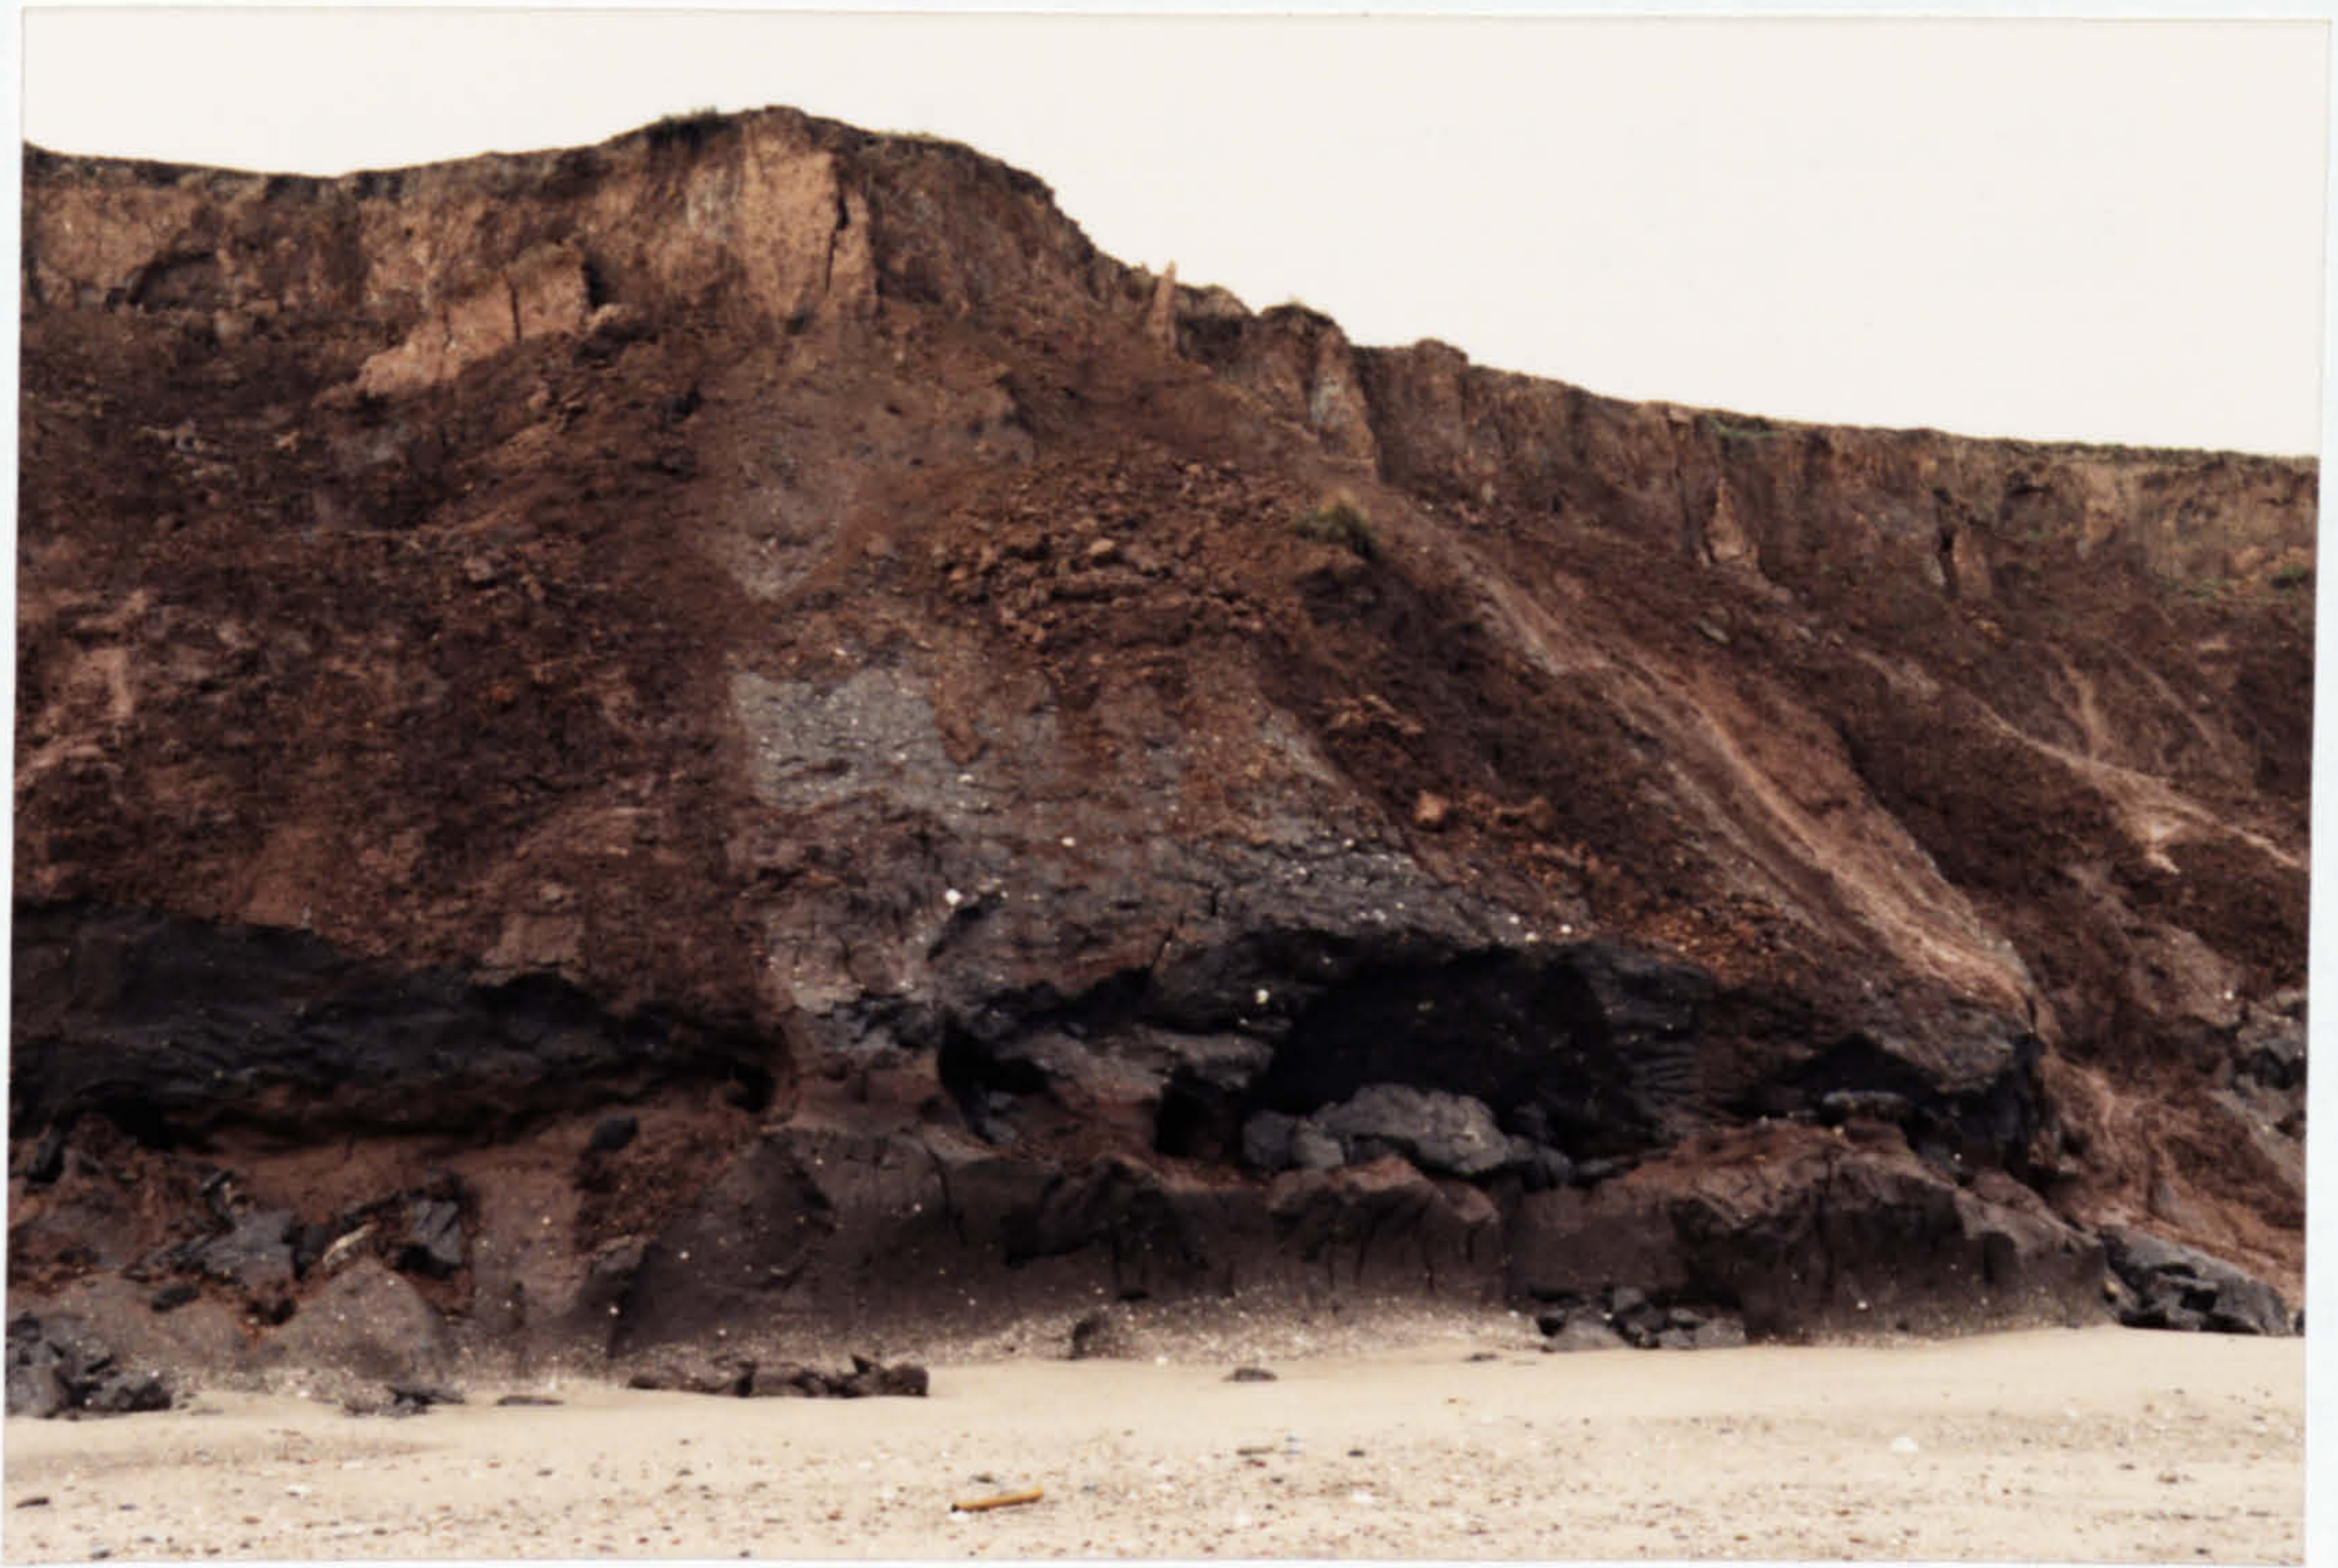
(a) Notch forming in cliffs by erosion of 'red clay' layer.

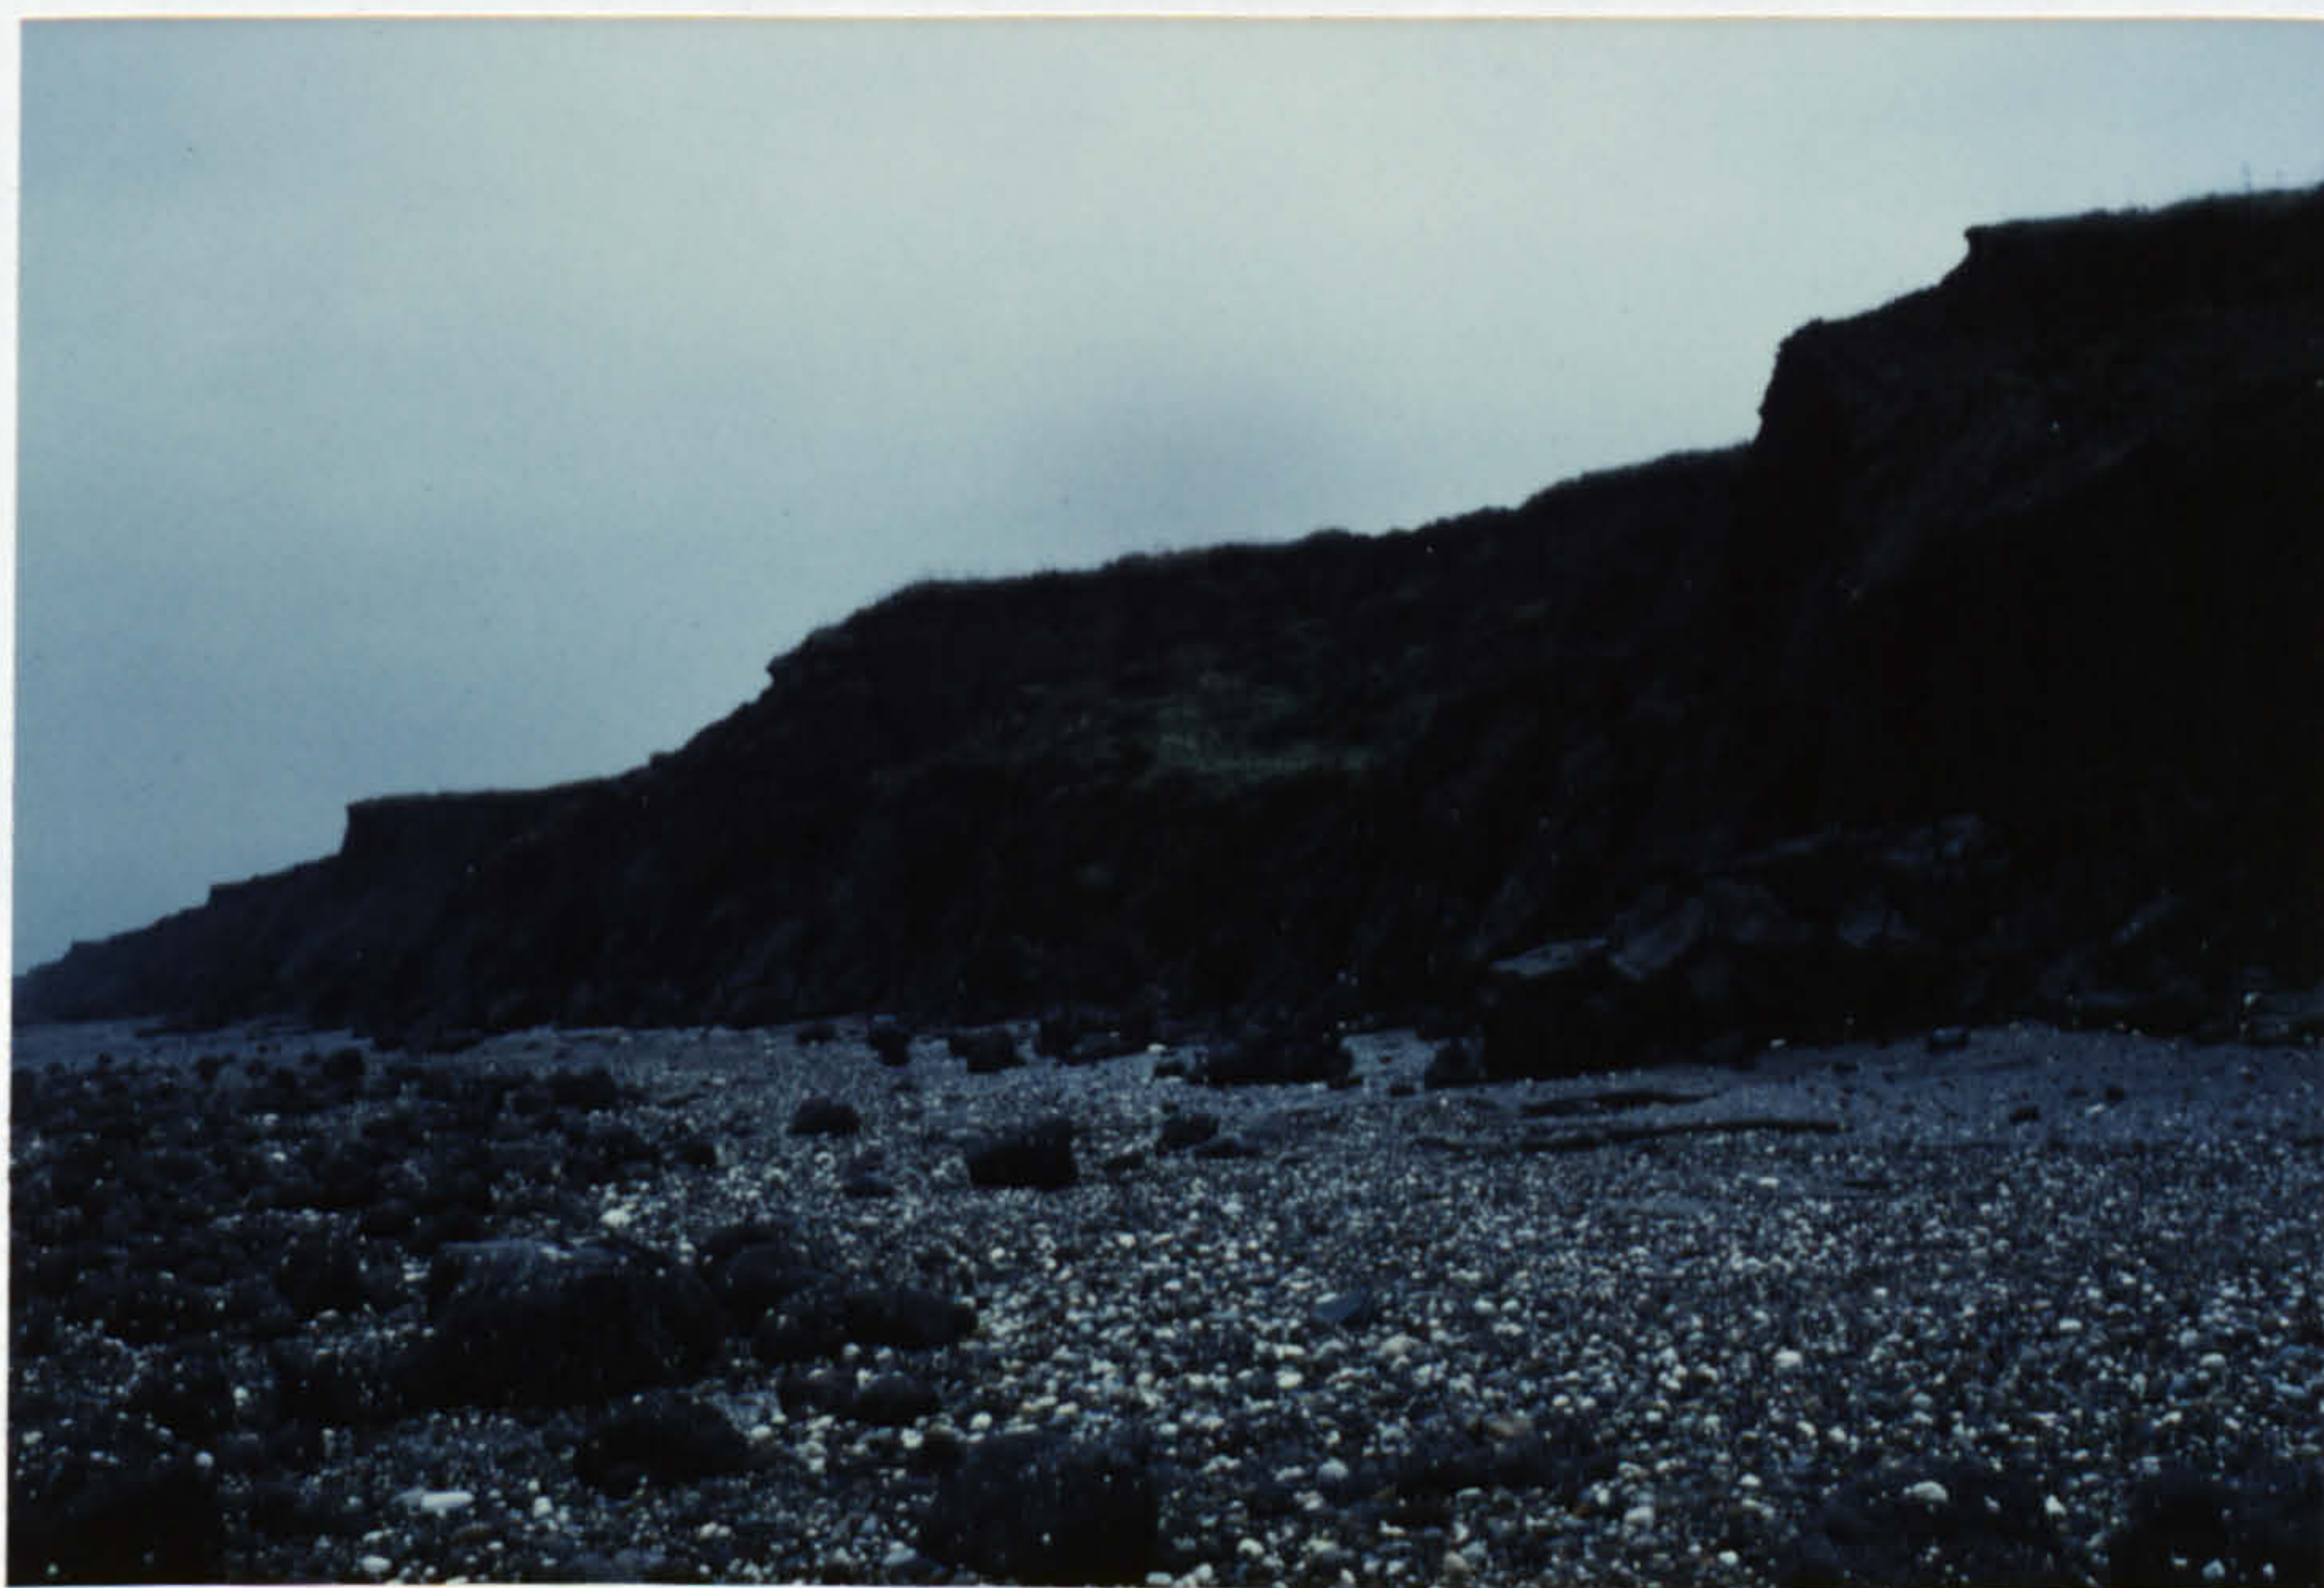
Figure 3-16
'Ord' conditions near Cowden

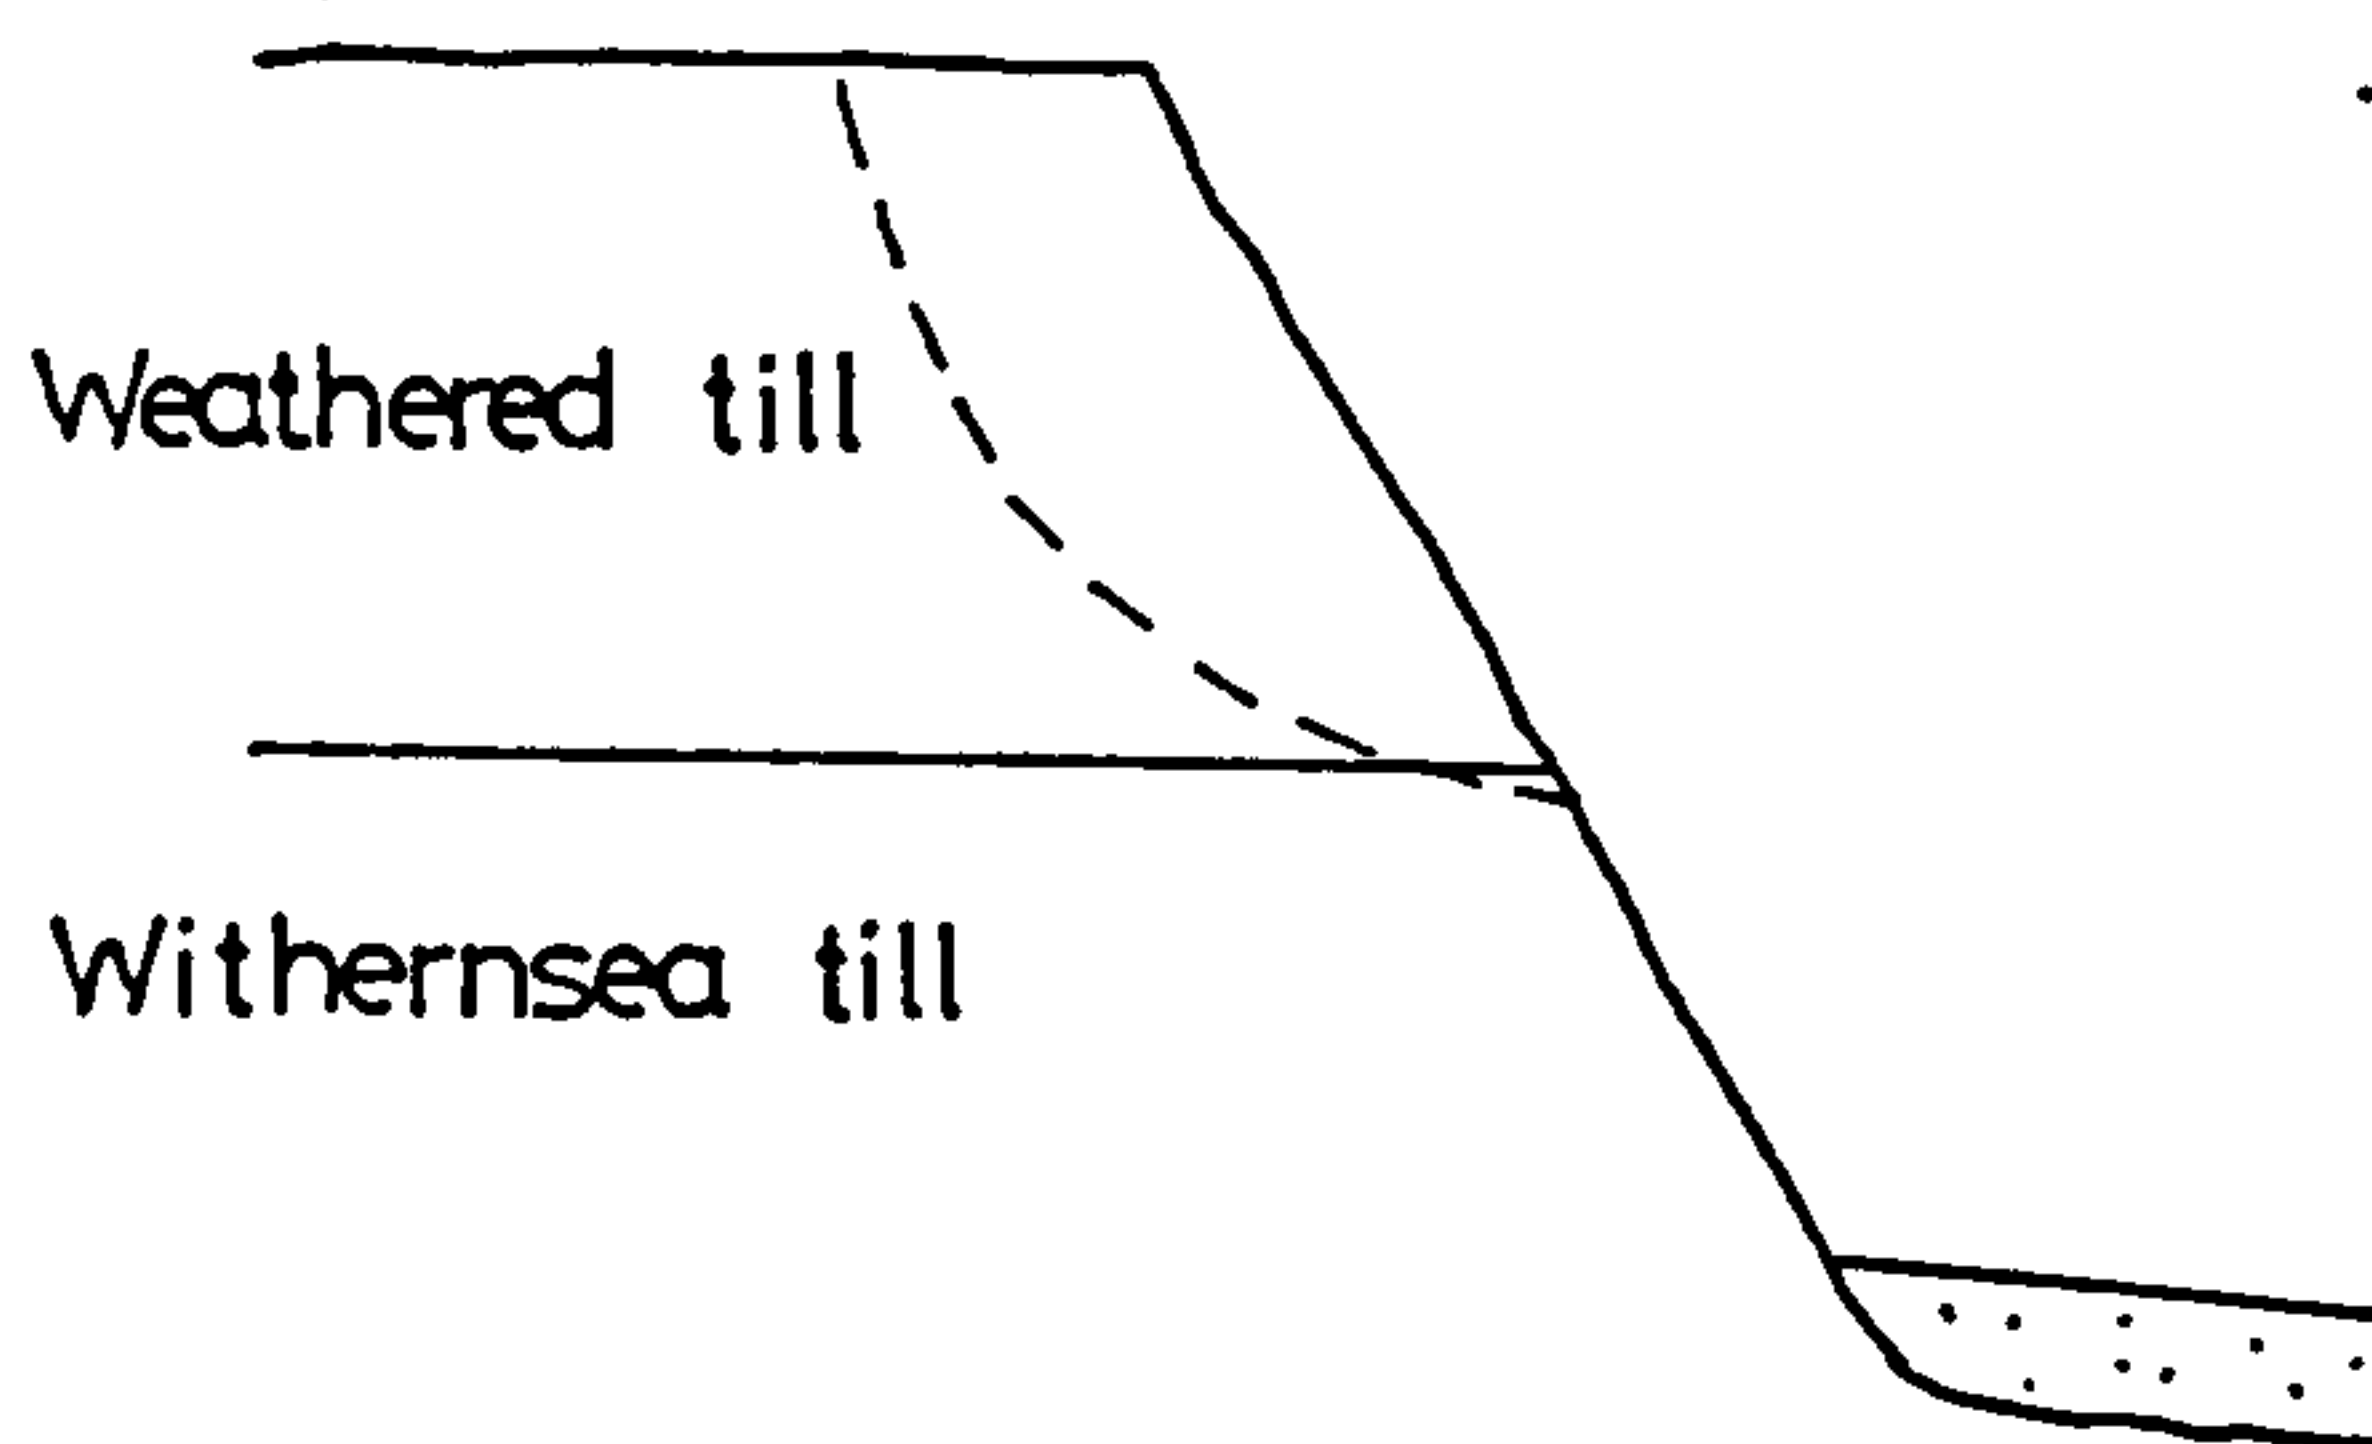
Slope failure
