Erosion and Stability of Till Cliffs
on the Holderness Coast

This thesis is submitted in fulfilment of the requirements
for the Degree of Doctor of Philosophy
in Geotechnical Engineering

Iain Robertson

University of Newcastle upon Tyne
Geotechnical Engineering

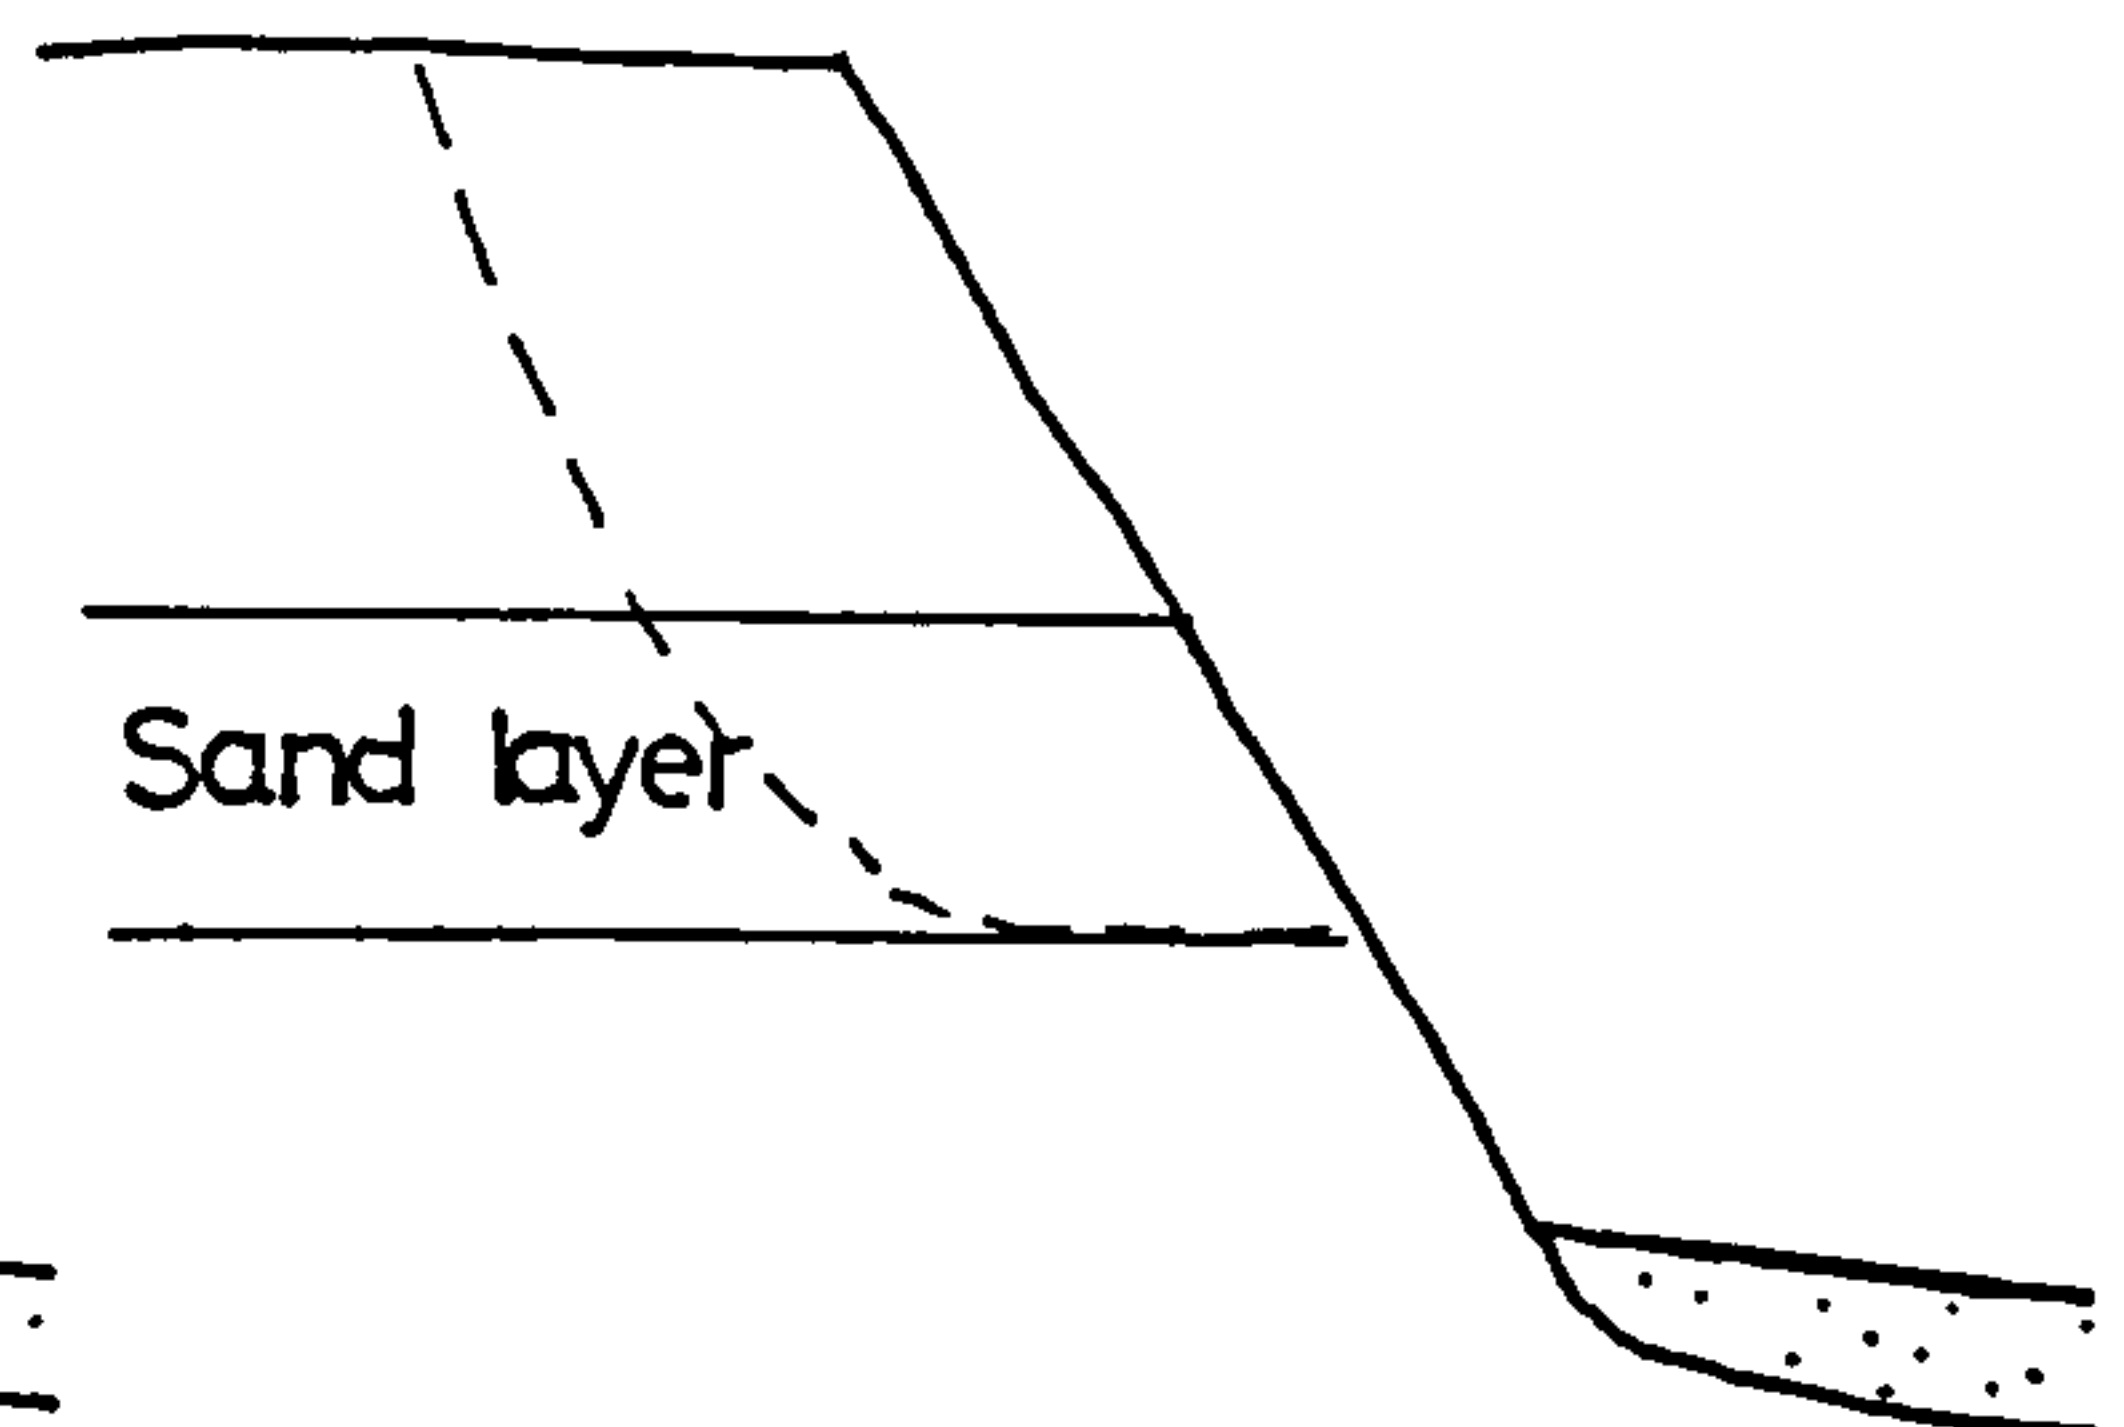
Toe failure (eg. Grimston site) TA 284 359)

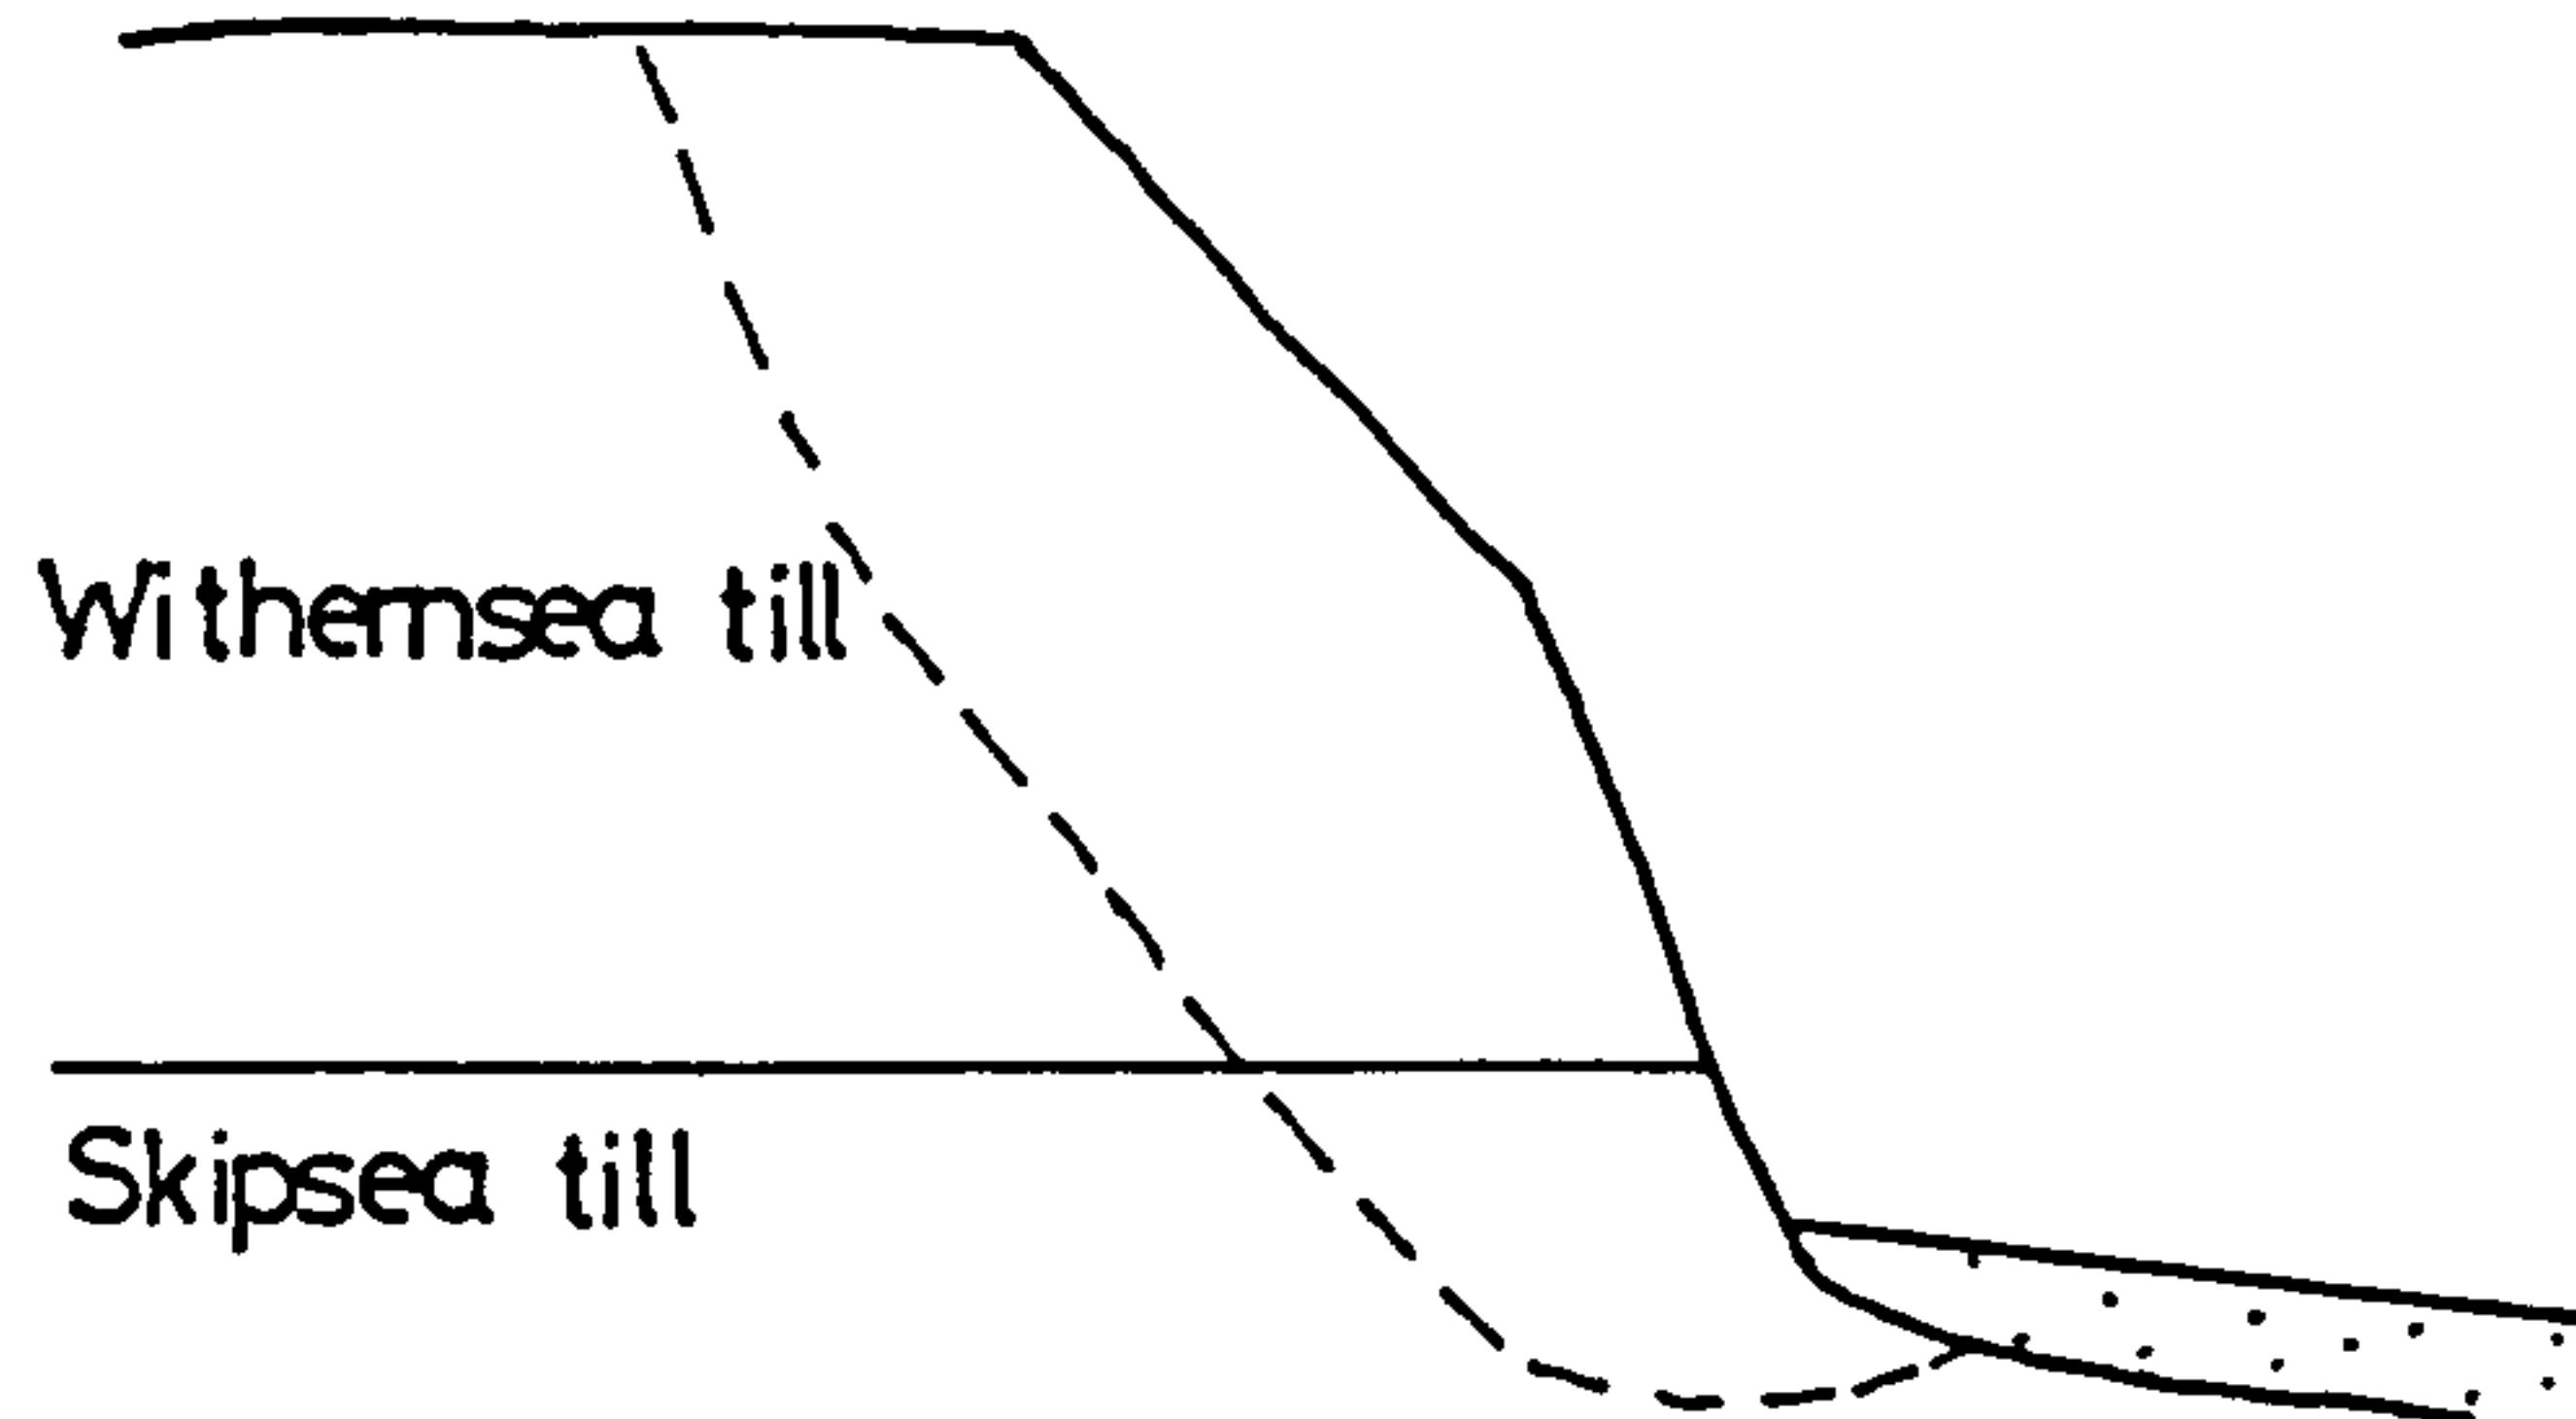
Base failure (eg. South Aldbrough TA 260 393)

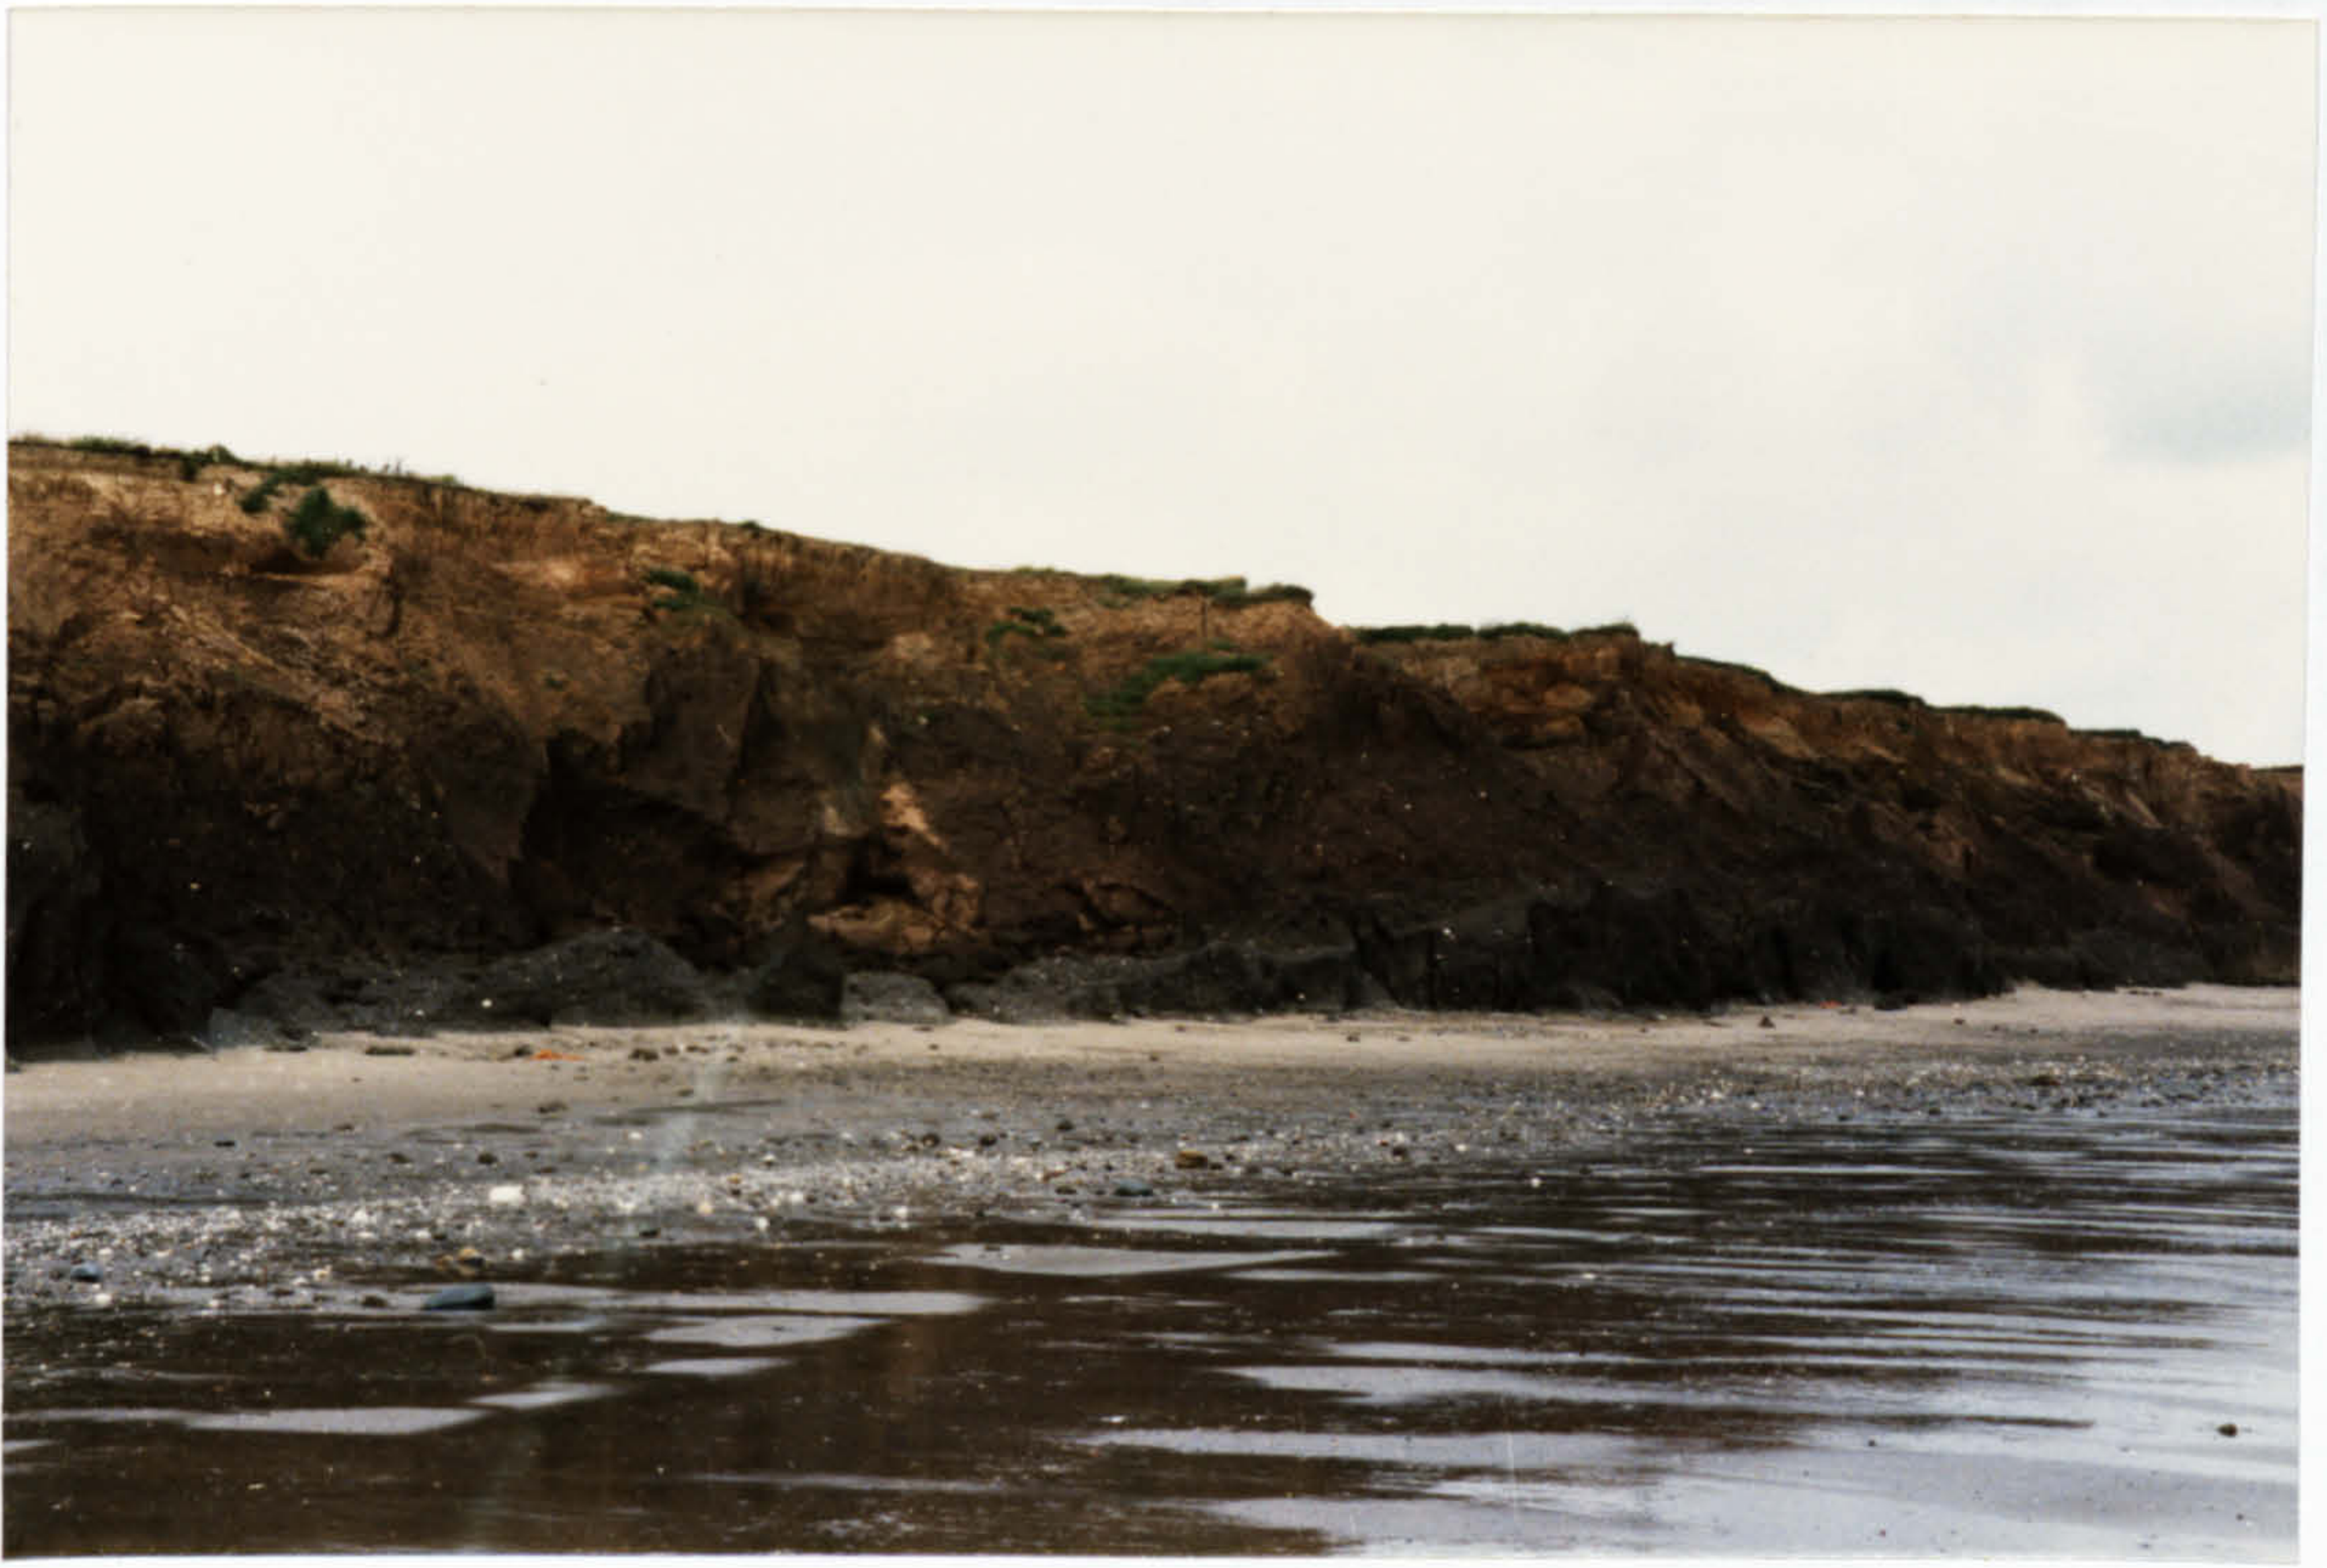
(a) Cliffs near East Newton (TA 269 379)
Note "till cliff" morphology and falls of brown Withernsea till

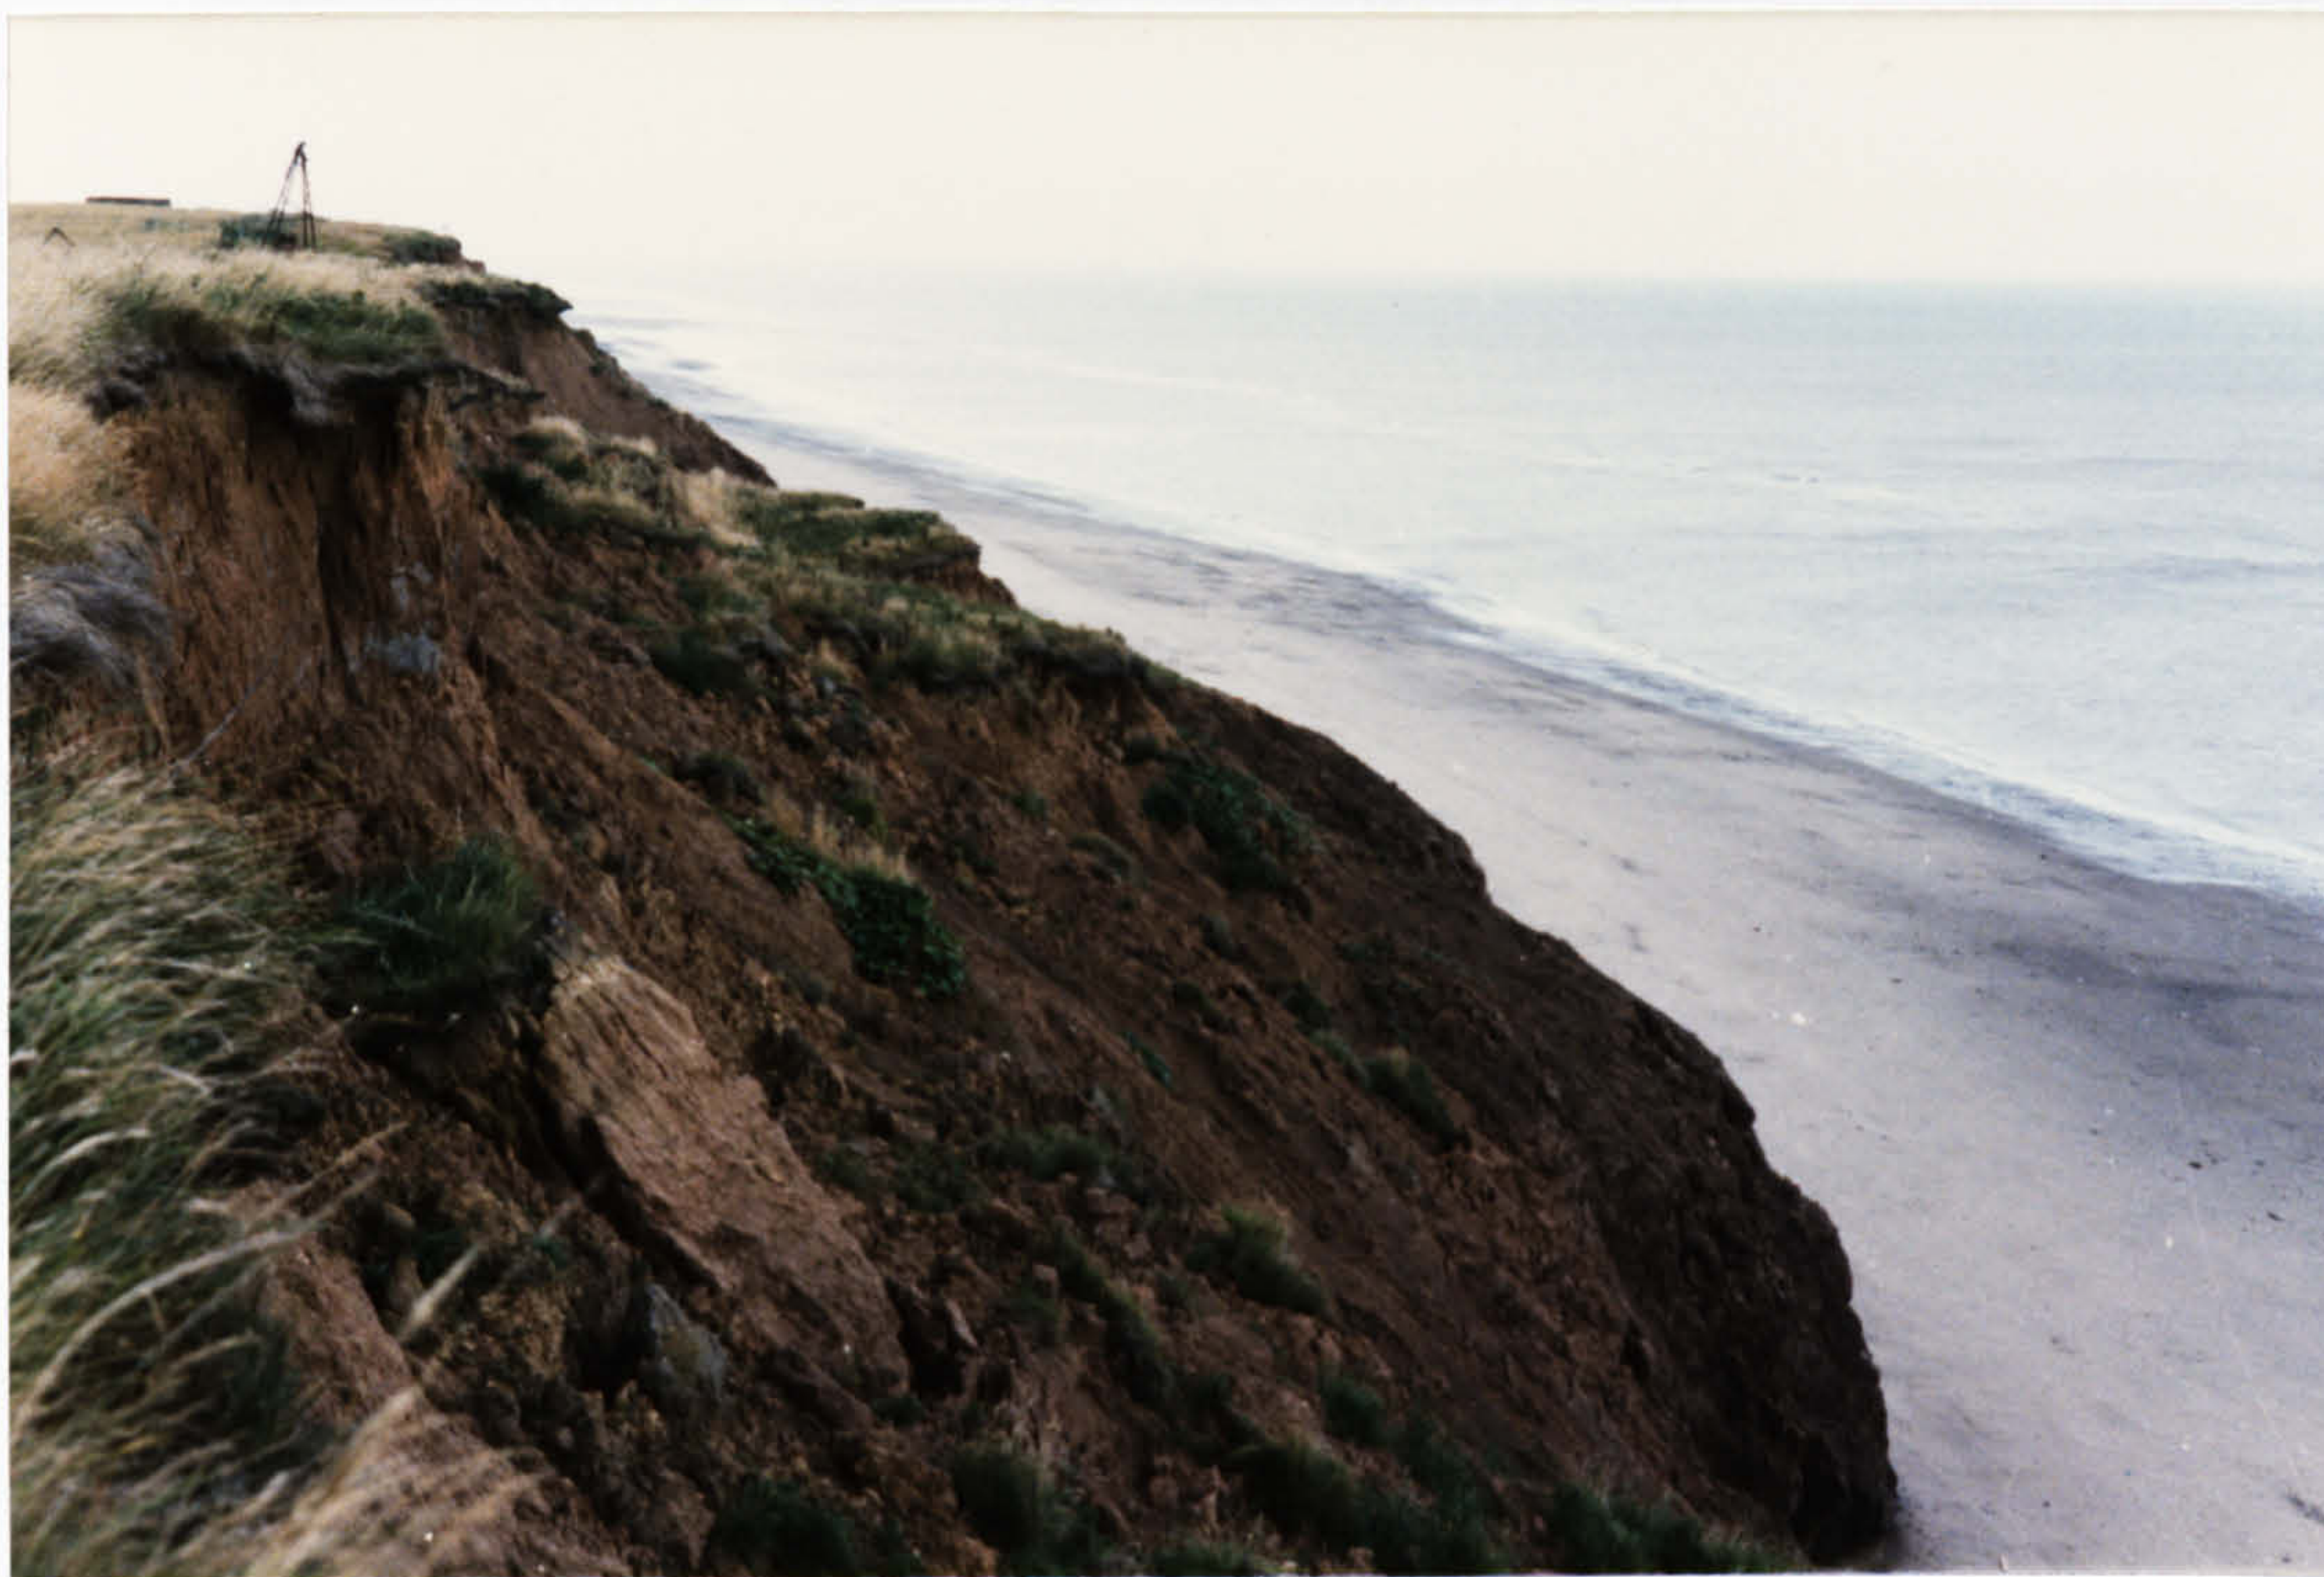
Figure 4.2
General features of the Grimston site

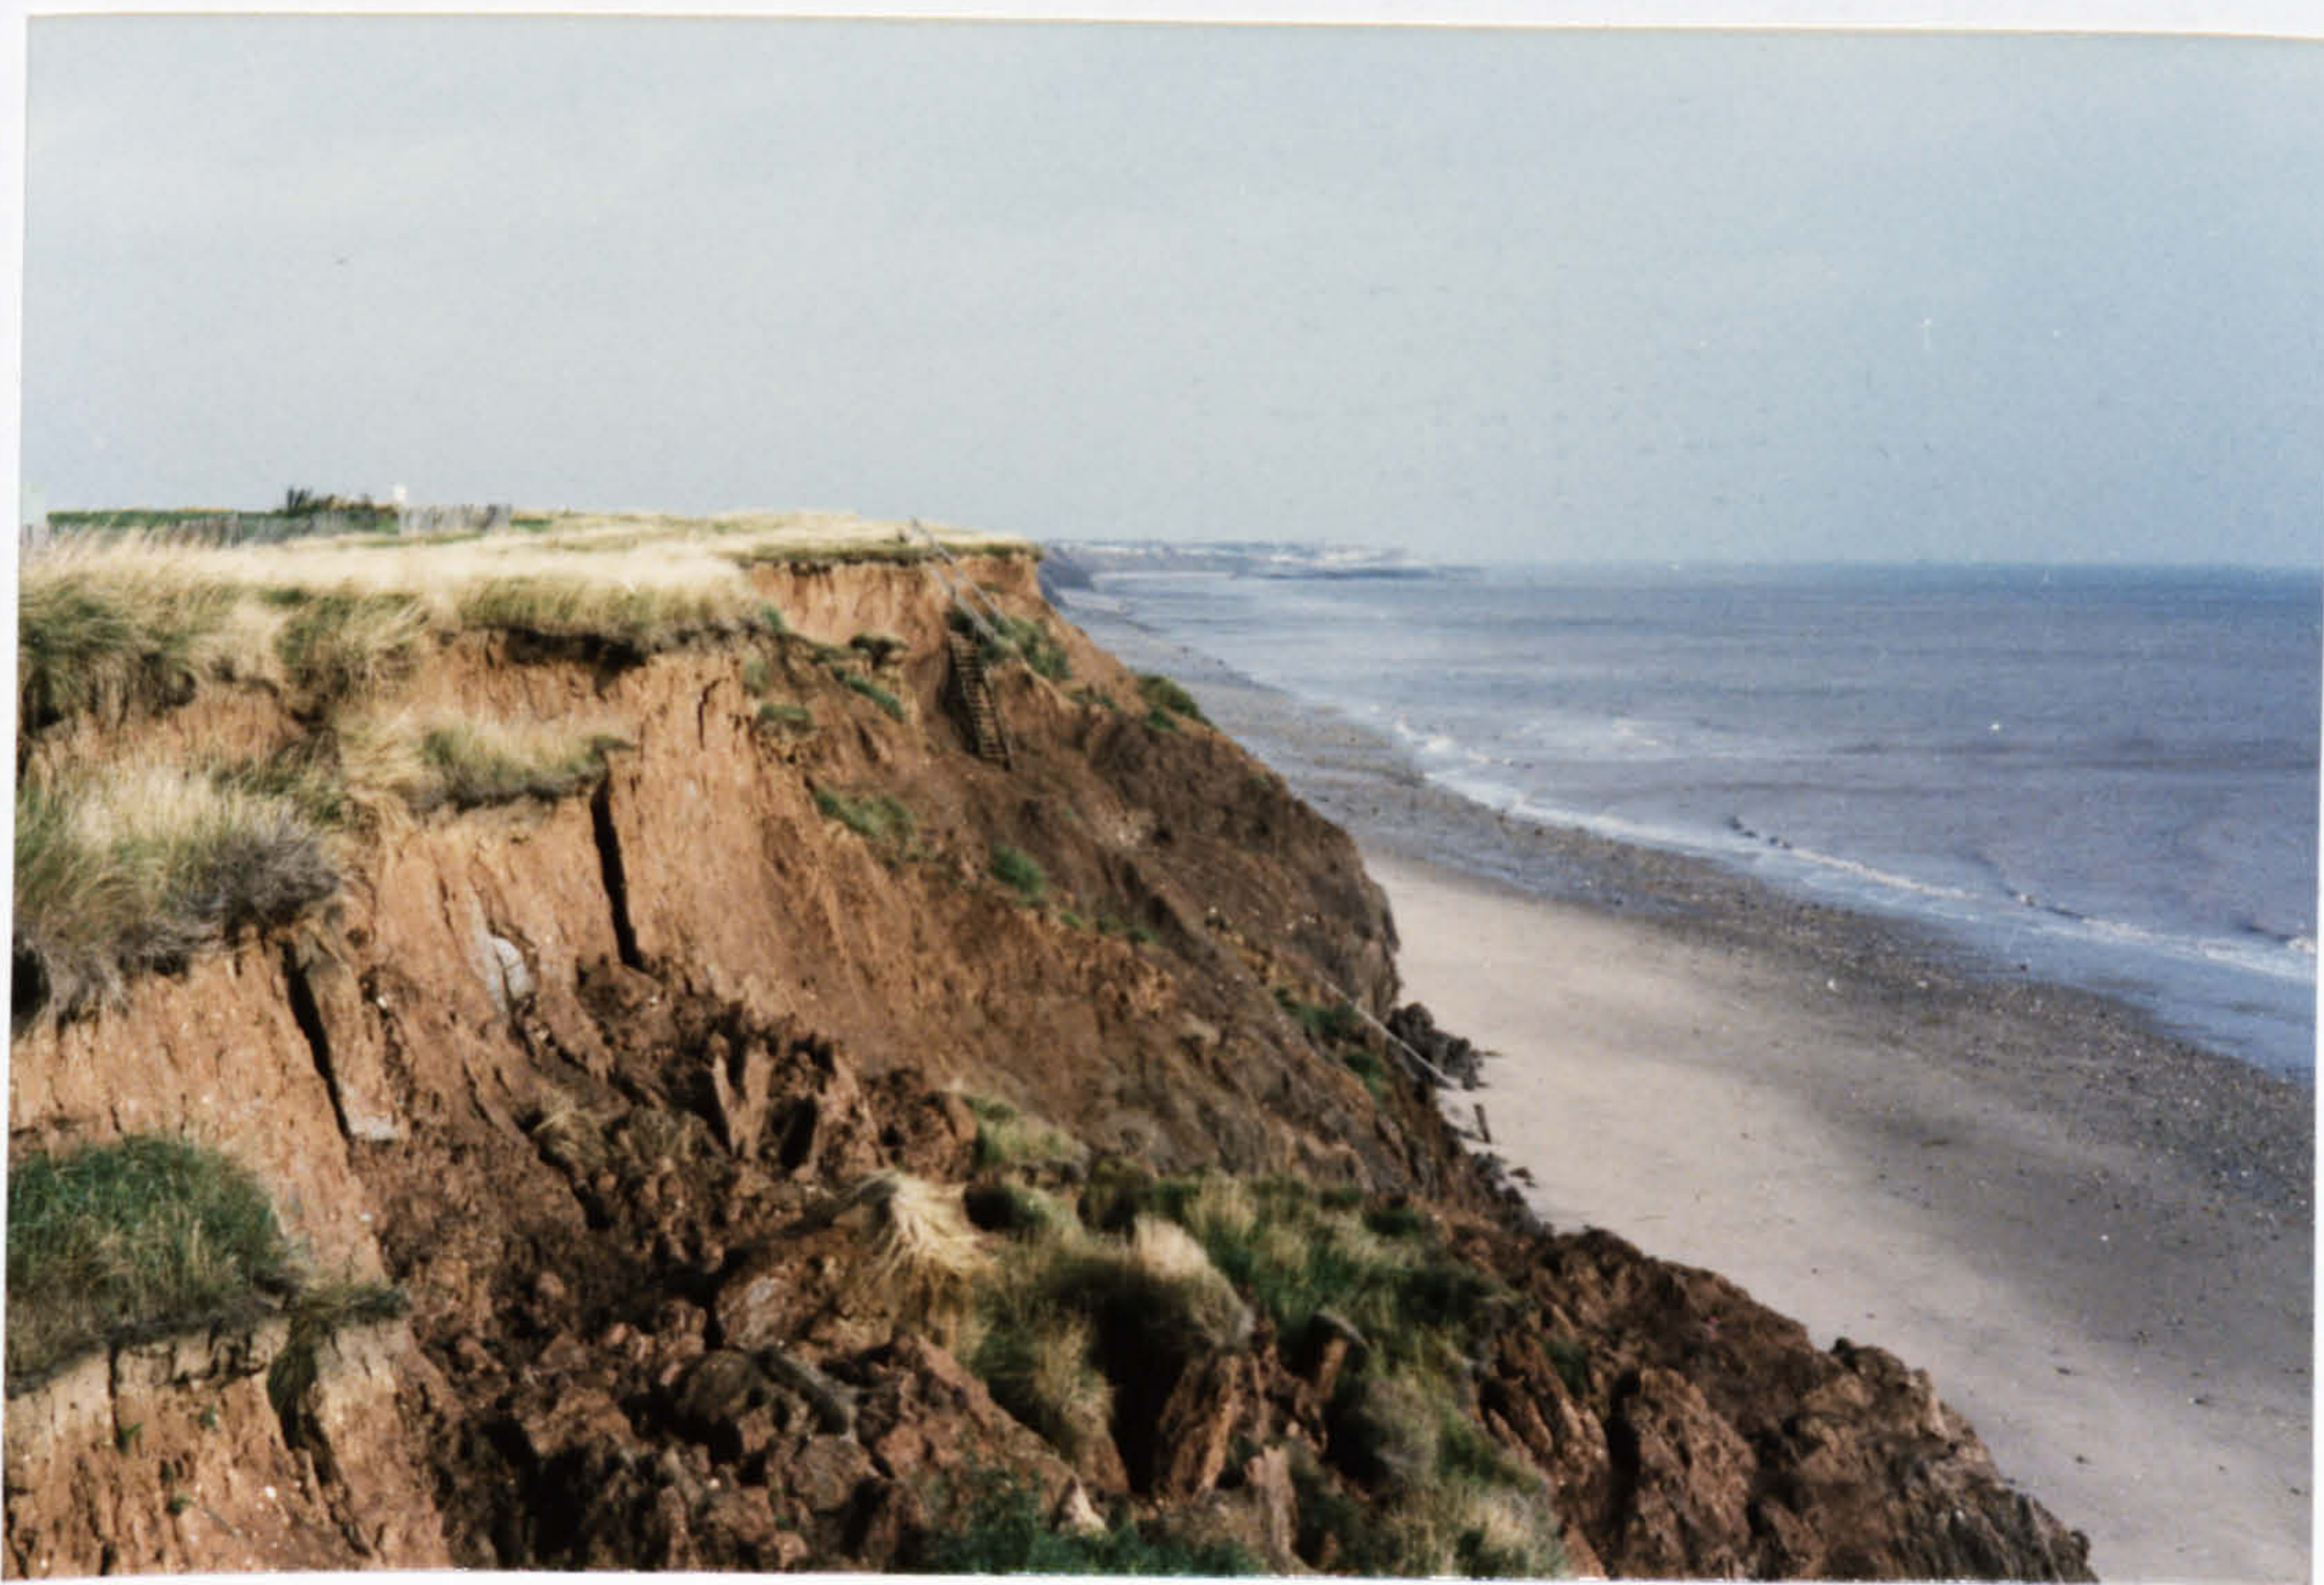
Figure 4.4
General features of the Rolston site

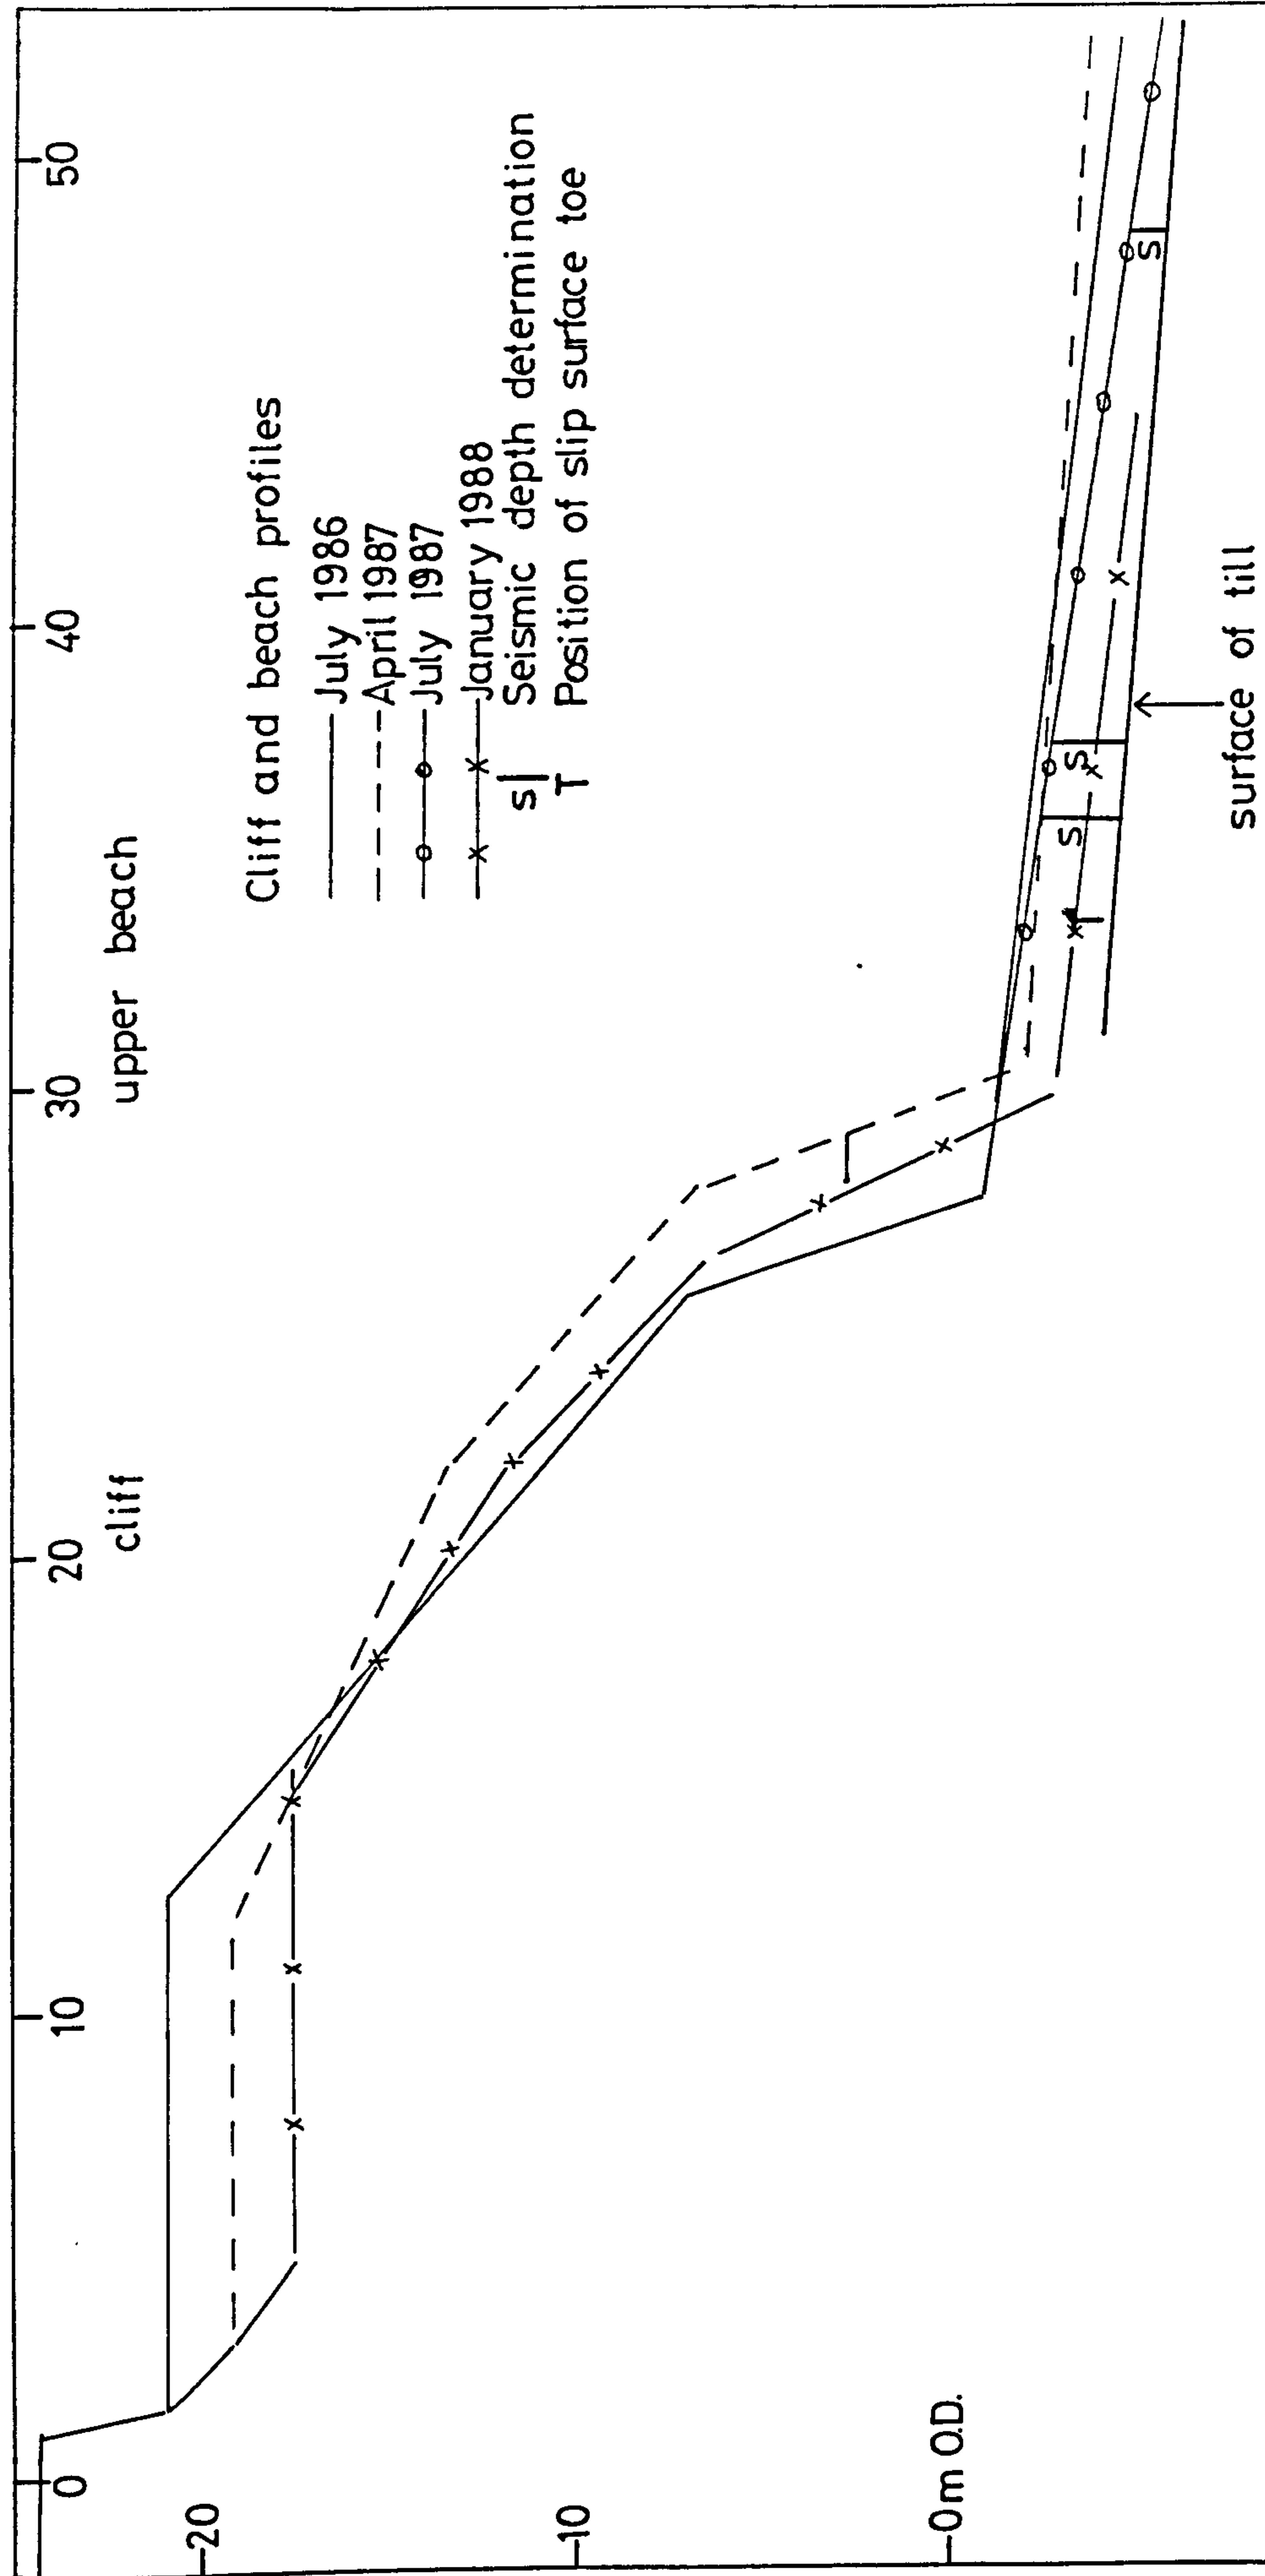
Figure 4:28
Changes in cliff profile for
slip'D' at Grimston
Scale 1:200
