Erosion and Stability of Till Cliffs
on the Holderness Coast

This thesis is submitted in fulfilment of the requirements
for the Degree of Doctor of Philosophy
in Geotechnical Engineering

Iain Robertson

University of Newcastle upon Tyne
Geotechnical Engineering

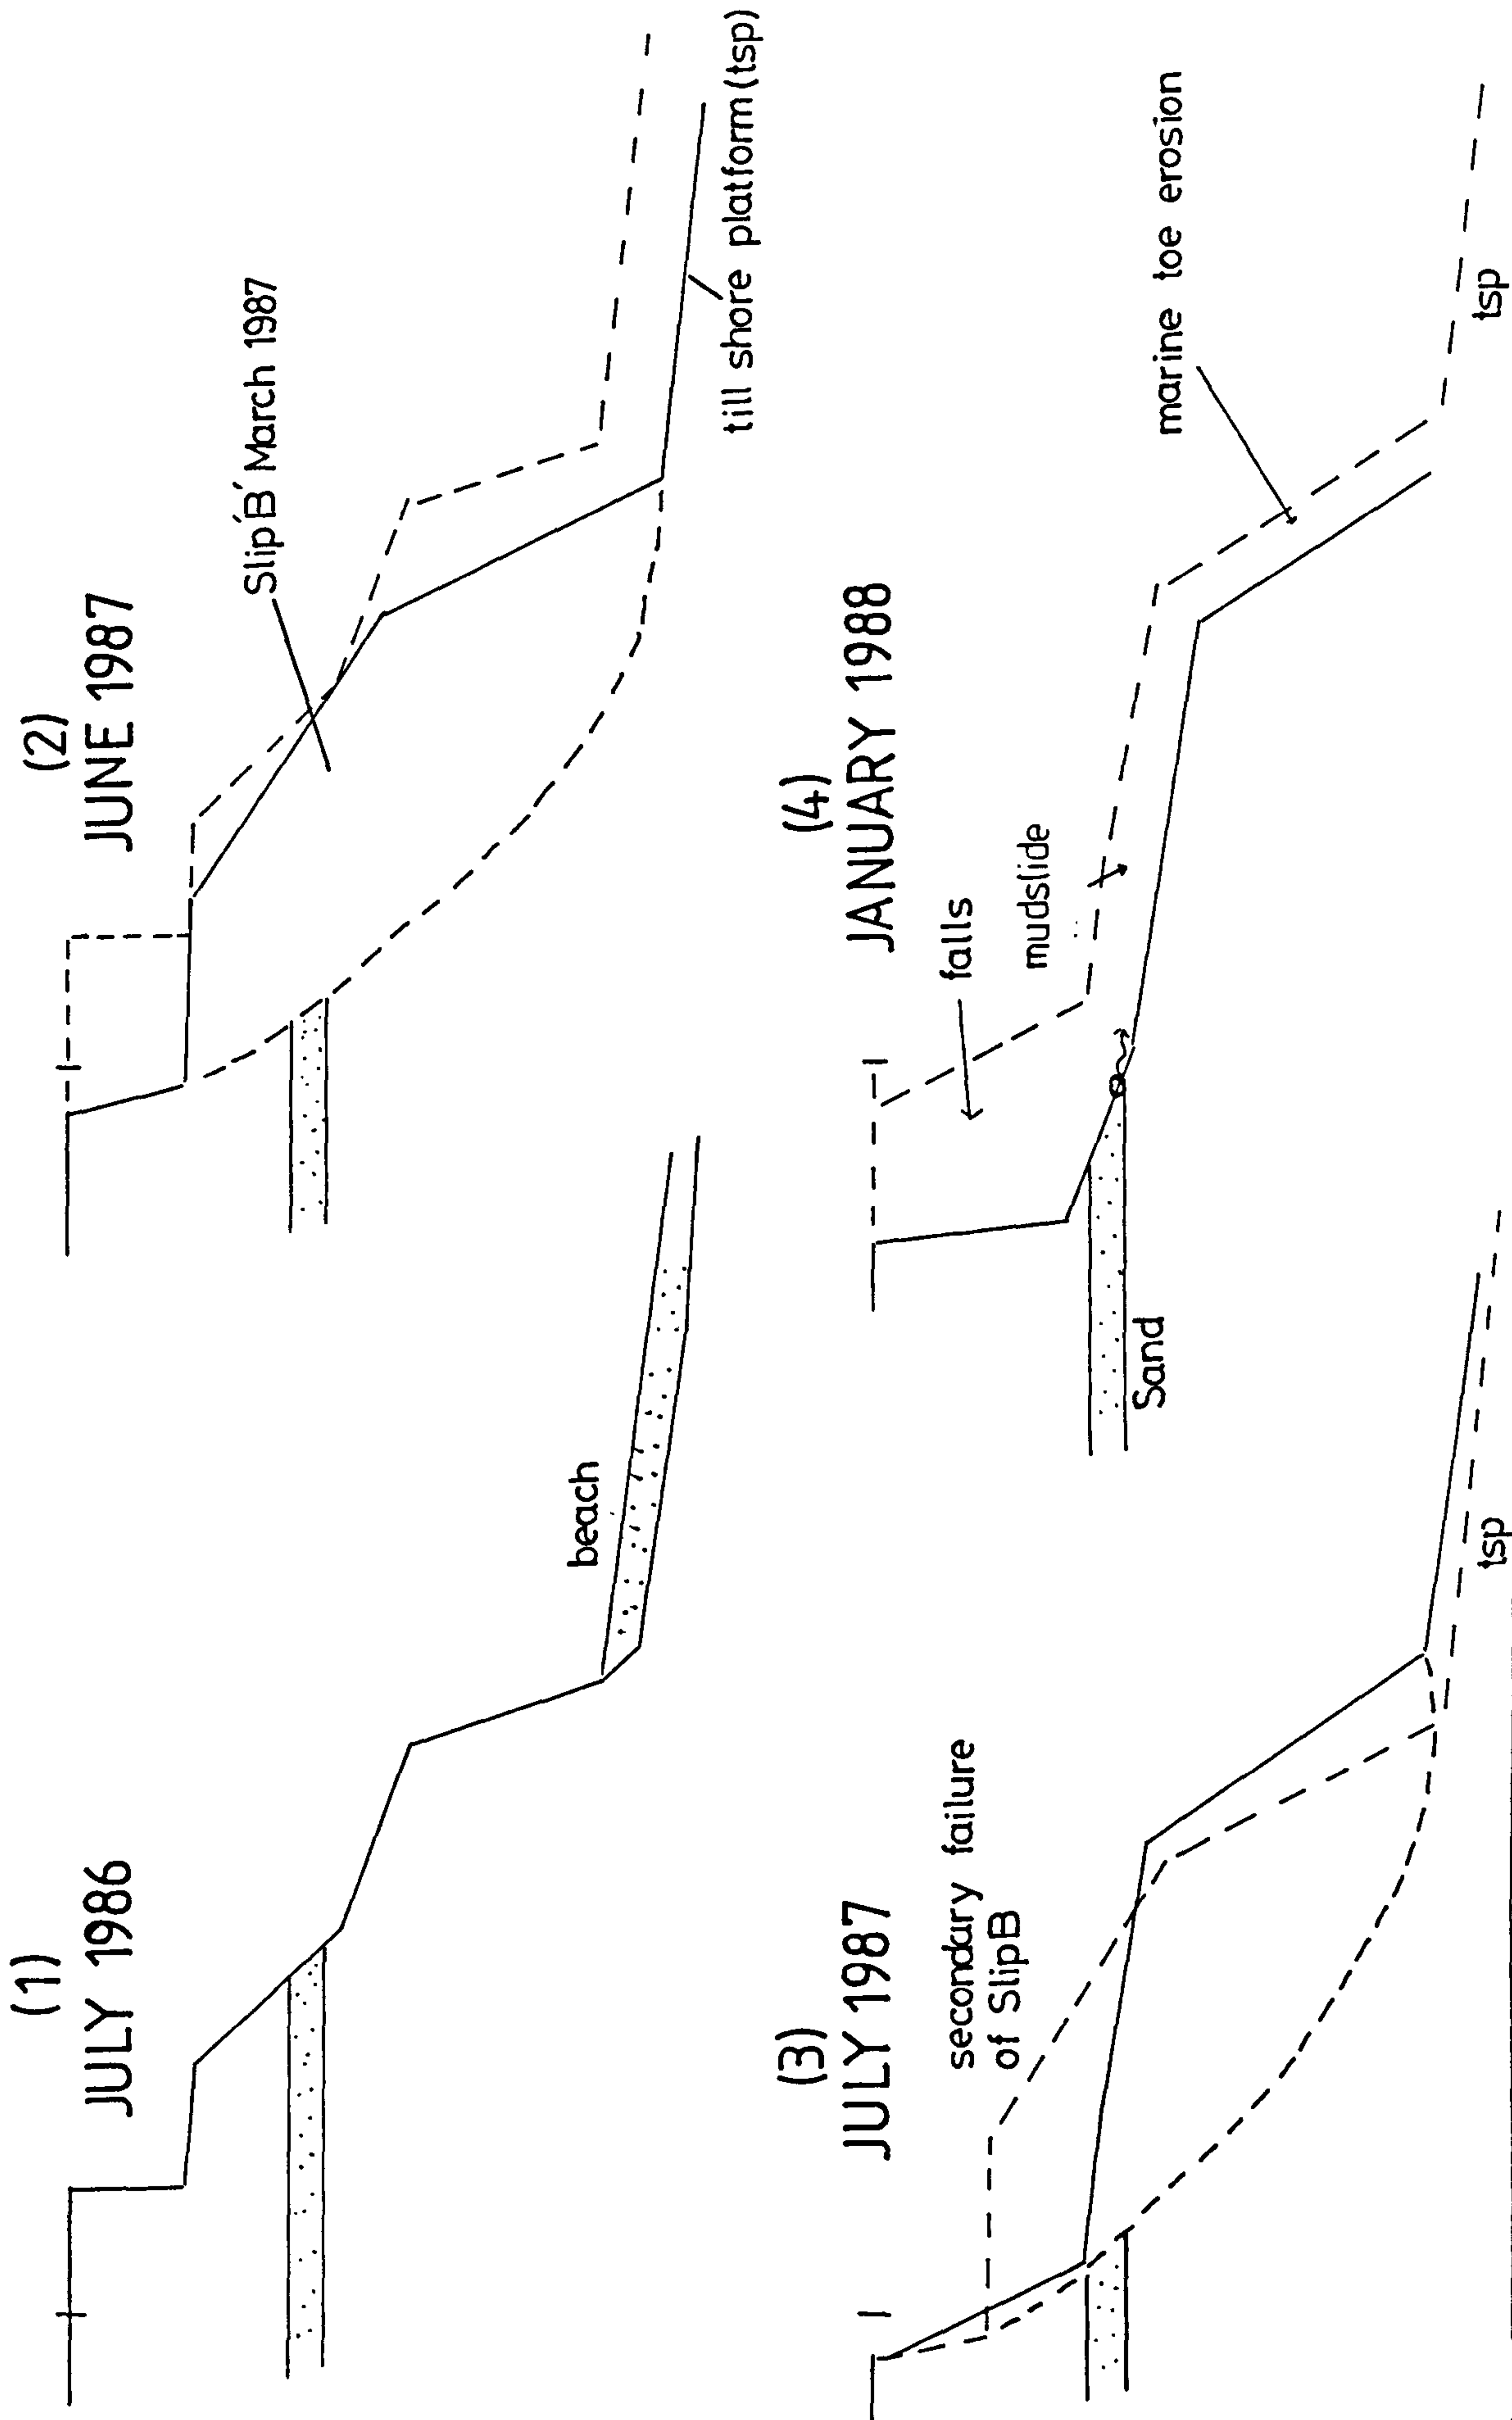
The slipped soil masses at Rolston were broken up quickly by the toe erosion, thus it was impossible to measure their movements. Two of the four major slips were surveyed soon after their occurrence. The profiles are shown in Figure 4.35, together with the estimated slip surface. The shape of the slip surface could not be found precisely owing to the lack of slip movement measurements. However it was probably similar to the Grimston slips, from examination of exposed slip surfaces nearby. Also the slipped soil masses are backtilted less than would be expected for a circular slip. The position of the toe was not influenced by the unusual red clay layer near the cliff foot.

FIGURE 4-33
 ROLSTON CLIFF PROFILE CHANGES
 SCALE 1:250
