Hip simulator wear testing of the taper-trunnion junction and bearing surfaces of modular hip prostheses

**This thesis is submitted in partial fulfilment of the requirements for the
Degree of Doctor of Philosophy**

**Newcastle University
School of Engineering**

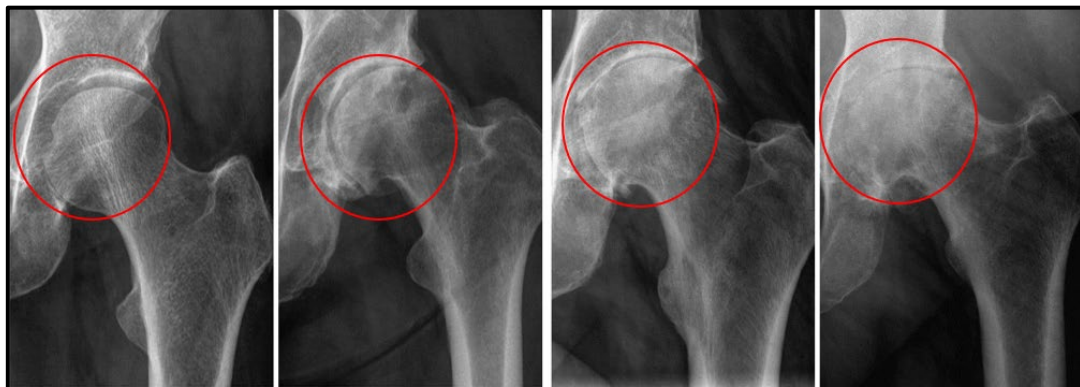
Figure 10 X-rays (from left to right) showing the joint space narrowing (inside the red circle) due to osteoarthritis. Image from Altman and Gold (2007)⁶³.

Osteoarthritis was responsible for 90% of the primary hip replacement surgeries as per the 15th Annual Report of the National Joint Registry (NJR) for England, Wales, Northern Ireland, and the Isle of Man (2016/17)⁵. In osteoarthritis, the articular cartilage of the load-bearing joints degenerates leading to rubbing of bones against each other, causing distress due to pain, inflammation, swelling and reduced range of motion⁶² see Figure 10.

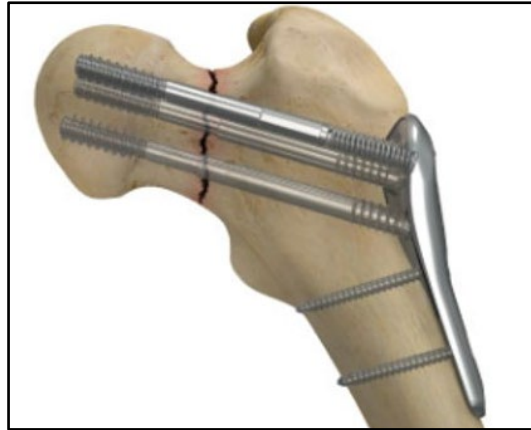
Figure 12 The CONQUEST FNT™ system launched by Smith & Nephew in June 2019. Image from Smith & Nephew (2019)⁷².

Since the year 2000, there were 1.6 million incidents (over 50 years age) of hip fracture occurred due to osteoporosis out of which 70% were women⁷⁰. Sambrook and Cooper estimated that the number of hip fractures worldwide would increase from 1.7 million in 1990 to 6.3 million in 2050⁷¹. Internal fixation devices such as bone screws are typically used for the femoral neck fractures, see Figure 12, but more complicated fractures are treated with hip replacement surgery.

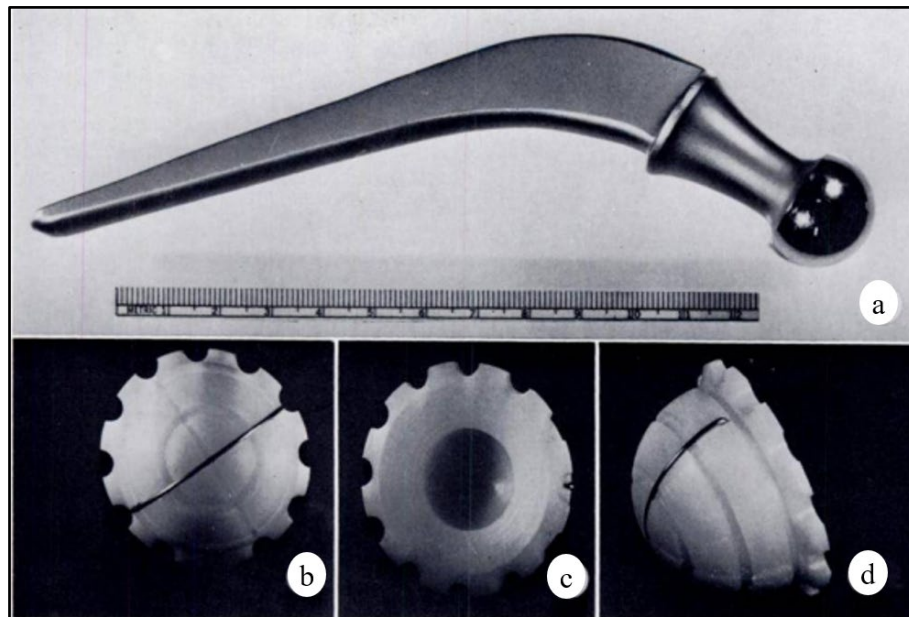
Figure 17 Charnley's low friction THR a) the stainless-steel femoral component and b), c) and d) high-molecular-weight polyethylene acetabular component. Image from Campbell and Rothman (1971)⁹⁸.

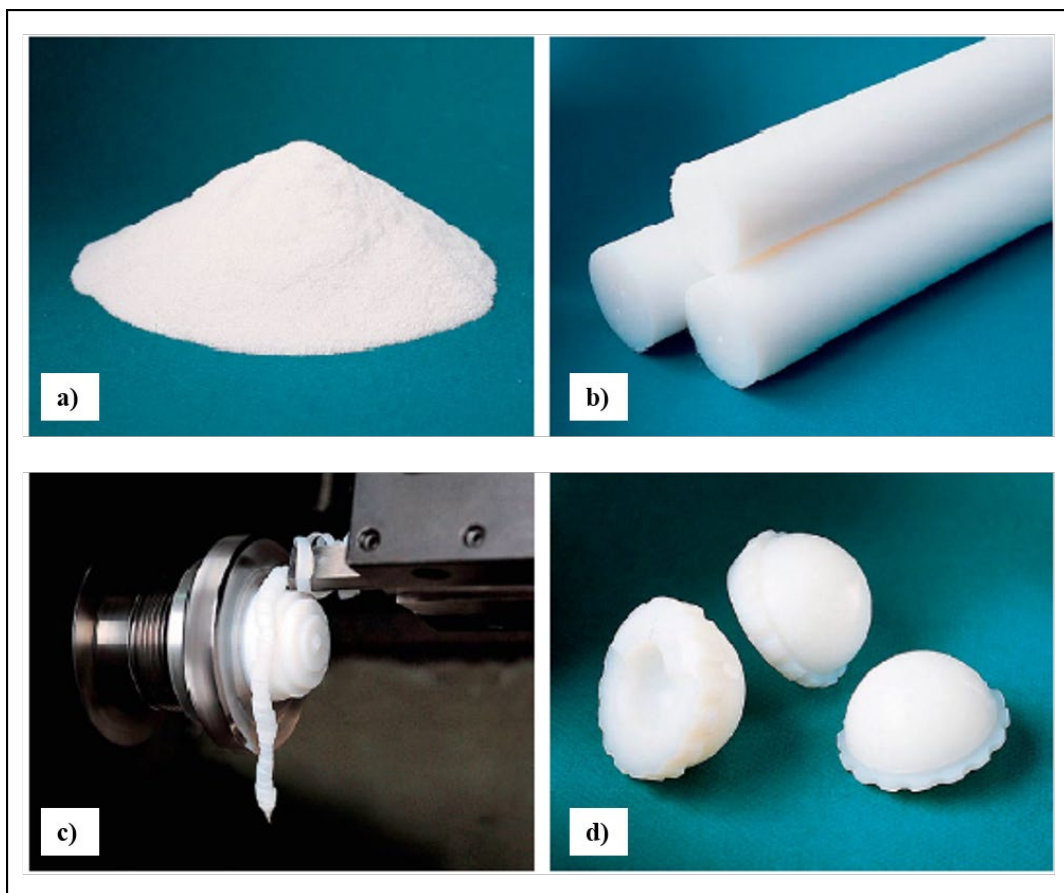
Figure 25 Processing of UHMWPE acetabular liners. a) UHMWPE resin powder, b) semi-finished UHMWPE rods that have been consolidated from the UHMWPE resin powder, c) Machining of the UHMWPE rods on a lathe, and d) UHMWPE acetabular liners after machining. Image from Kurtz (2009)¹³⁷.

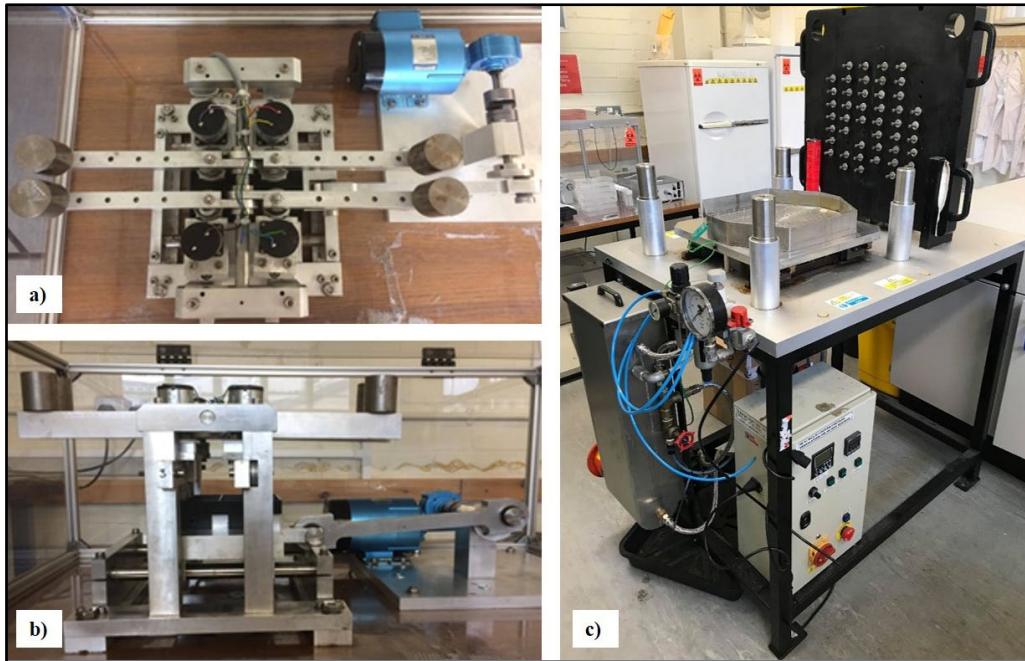
Figure 29 a) and b) shows top and side views of pin-on-plate wear testing rig respectively and c) shows pin-on-disk rig from the Biotribology lab, Newcastle University.

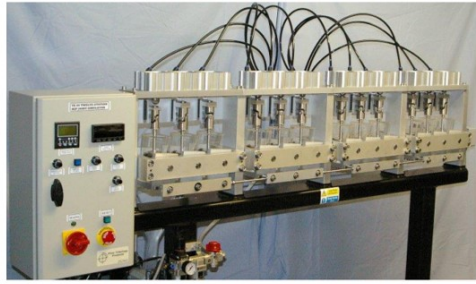
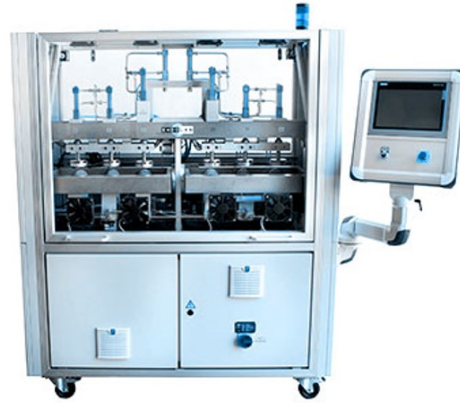
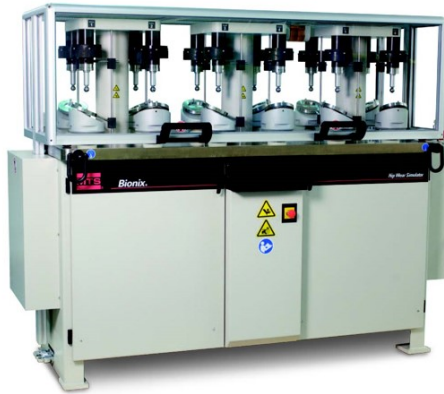
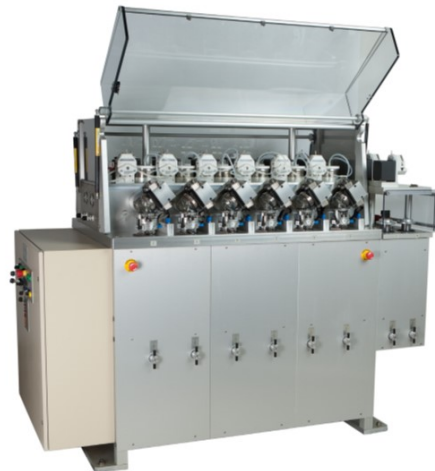
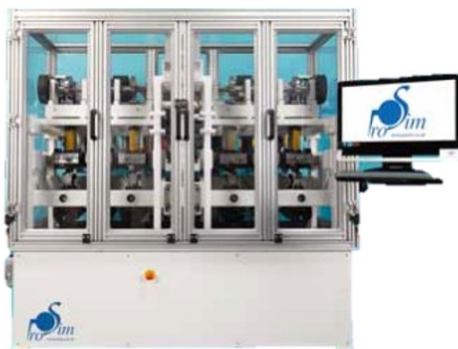
Figure 34 Commercially available hip simulators. Images from manufacturers websites, respectively.

Commercial hip simulators have been available since the 1990s. Nowadays, the laboratories of almost every one of the major orthopaedic companies and several universities worldwide possess hip joint simulators¹⁶⁶. Figure 34 shows the commercially available hip simulators.

Hip Simulator's Name	Applied dynamic loading data					Applied motions			Number of test stations (A:Anatomical, N:Non-anatomical)
	Type	Max(kN)	Min(kN)	Profile	f (Hz)	FE	AA	IER	
HUT-4 ¹⁸⁹ (Figure 34 a)	Pneumatic	2.000	0.400	Double-peak	1.0	±23°	±6°	-	12 or 6 (A)
Endolab ¹⁹⁰ (Figure 34 b)	Hydraulic	3.000	0.300	Paul	1.0	+25° to -18°	+7° to -4°	+2° to -11°	6 (N)
MTS ¹⁹¹ (Figure 34 c)	Hydraulic	2.450	0.050	Physiologic	1.0	Bi-axial rocking motion ±22.5°			12 (A)
AMTI ¹⁹² (Figure 34 d)	Hydraulic	2.870	NG	Paul	NG	±23°	±8.5°	±10°	12 (N)
ProSim ¹⁹³⁻¹⁹⁵ (Figure 34 e)	Pneumatic	3.000	0.100	Double-peak	1.0	+30° to -15°	-	±10°	10 (A)
Durham Mark II ¹⁹⁶ (Figure NA)	Pneumatic	2.500	0.100	Square wave	1.0	+30° to -15°	-	±10° or ±5°	5 (A)
Leeds Mark II ¹⁹⁷ (Figure NA)	Pneumatic	3.000	0.050	Double-peak	1.0	+30° to -15°	-	±10°	6 (A)
Shore Western ^{198,199} (Figure NA)	Hydraulic	2.000	0.200	Sinusoidal	1.1	Bi-axial rocking motion ±22.5°			12 (N)

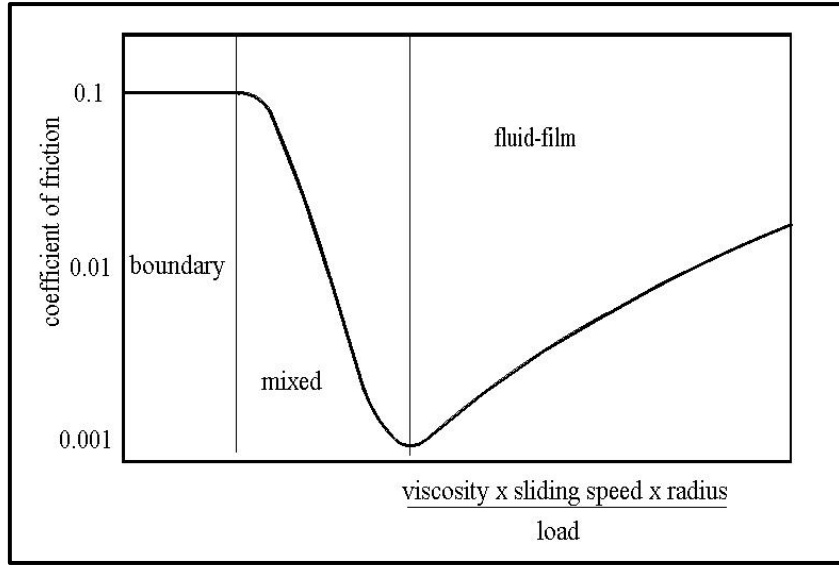
Figure 36 An Idealised Stribeck curve showing different lubrication regimes. Image from Smith and Joyce (2017)⁴¹.

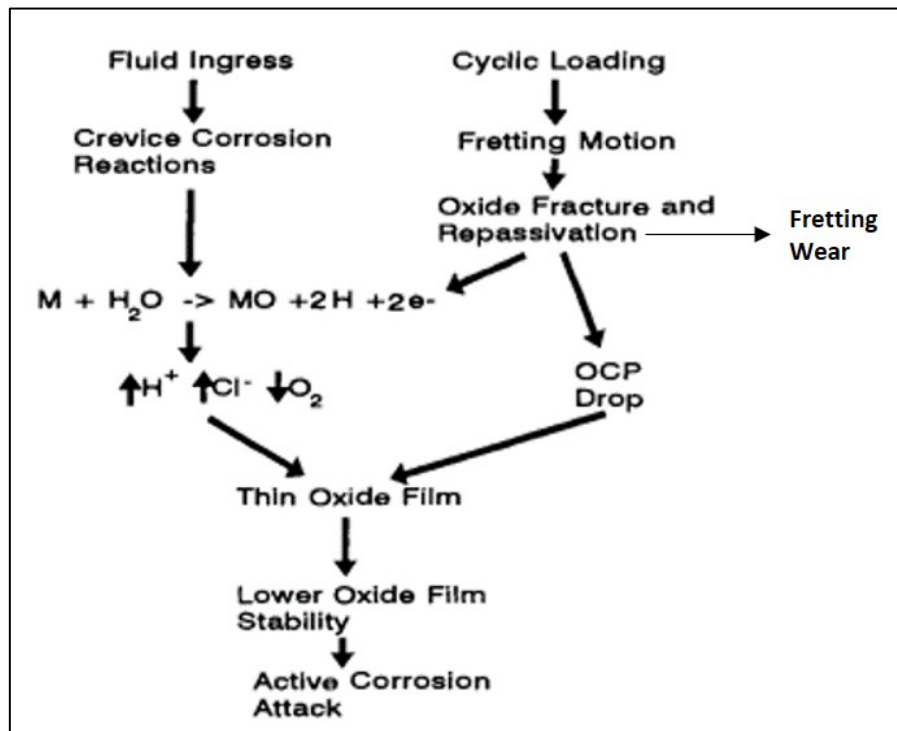
Figure 44 Mechanically Assisted Crevice Corrosion (MACC). Image adapted from Gilbert and Jacobs (1997)²⁴⁹.

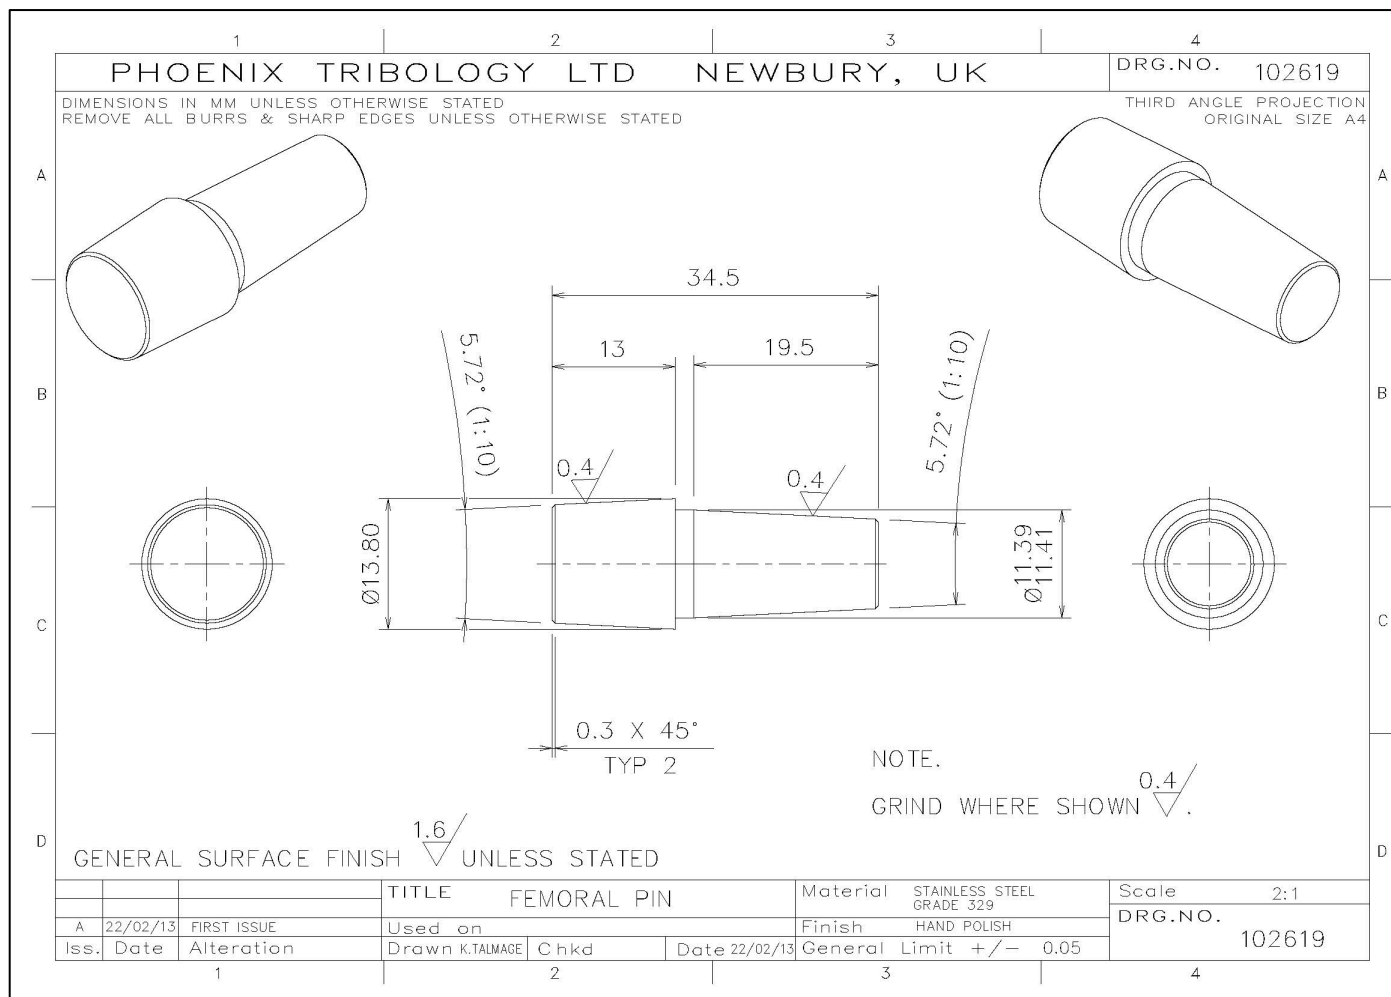
Figure 49 Engineering drawing of the trunnion used in tests involving CoC THR.

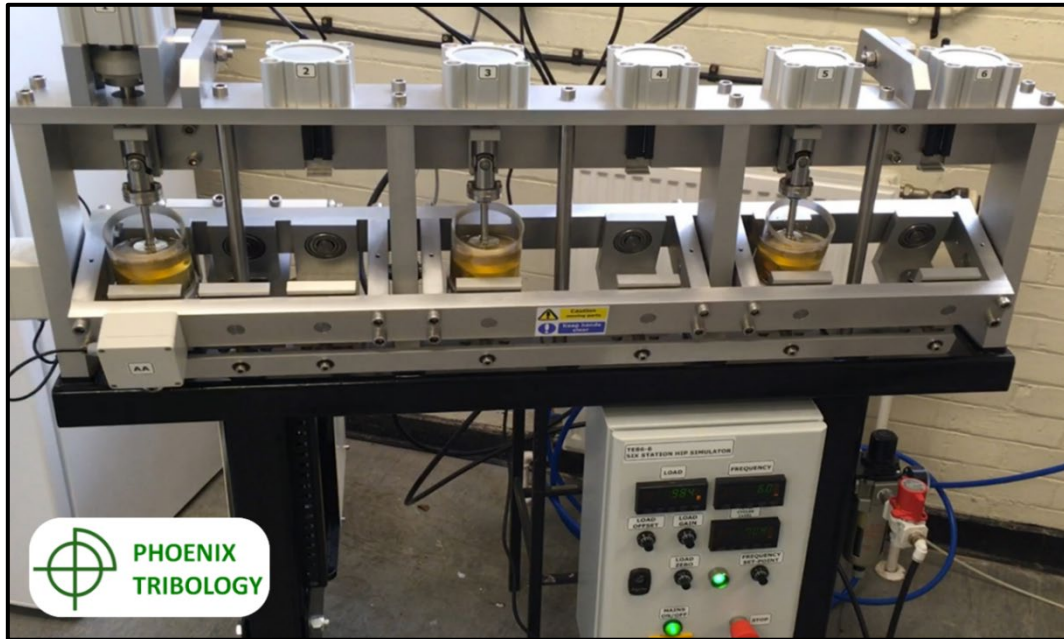
Figure 50 The six-station anatomical hip joint simulator showing three CoC test components immersed in diluted new-born-calf serum²⁹⁵.

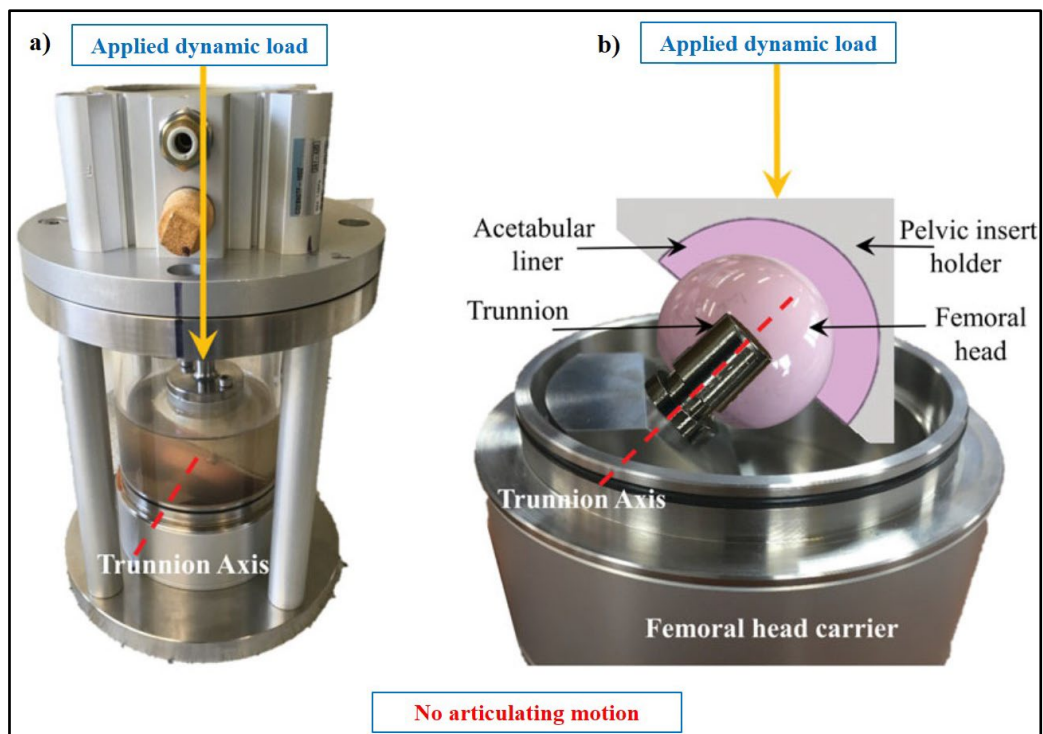
Figure 55 a) A DL station and b) schematic of the ceramic femoral head, ceramic acetabular liner, and Ti trunnion in the DL test set up

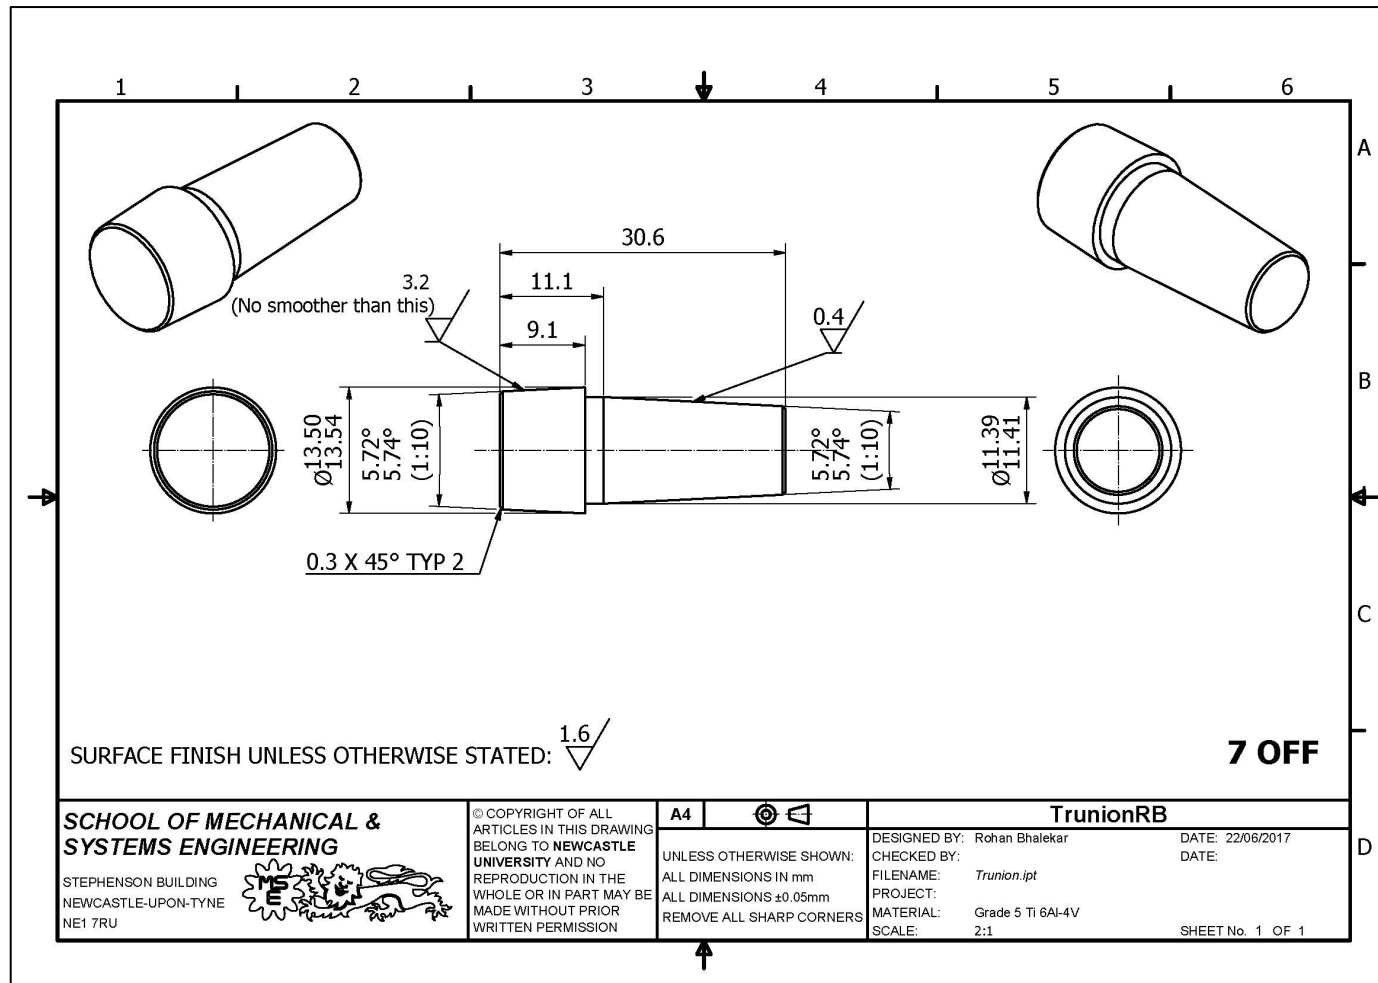
Figure 57 Engineering drawing of the trunnion used in tests involving MoXLPE THR.s.

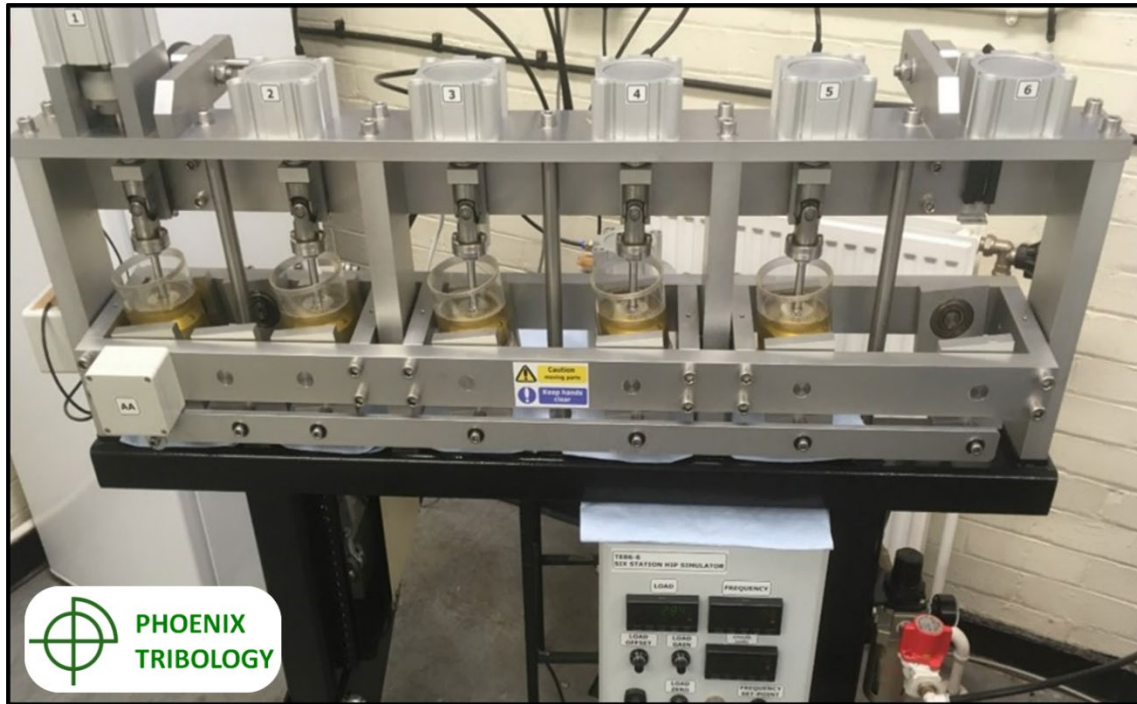
Figure 58 The six-station anatomical hip joint simulator showing five MoXLPE test components immersed in diluted new-born-calf serum³⁰⁰.

The 6-station anatomical hip joint was used for *in vitro* wear testing of five MoXLPE joints mounted on Ti trunnions for 5 Mc, see Figure 58¹⁸⁹. Although the hip simulator had six test stations, only five were used in this wear test. The kinematics used in the MoXLPE hip simulator test was based on Saikko (2005)¹⁸⁹. All test specimens were subject to time-varying double-peak load with a minimum load value 400 N and a maximum load value 2000 N and relative articulating motion, generating an elliptical wear path^{189,295}. The articulating motion of the simulator comprised of sinusoidal flexion-extension and abduction-adduction with an excursion of 46° and 12° respectively¹⁸⁹. Although the hip simulator had six test stations, only five were used in the MoXLPE hip simulator wear test. A sixth MoXLPE joint used as a dynamically loaded soak control specimen was subject to the same time-varying loading but no articulating motion as per the international standard for wear testing of total hip prostheses ISO 14242-1¹⁸⁷.

The TE-86 (PLINT, Phoenix Tribology Limited, UK) hip simulator was used for *in vitro* wear testing of the modular hip prostheses. The TE 86 design is based on Helsinki University of Technology (HUT)-4 simulator designed by Saikko¹⁸⁹. The hip simulator contains an electromechanical drive system and servo pneumatic loading system. Figure 50 and Figure 58 shows the TE-86 hip joint simulator.

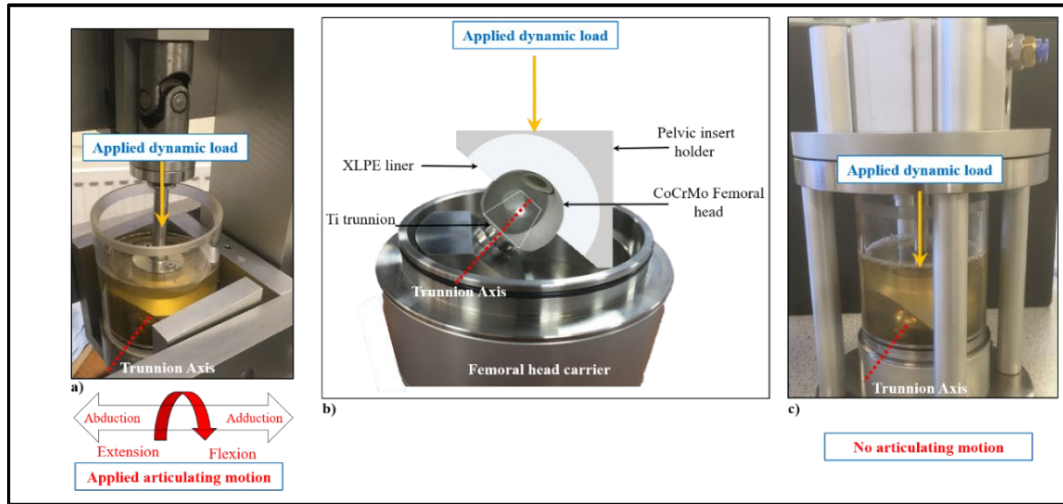
Figure 59 a) A test station, b) schematic of CoCrMo femoral head, XLPE acetabular liner, and Ti trunnion in test and control station setup, and c) the control station.

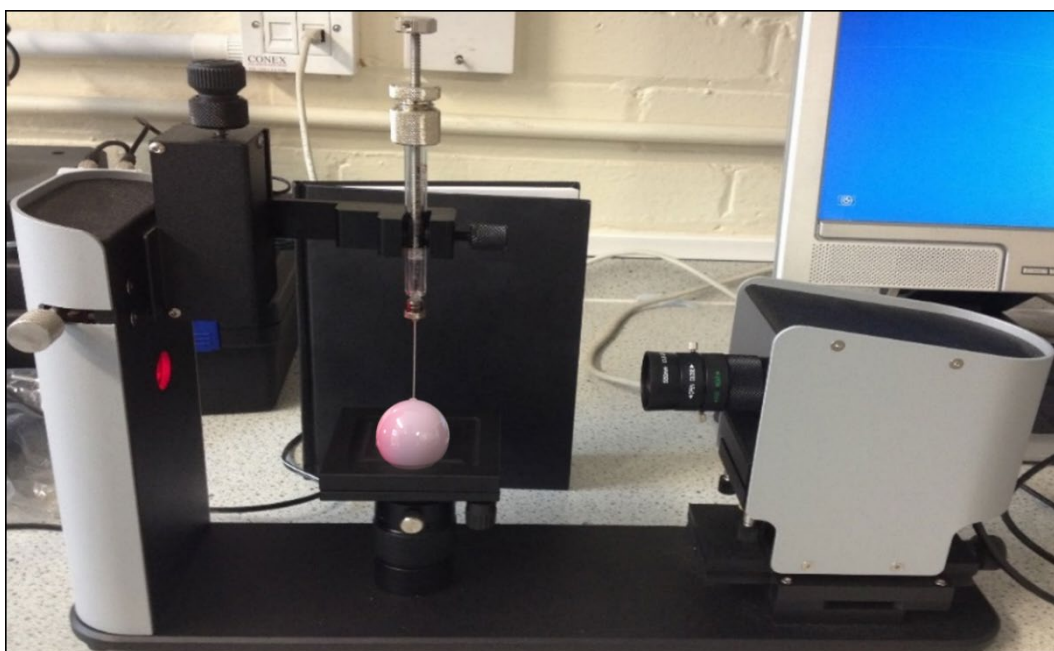
Figure 61 Contact angle measurement of BIOLOX[®]*delta* femoral head using Theta Lite Optical Tensiometer

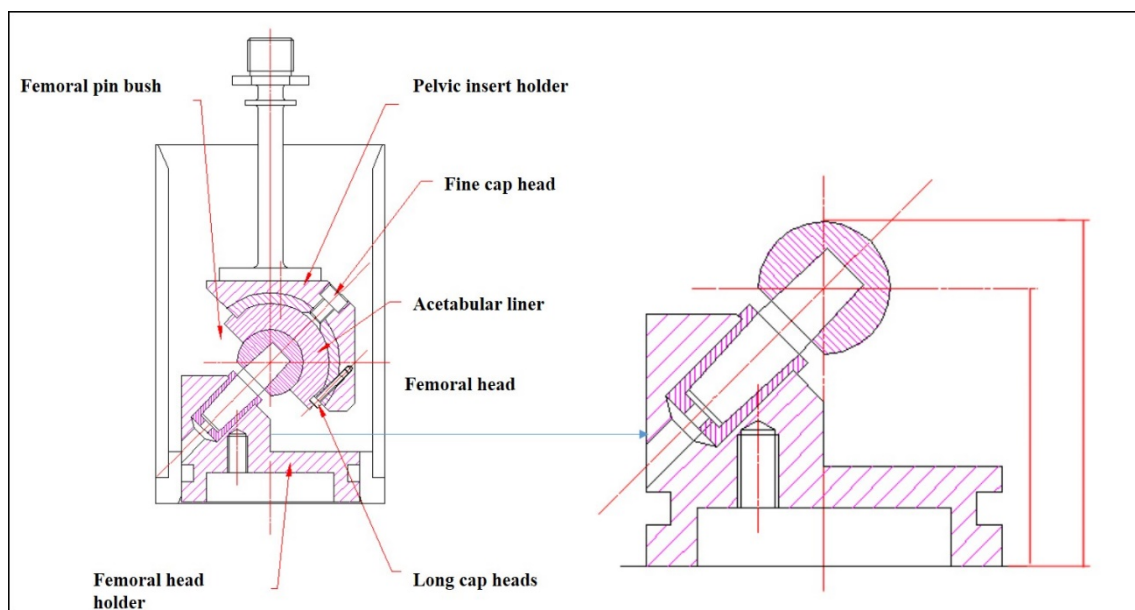
Figure 66 Schematic diagram showing the self-centring alignment of the components.

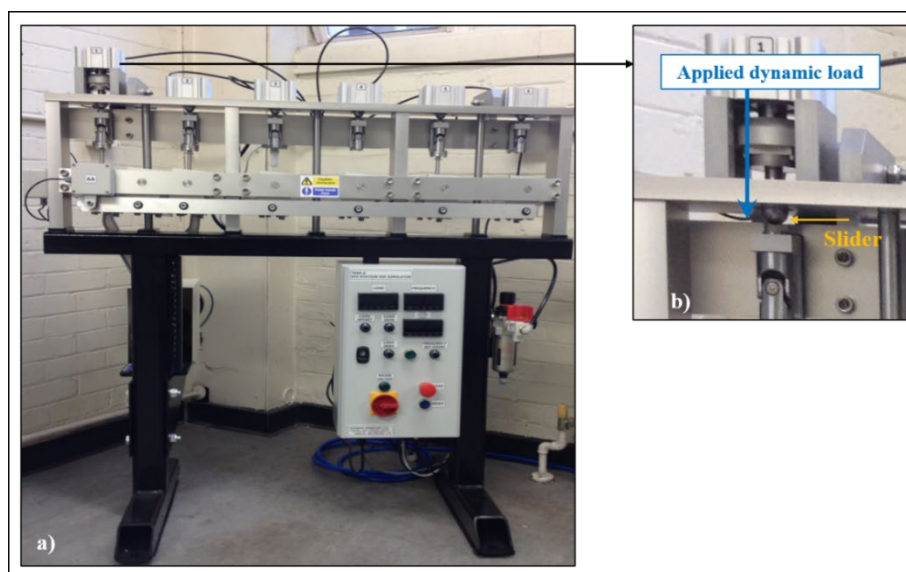
Figure 68 a) TE-86 hip simulator and b) Zoomed-in image of the station no. 1 showing the slider of a vertical linear guide.

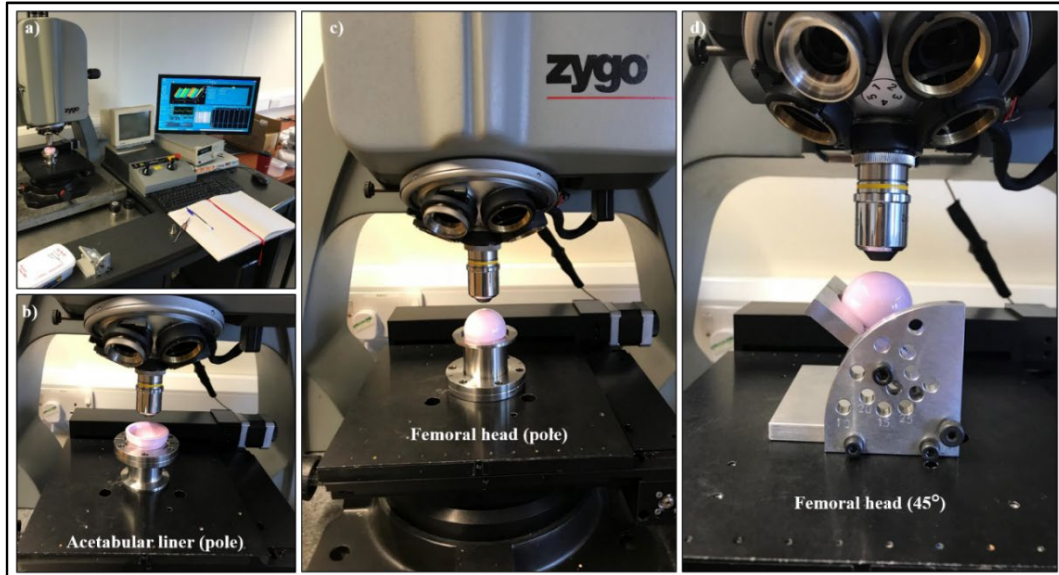
Figure 74 a) Three-dimensional (3D) surface roughness (Sa) measurements using Zygo NewView 5000 on b) an acetabular liner at the pole, c) a femoral head at the pole and d) femoral head at 45° tilt.

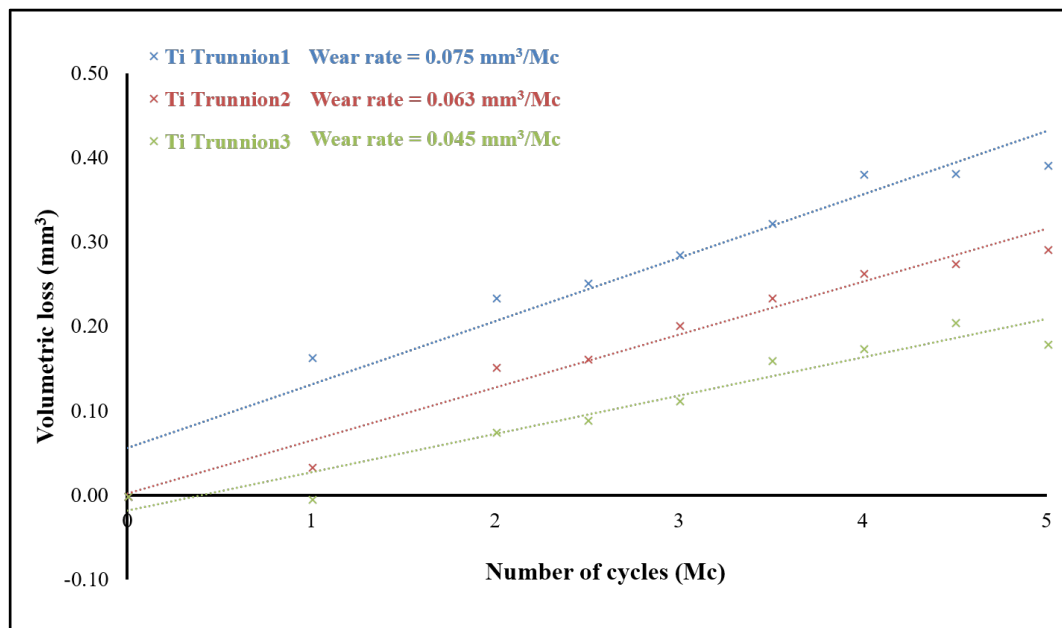
Figure 75 Mean volumetric measurements of all titanium (Ti) trunnions from CoC hip simulator wear test (measured gravimetrically).

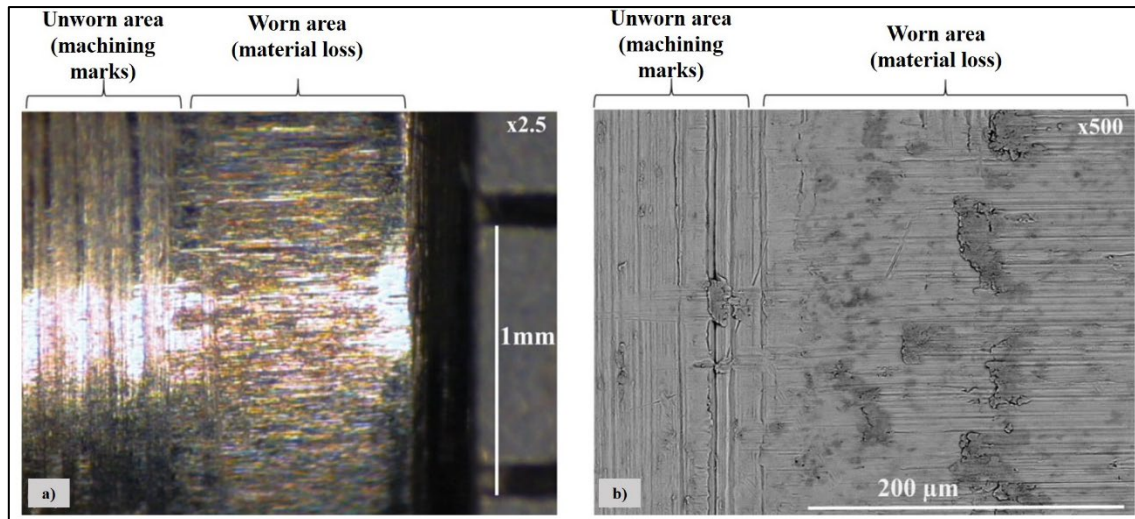
Figure 81 a) An optical microscopic image at 2.5× magnification and b) scanning electron microscopy (SEM) image of the test trunnion at 500× magnification showing worn and unworn areas.

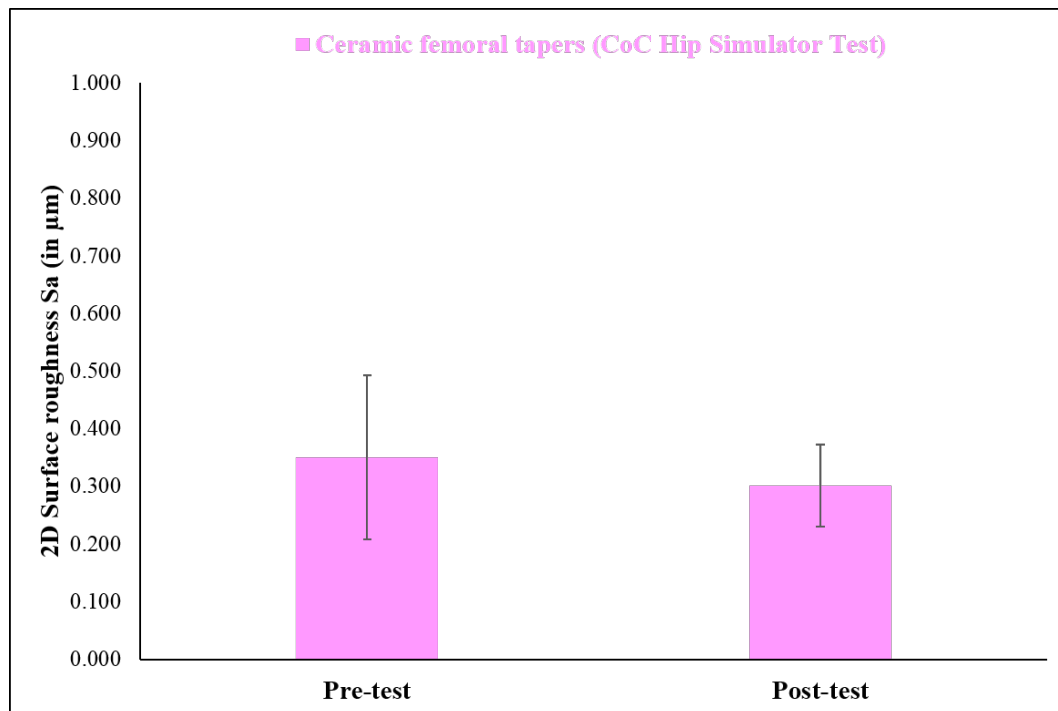
Figure 84 Mean 2D surface roughness Ra (in μm), of ceramic femoral tapers measured pre and post-CoC hip simulator wear test. Error bars represent \pm standard deviation.

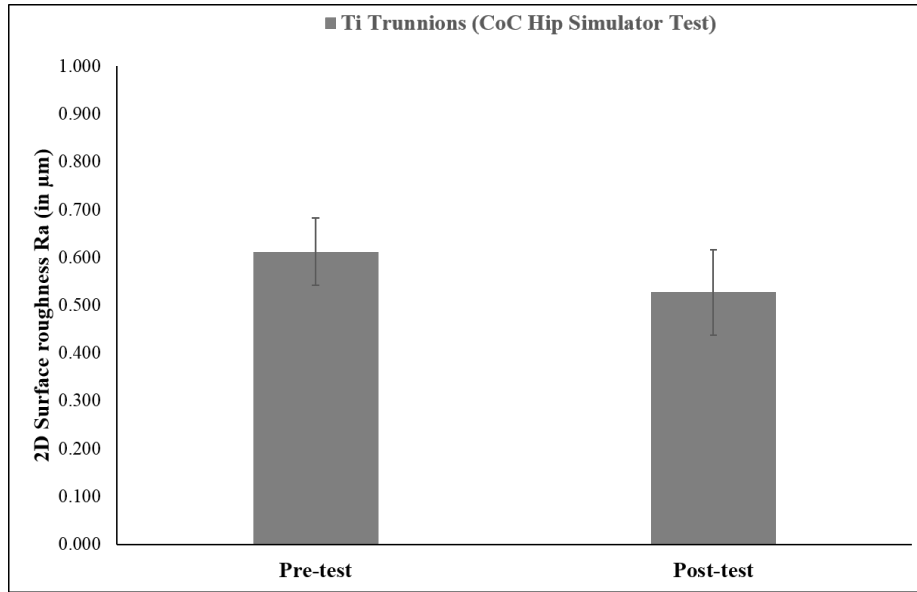
Figure 85 Mean 2D surface roughness Ra (in µm), of titanium (Ti) trunnions measured pre and post-CoC hip simulator wear test. Error bars represent \pm standard deviation.

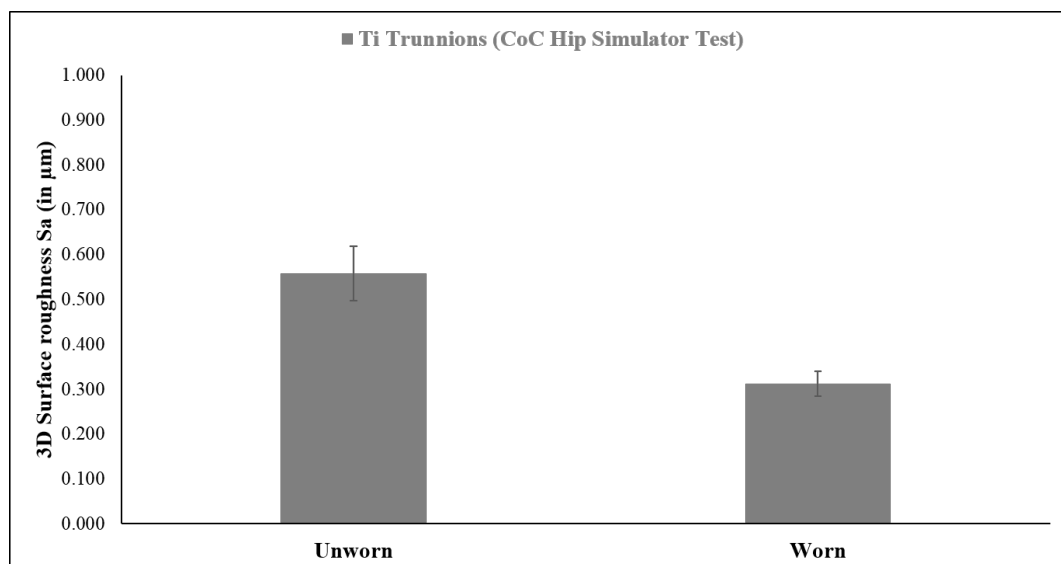
Figure 88 Mean 3D surface roughness S_a (in μm), of titanium (Ti) trunnions measured on unworn and worn areas after CoC hip simulator wear test. Error bars represent \pm standard deviation.

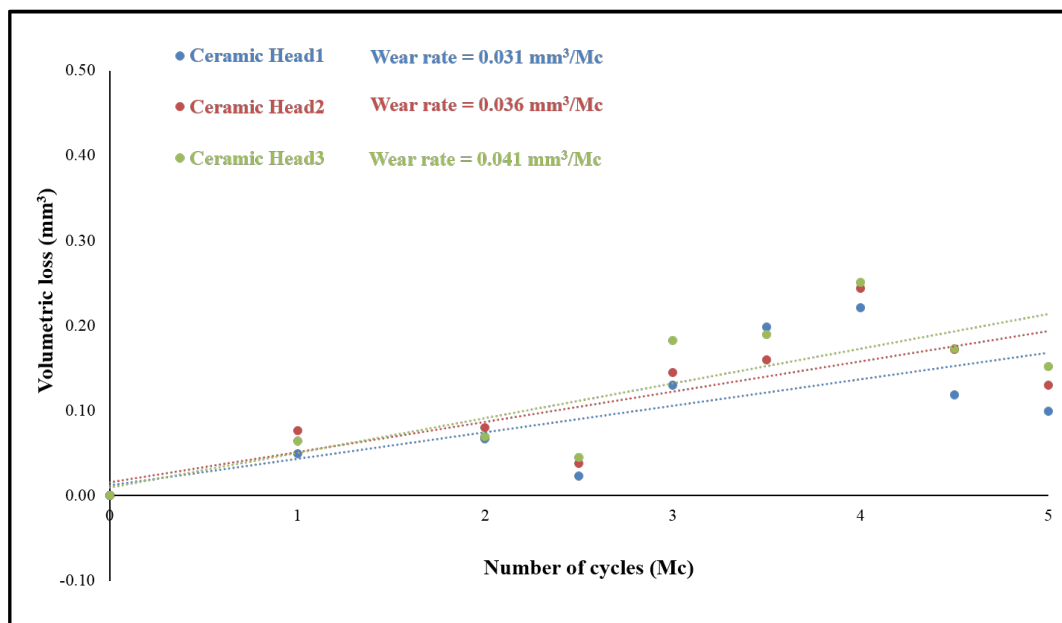
Figure 89 Mean volumetric measurements of all ceramic femoral heads from CoC hip simulator wear test (measured gravimetrically).

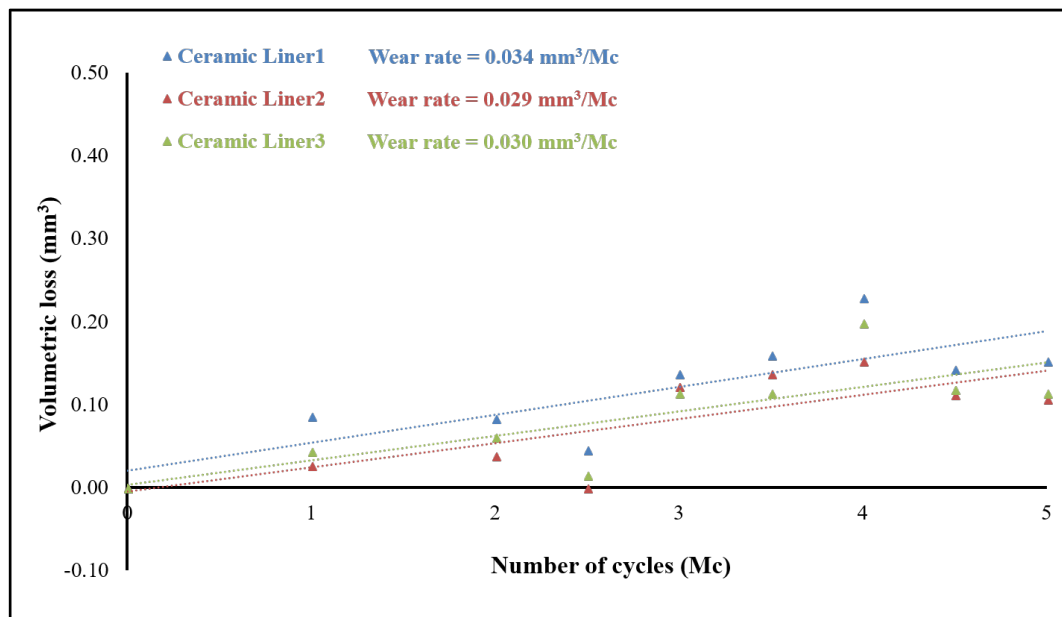
Figure 91 Mean volumetric measurements of all ceramic acetabular liners from CoC hip simulator wear test (measured gravimetrically).

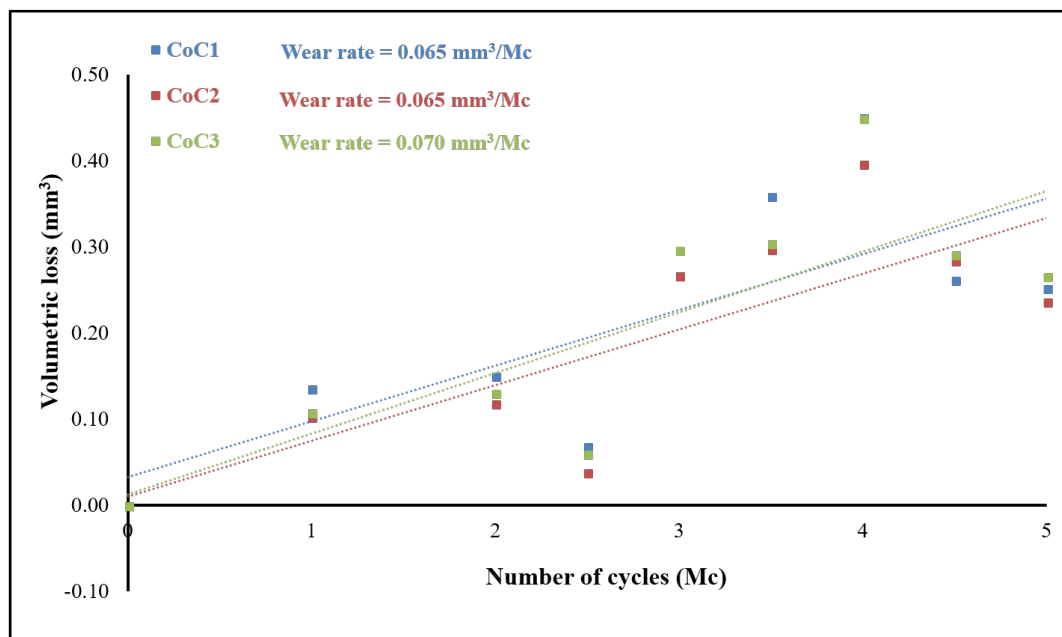
Figure 93 Mean volumetric measurements of all CoC joints from CoC hip simulator wear test (measured gravimetrically).

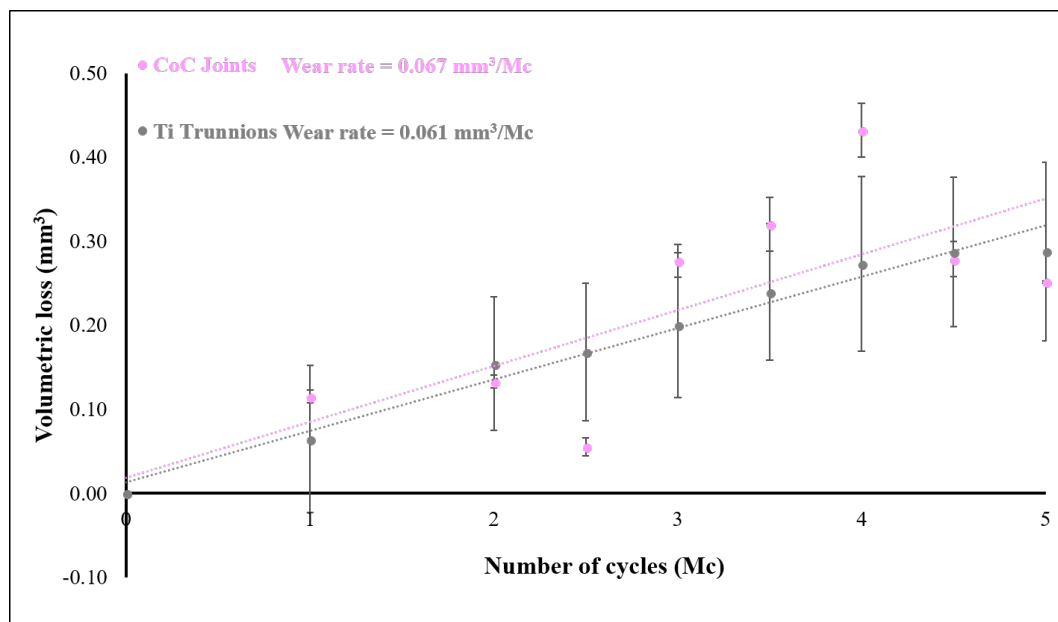
Figure 95 Mean volumetric measurements of CoC joints and titanium (Ti) trunnions from CoC hip simulator wear test (measured gravimetrically). Error bars represent \pm standard deviation ²⁹⁵.

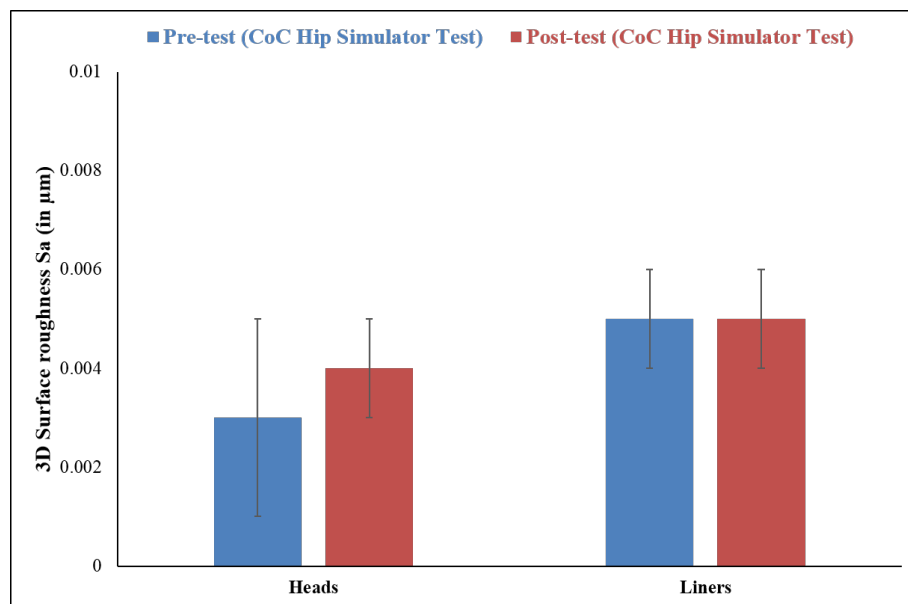
Figure 96 Mean 3D surface roughness Sa (in μm), of the ceramic femoral head and acetabular liners measured pre and post-CoC hip simulator wear test. Error bars represent \pm standard deviation.

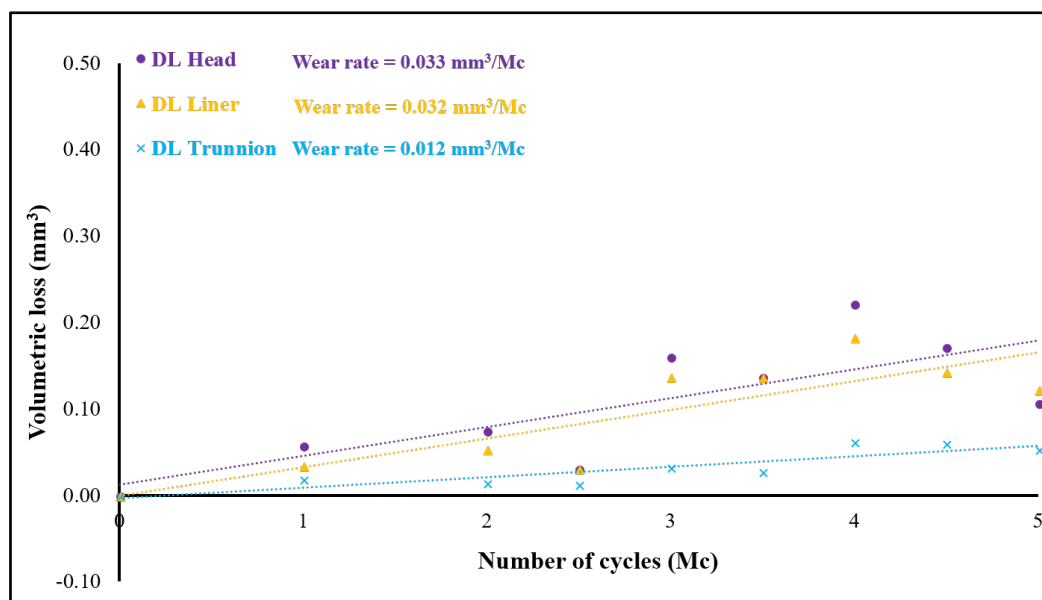
Figure 99 Mean volumetric measurements of the ceramic femoral head, ceramic acetabular liner and titanium (Ti) trunnion used in the DL test (measured gravimetrically).

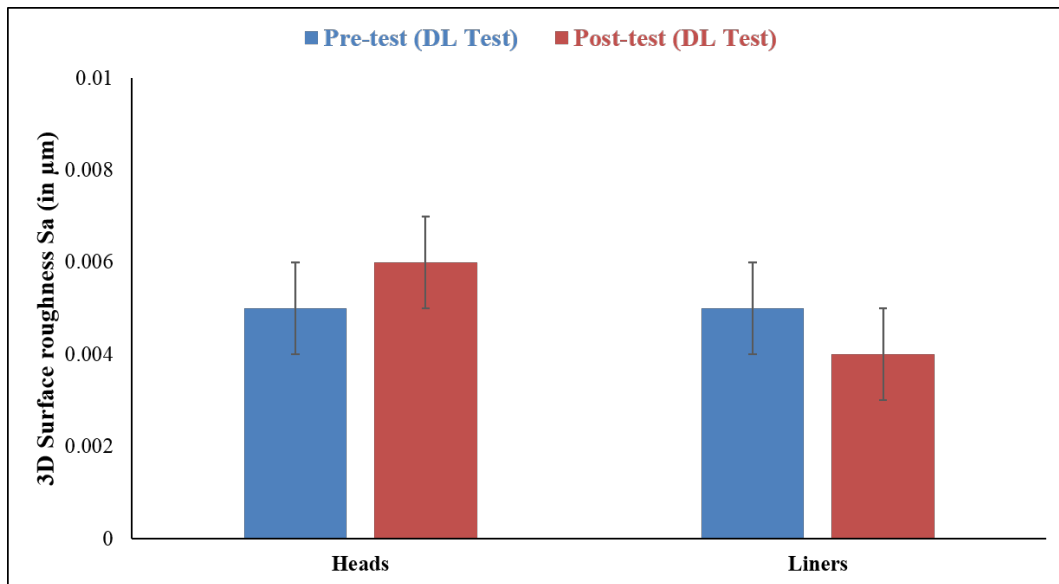
Figure 102 Mean 3D surface roughness Sa (in µm), of the ceramic femoral head and acetabular liner measured pre (blue) and post (red)-DL test. Error bars represent \pm standard deviation.
