Hip simulator wear testing of the taper-trunnion junction and bearing surfaces of modular hip prostheses

**This thesis is submitted in partial fulfilment of the requirements for the
Degree of Doctor of Philosophy**

**Newcastle University
School of Engineering**

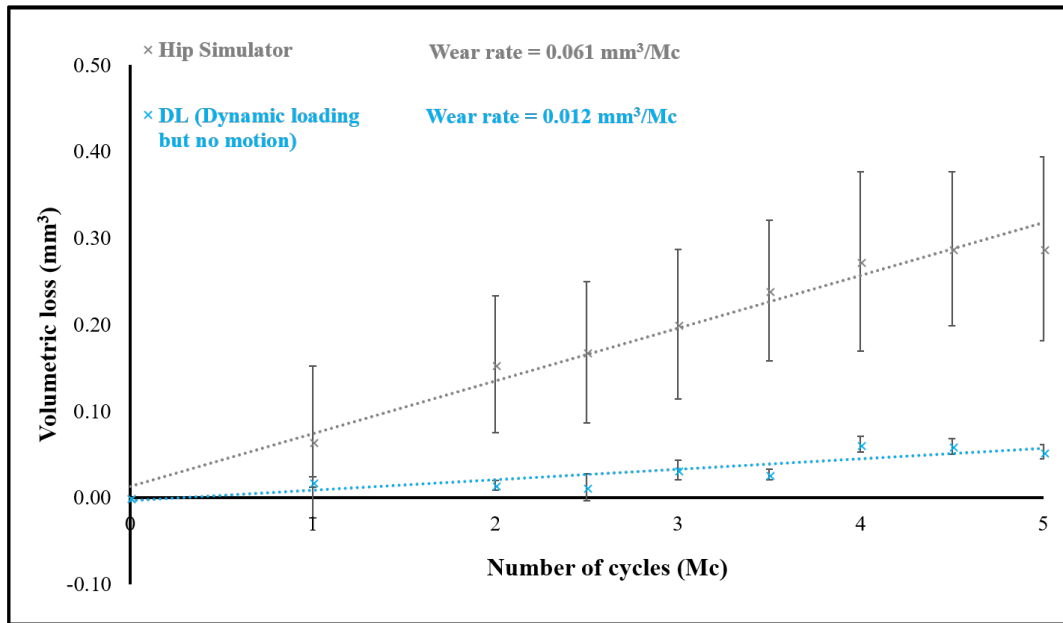
Figure 103 The mean volumetric measurements of titanium trunnions used in CoC hip simulator wear test and the DL test (measured gravimetrically). Error bars represent \pm standard deviation²⁹⁵.

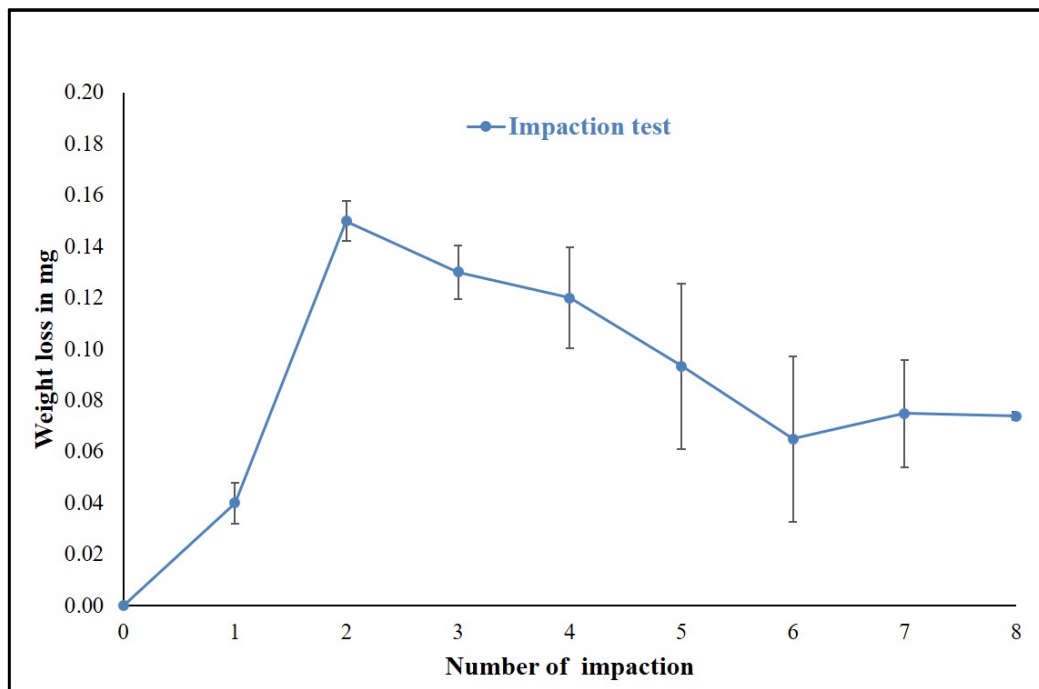
Figure 104 Gravimetric measurement of impaction test trunnions. Error bars represent \pm standard deviation.

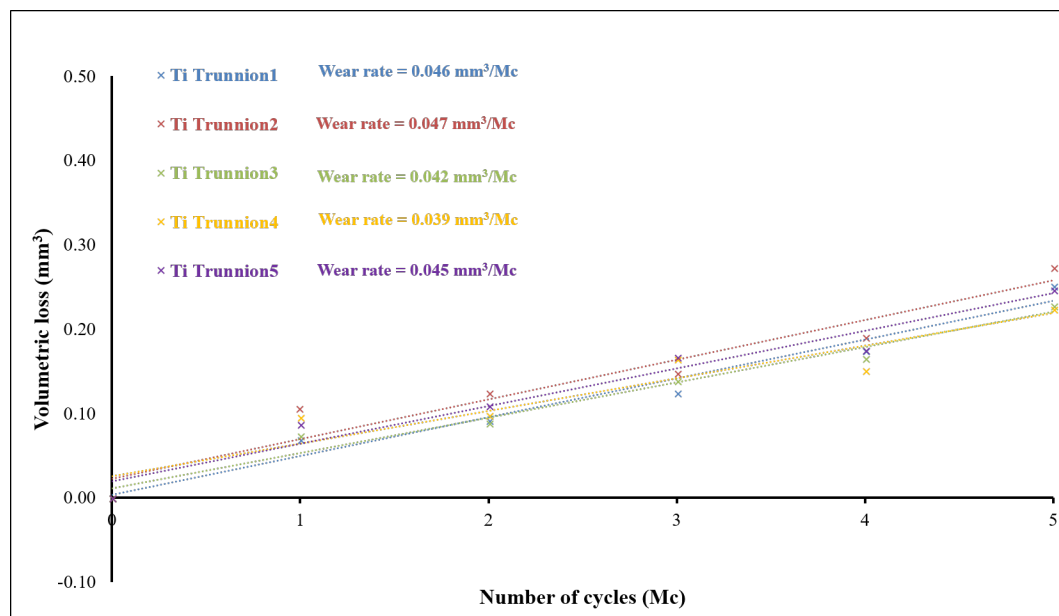
Figure 106 Mean volumetric measurements of all titanium (Ti) trunnions from MoXLPE hip simulator wear test (measured gravimetrically).

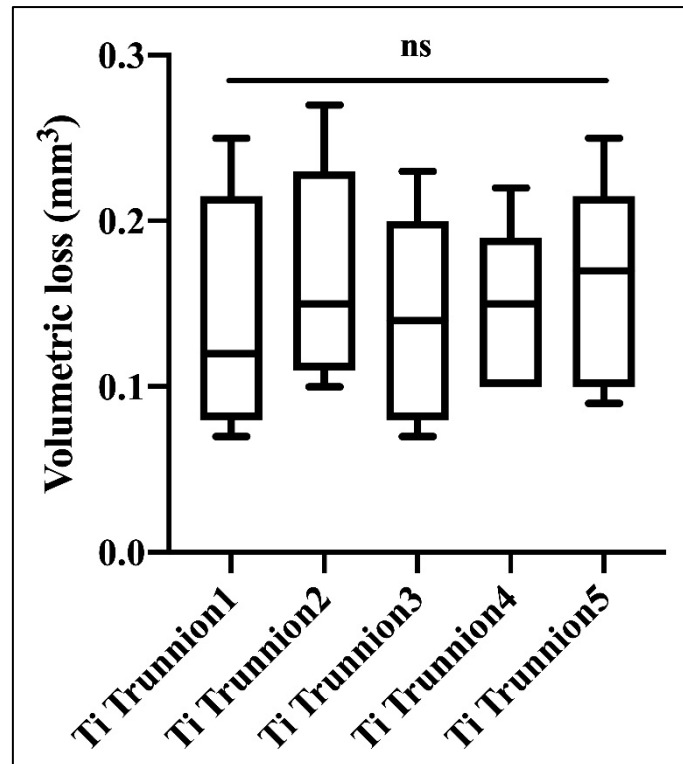
Figure 107 Box-plot of volumetric measurement of all titanium (Ti) trunnions from MoXLPE hip simulator wear test (measured gravimetrically). ns: no significant difference with adjusted p-value >0.999.

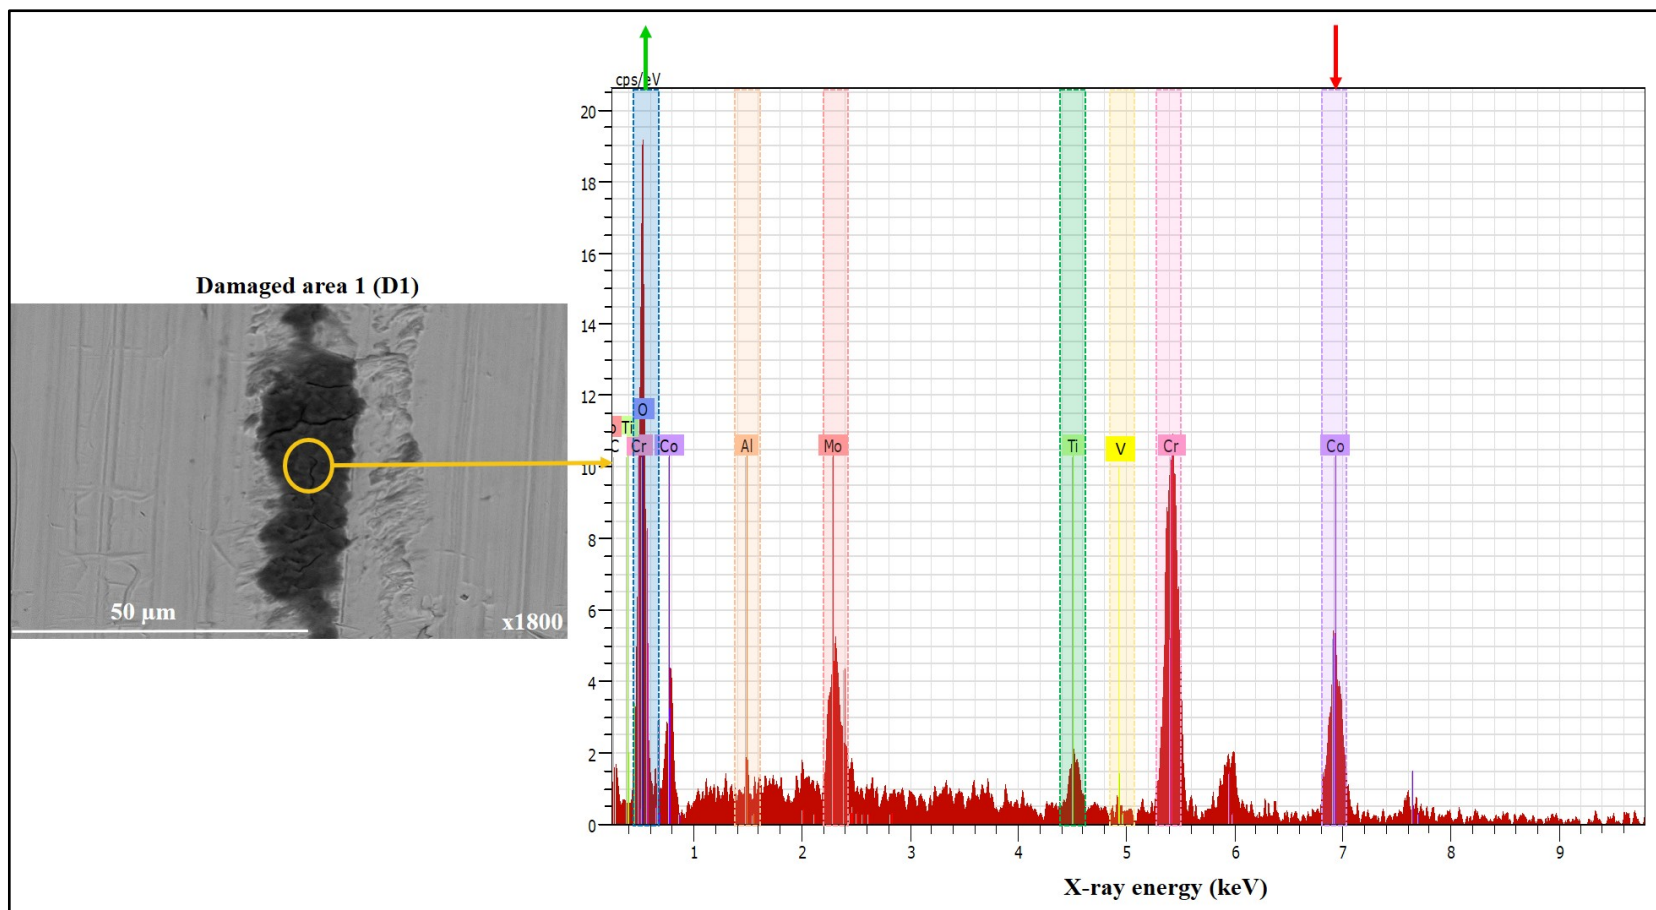
Figure 114 SEM image of the same femoral taper showing the area (yellow circle) where spot EDX analysis were taken and Spot EDX spectrum showing damaged area (D1). The green arrow indicates an increase in Oxygen, whereas the red arrow indicates a decrease in Cobalt.

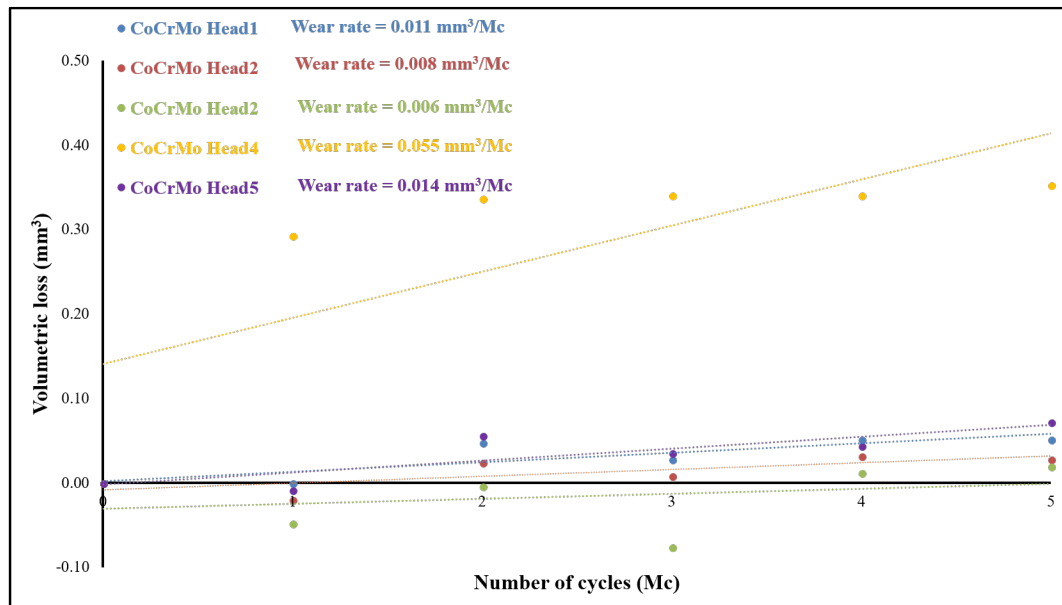
Figure 118 Mean volumetric measurements of all CoCrMo femoral heads from MoXLPE hip simulator wear test (measured gravimetrically).

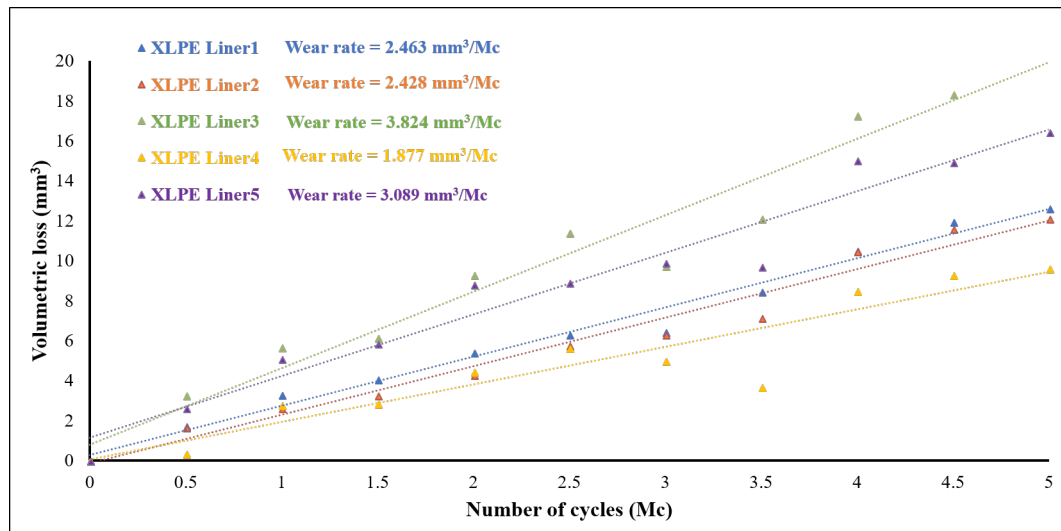
Figure 120 Mean volumetric measurements of all XLPE acetabular liners from MoXLPE hip simulator wear test (measured gravimetrically).

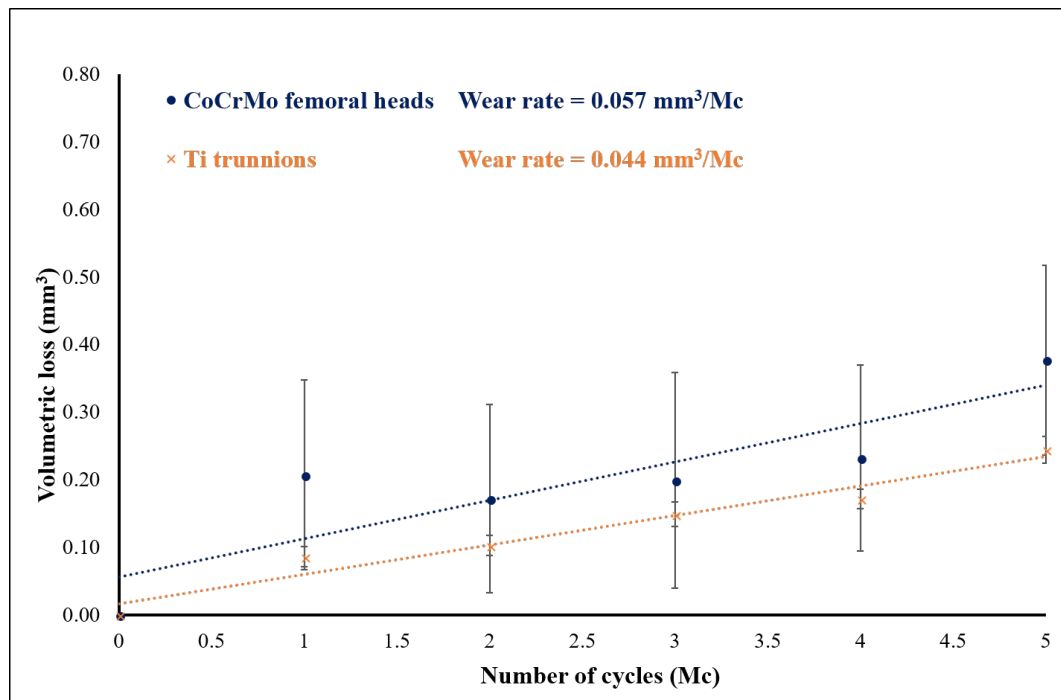
Figure 122 Mean volumetric wear of CoCrMo femoral heads and titanium trunnions (measured gravimetrically). Error bars represent \pm standard deviation.

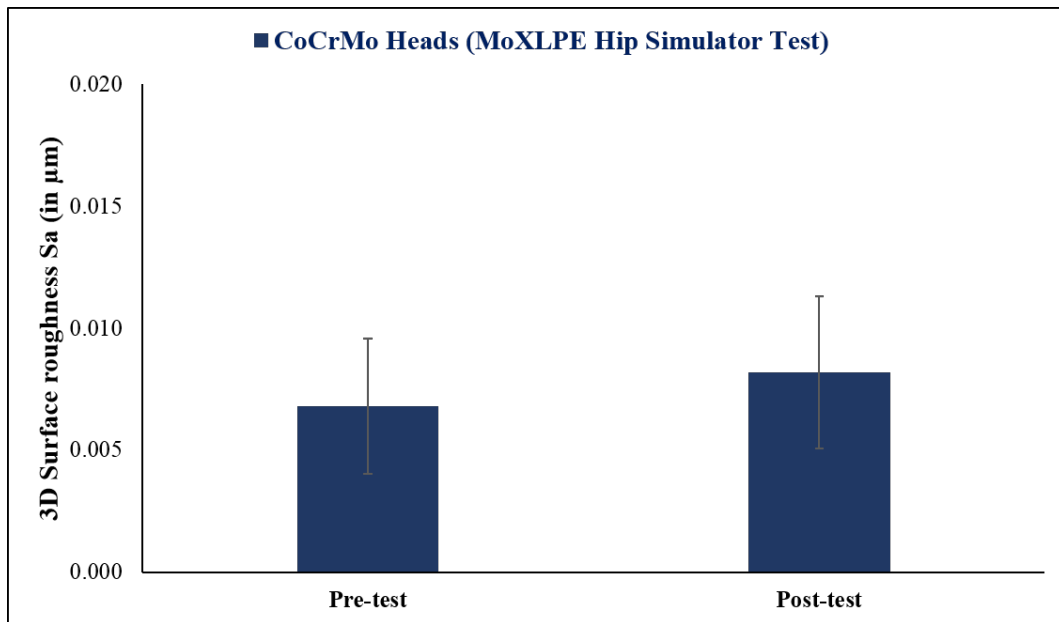
Figure 123 Mean 3D surface roughness Sa (in μm), of CoCrMo femoral heads measured pre and post-MoXLPE hip simulator wear test. Error bars represent \pm standard deviation.

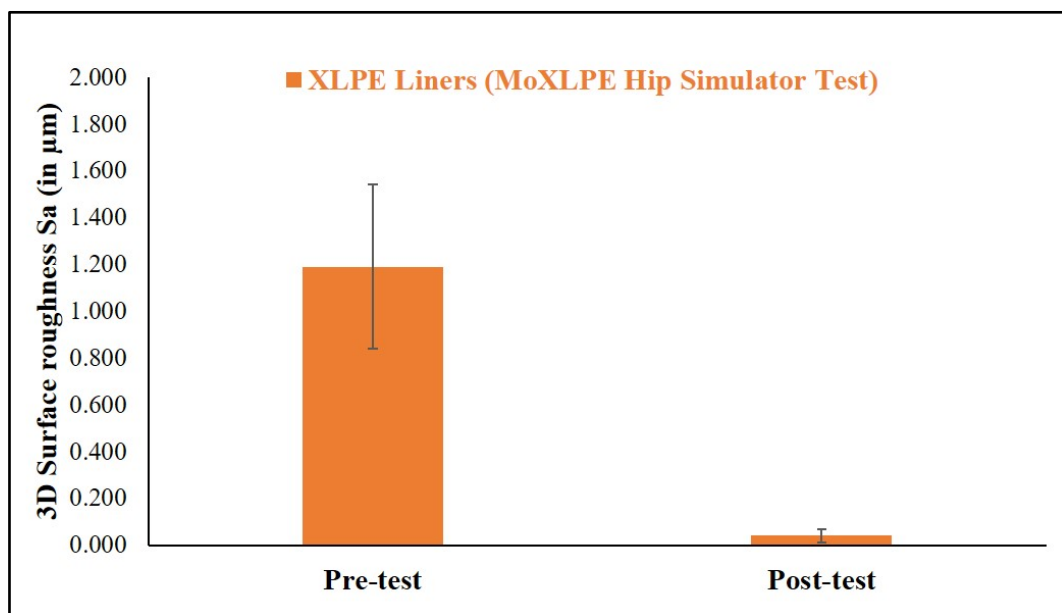
Figure 124 Mean 3D surface roughness Sa (in μm), of XLPE liners, measured pre and post-MoXLPE hip simulator wear test. Error bars represent \pm standard deviation.

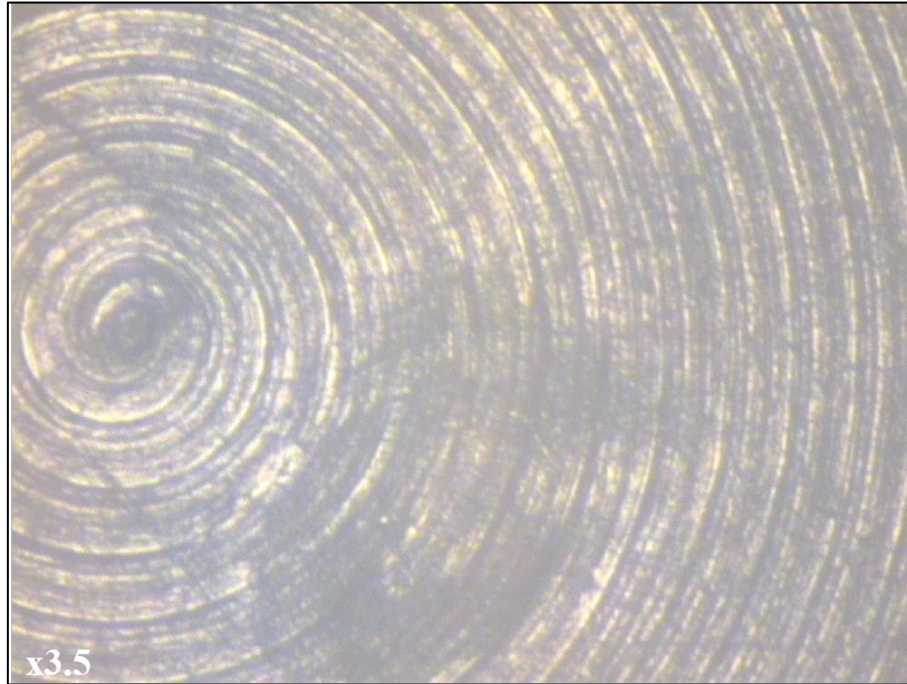
Figure 127 An optical microscopic image at a $3.2\times$ magnification of the backside of XLPE liner taken at the end of hip simulator testing, showing original machining marks, and thus an absence of wear.

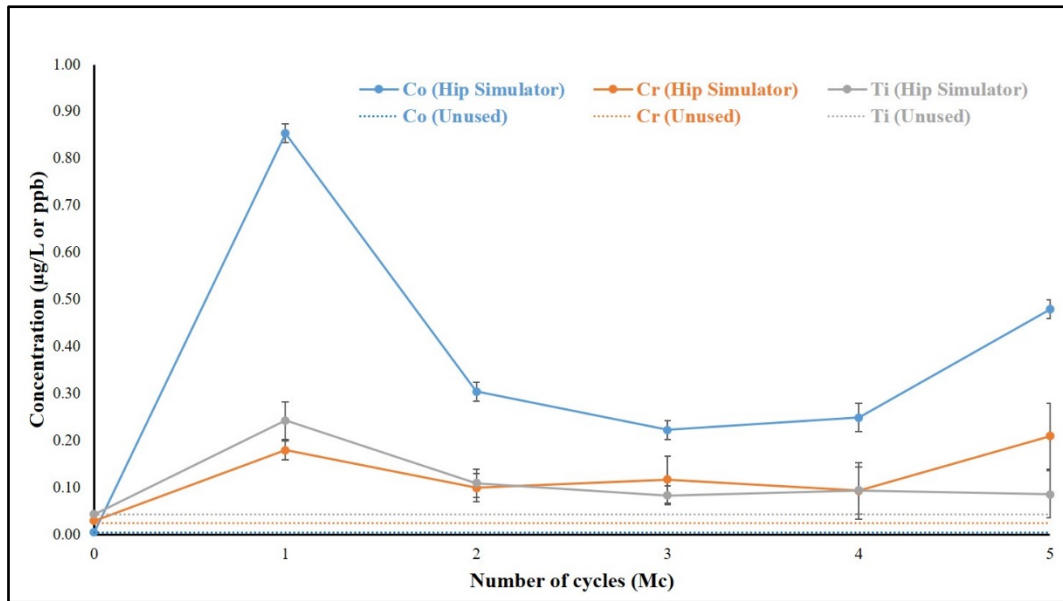
Figure 129 Lubricant cobalt (Co), chromium (Cr) and titanium (Ti) ion concentration at different intervals of the MoXLPE hip simulator wear test. Dotted lines indicate Co, Cr and Ti ions measured from the unused lubricant. Error bar represents \pm standard deviation.

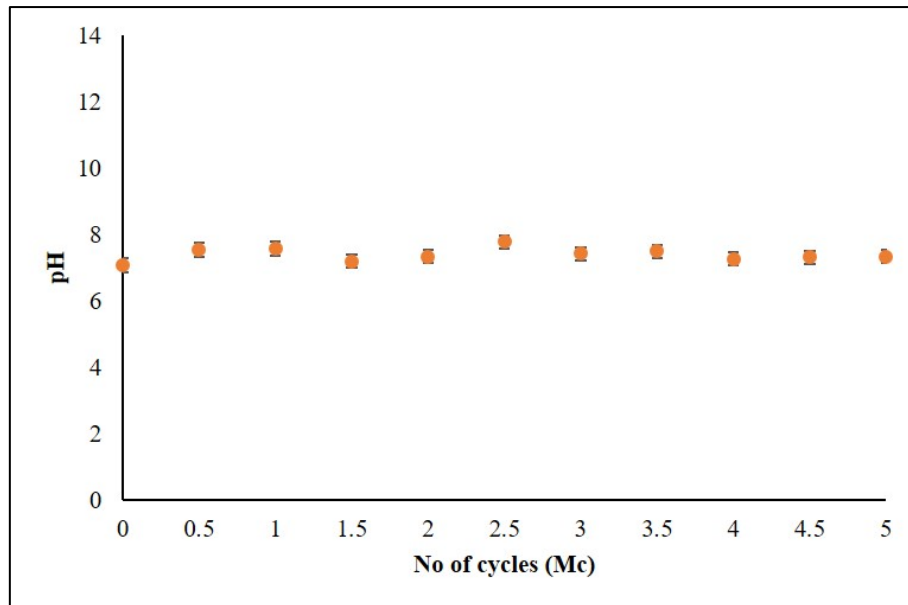
Figure 130 pH of the lubricant measured over every 0.5Mc of the CoC hip simulator test. Error bars represent \pm standard deviation.
