Erosion and Stability of Till Cliffs
on the Holderness Coast

This thesis is submitted in fulfilment of the requirements
for the Degree of Doctor of Philosophy
in Geotechnical Engineering

Iain Robertson

University of Newcastle upon Tyne
Geotechnical Engineering

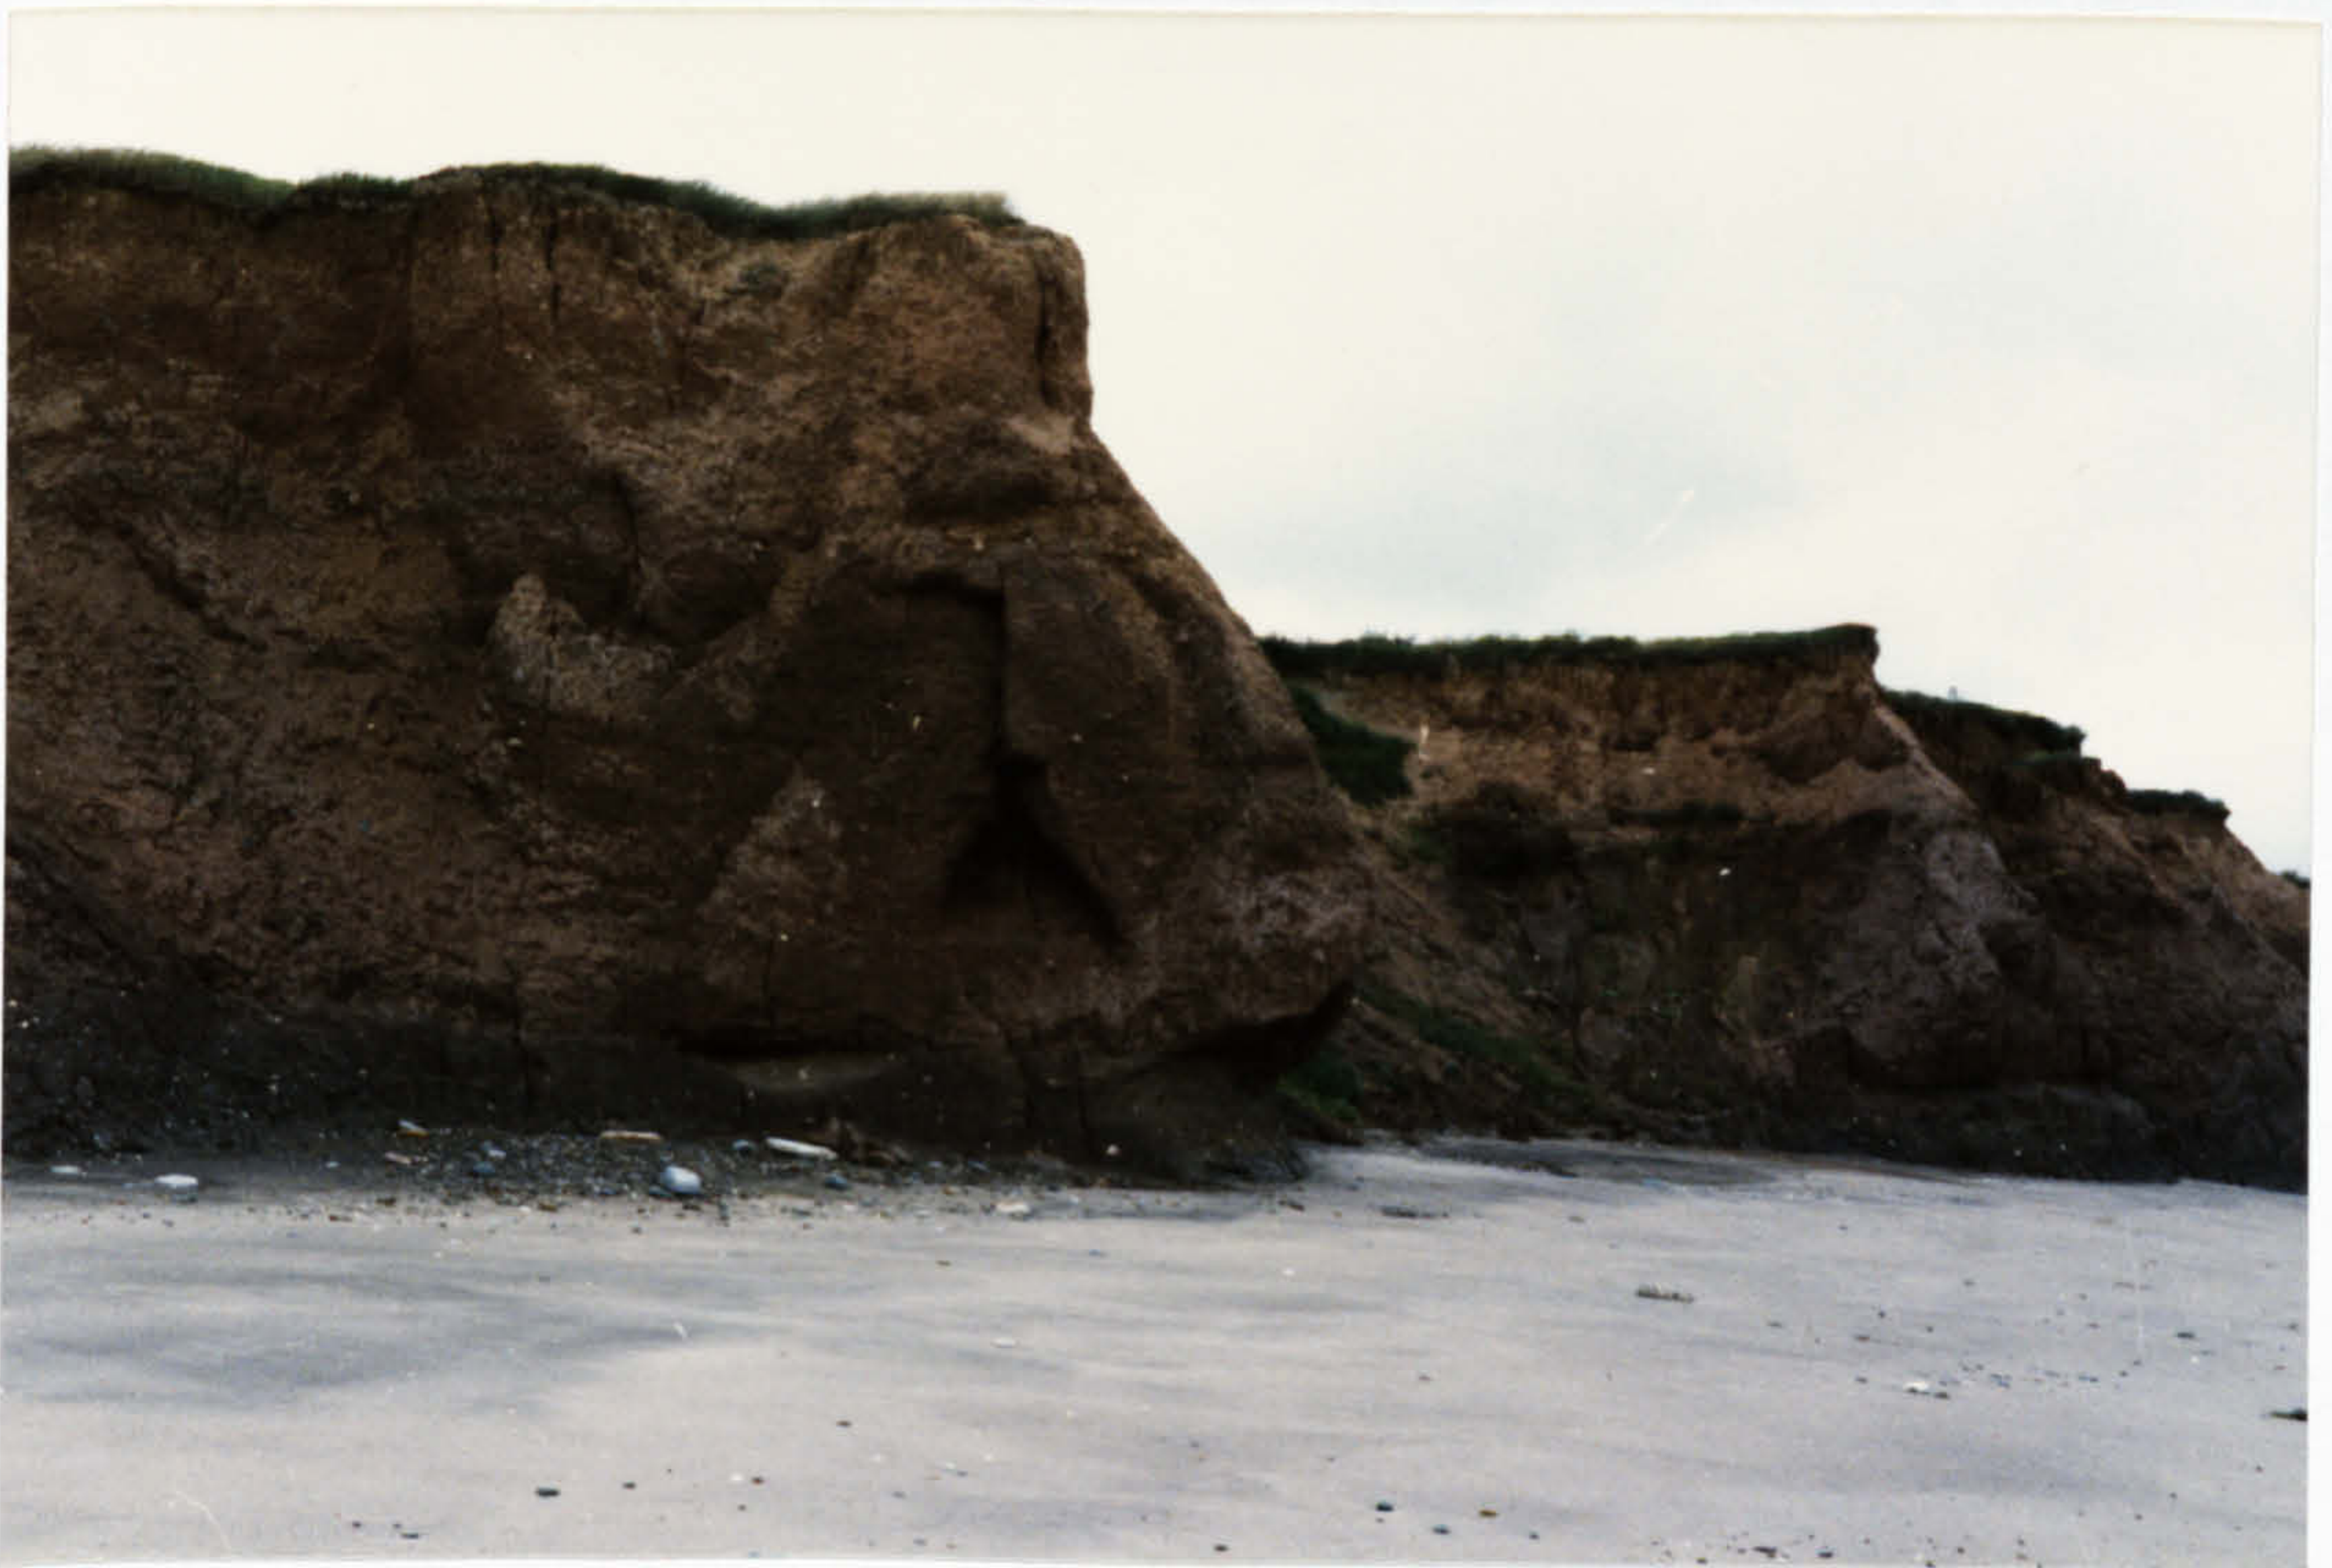
Figure 3.28

(b) Cliffs near East Newton (TA 269 379), with arete /corrie morphology.
Note seepage from sand deposit on the right side of the corrie.

Typical cliff morphology in zone "A"

The typical cliff morphology in zone "A" is shown in Figure 3.28, and the cycle of recession illustrated in Figure 3.29. The slope maintains a steep profile of "till cliff" throughout

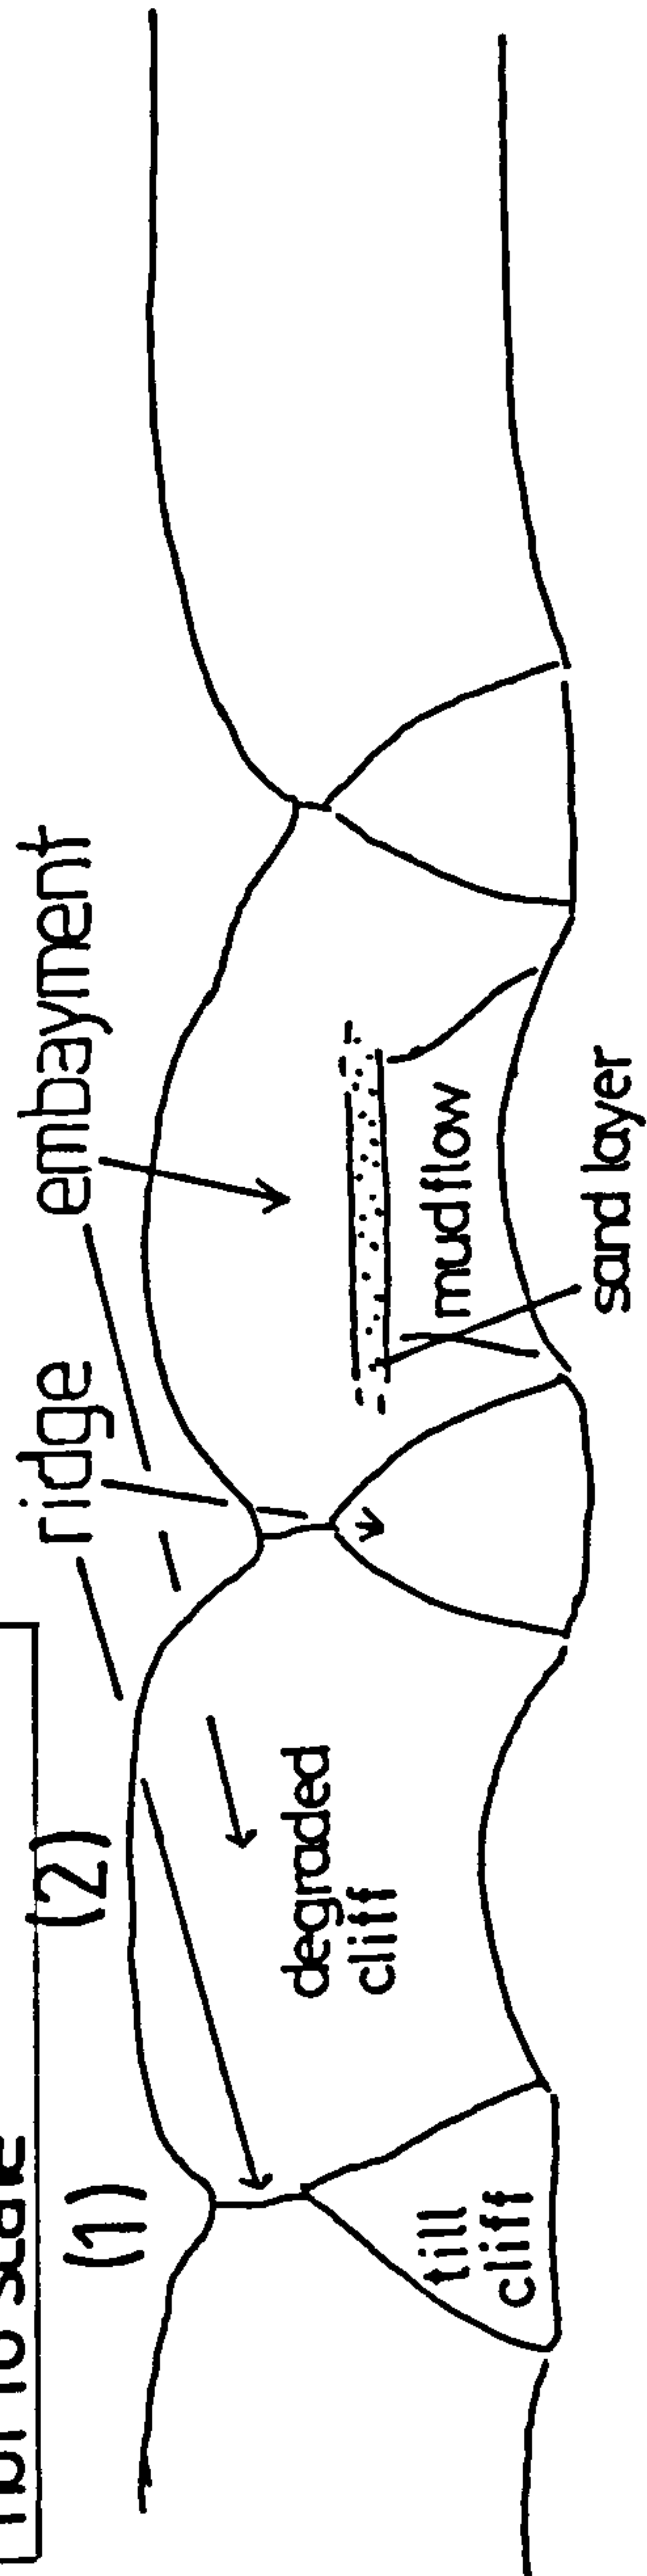
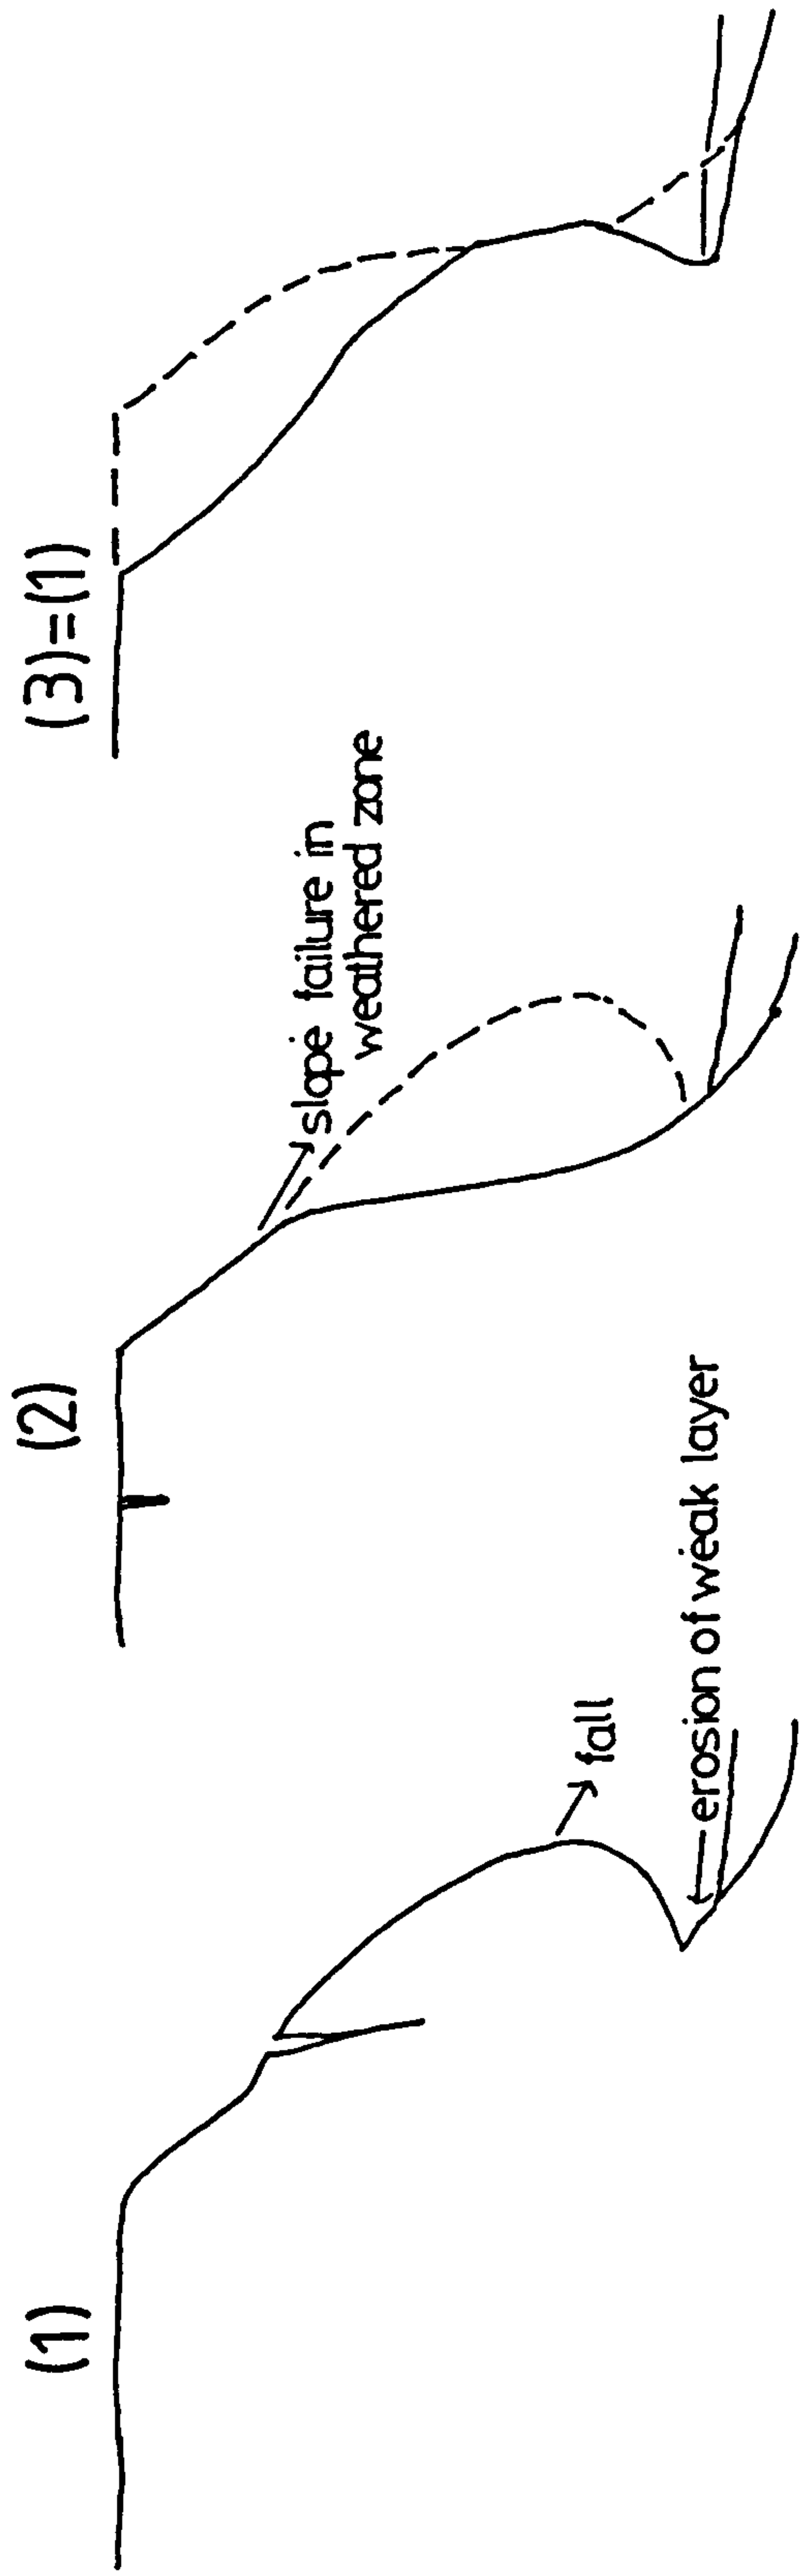
Figure 3:29
Cliff morphology and cycle
of recession in zone "A"
not to scale

the cycle, and the slope angle alternates between approximately 40° (profile 1) and 65° (profile 2), as falls occur from the lower and upper cliff respectively. If embayments develop these may contain "degraded cliff" at an angle of 25° to 30° . The position of the embayments may be controlled by the presence of a sand layer, causing mudslides and seepage erosion. If so they will not shift position laterally as the cliff recedes. Otherwise the positions of ridges and embayments may interchange.

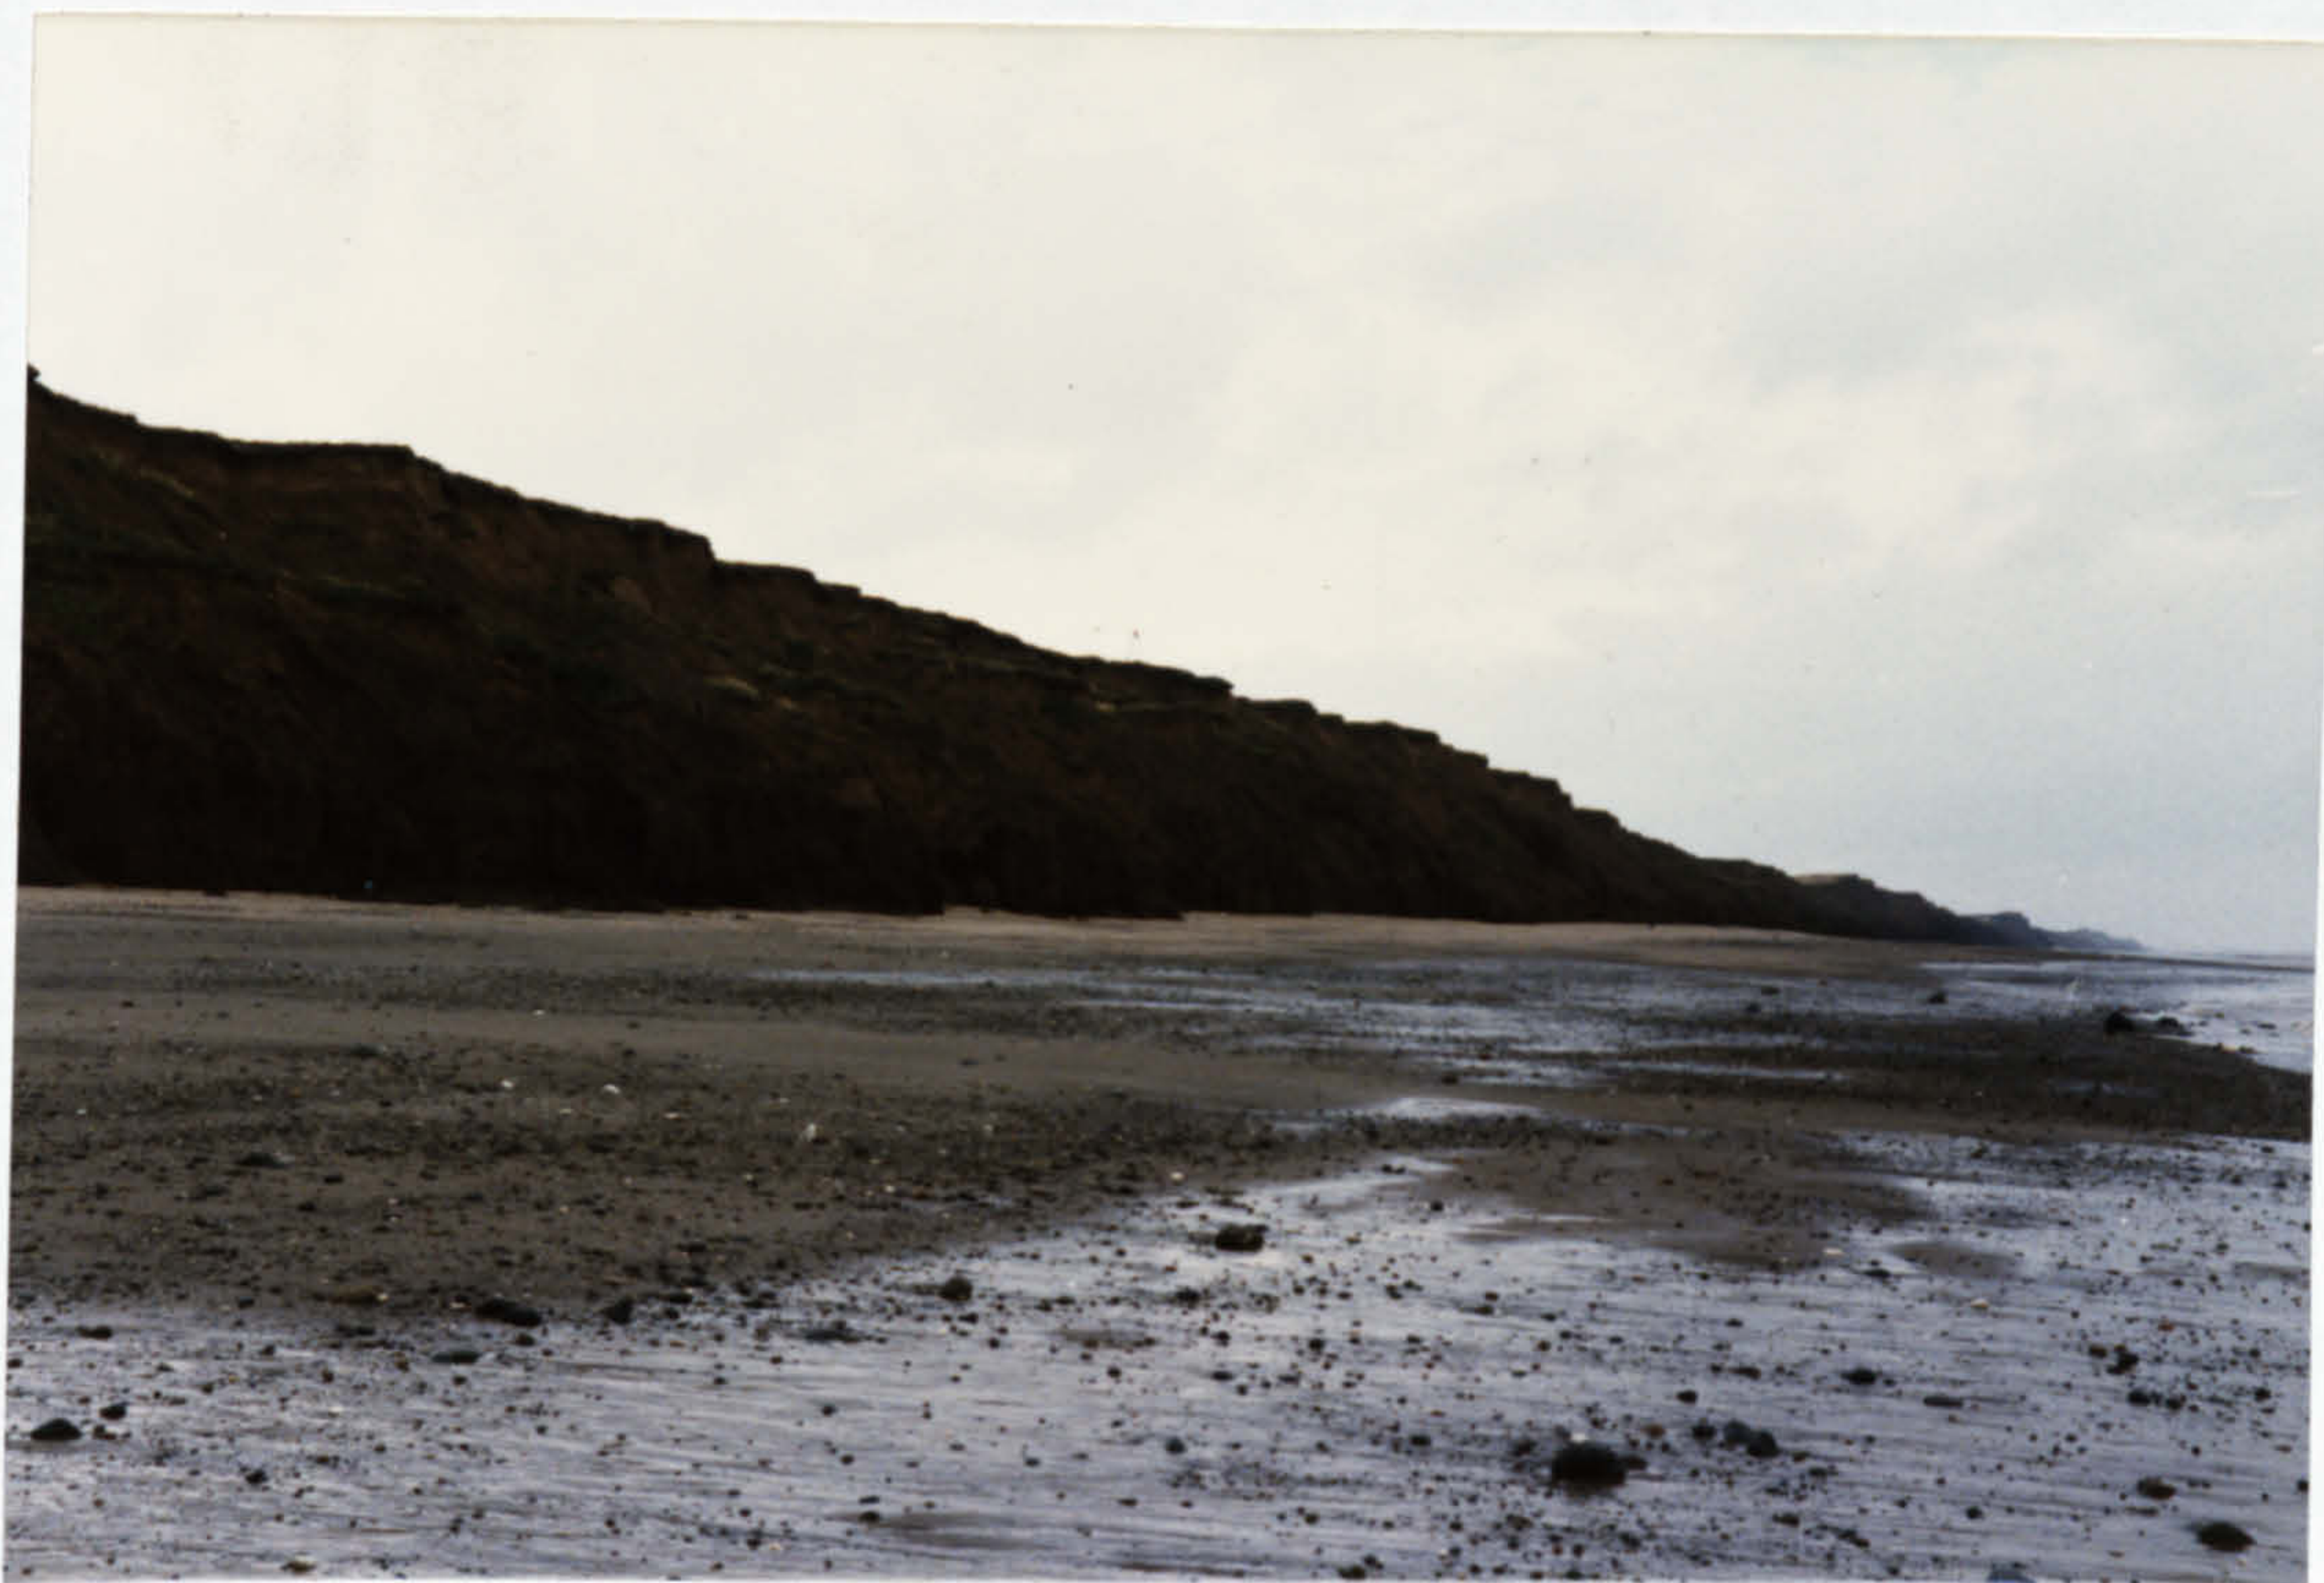
of minor soil types is small. The typical cliff morphology is shown in Figure 3.30 and the cycle of failure in Figure 3.31. The cliff morphology goes through a cycle of "recent slip" (profile 1), "degraded slip" and "degraded cliff" (profile 2), "till cliff" (profiles 3 and 4) and returns to "recent slip". The slope angle varies from a minimum of 35° during degradation, to a maximum of 50° just before failure. The positions of the slips alternate with the positions of "till cliff" and "ridges" which occur between them, as the cliff recedes. The cycle of failure is discussed in more detail at the Grimston site (in zone "B") in Section 5.5.

Typical cliff morphology in zone "B" near the Grimston site (TA 284 358). Note "degraded cliff" to left, "recent slip" centre and "till cliff" to right.

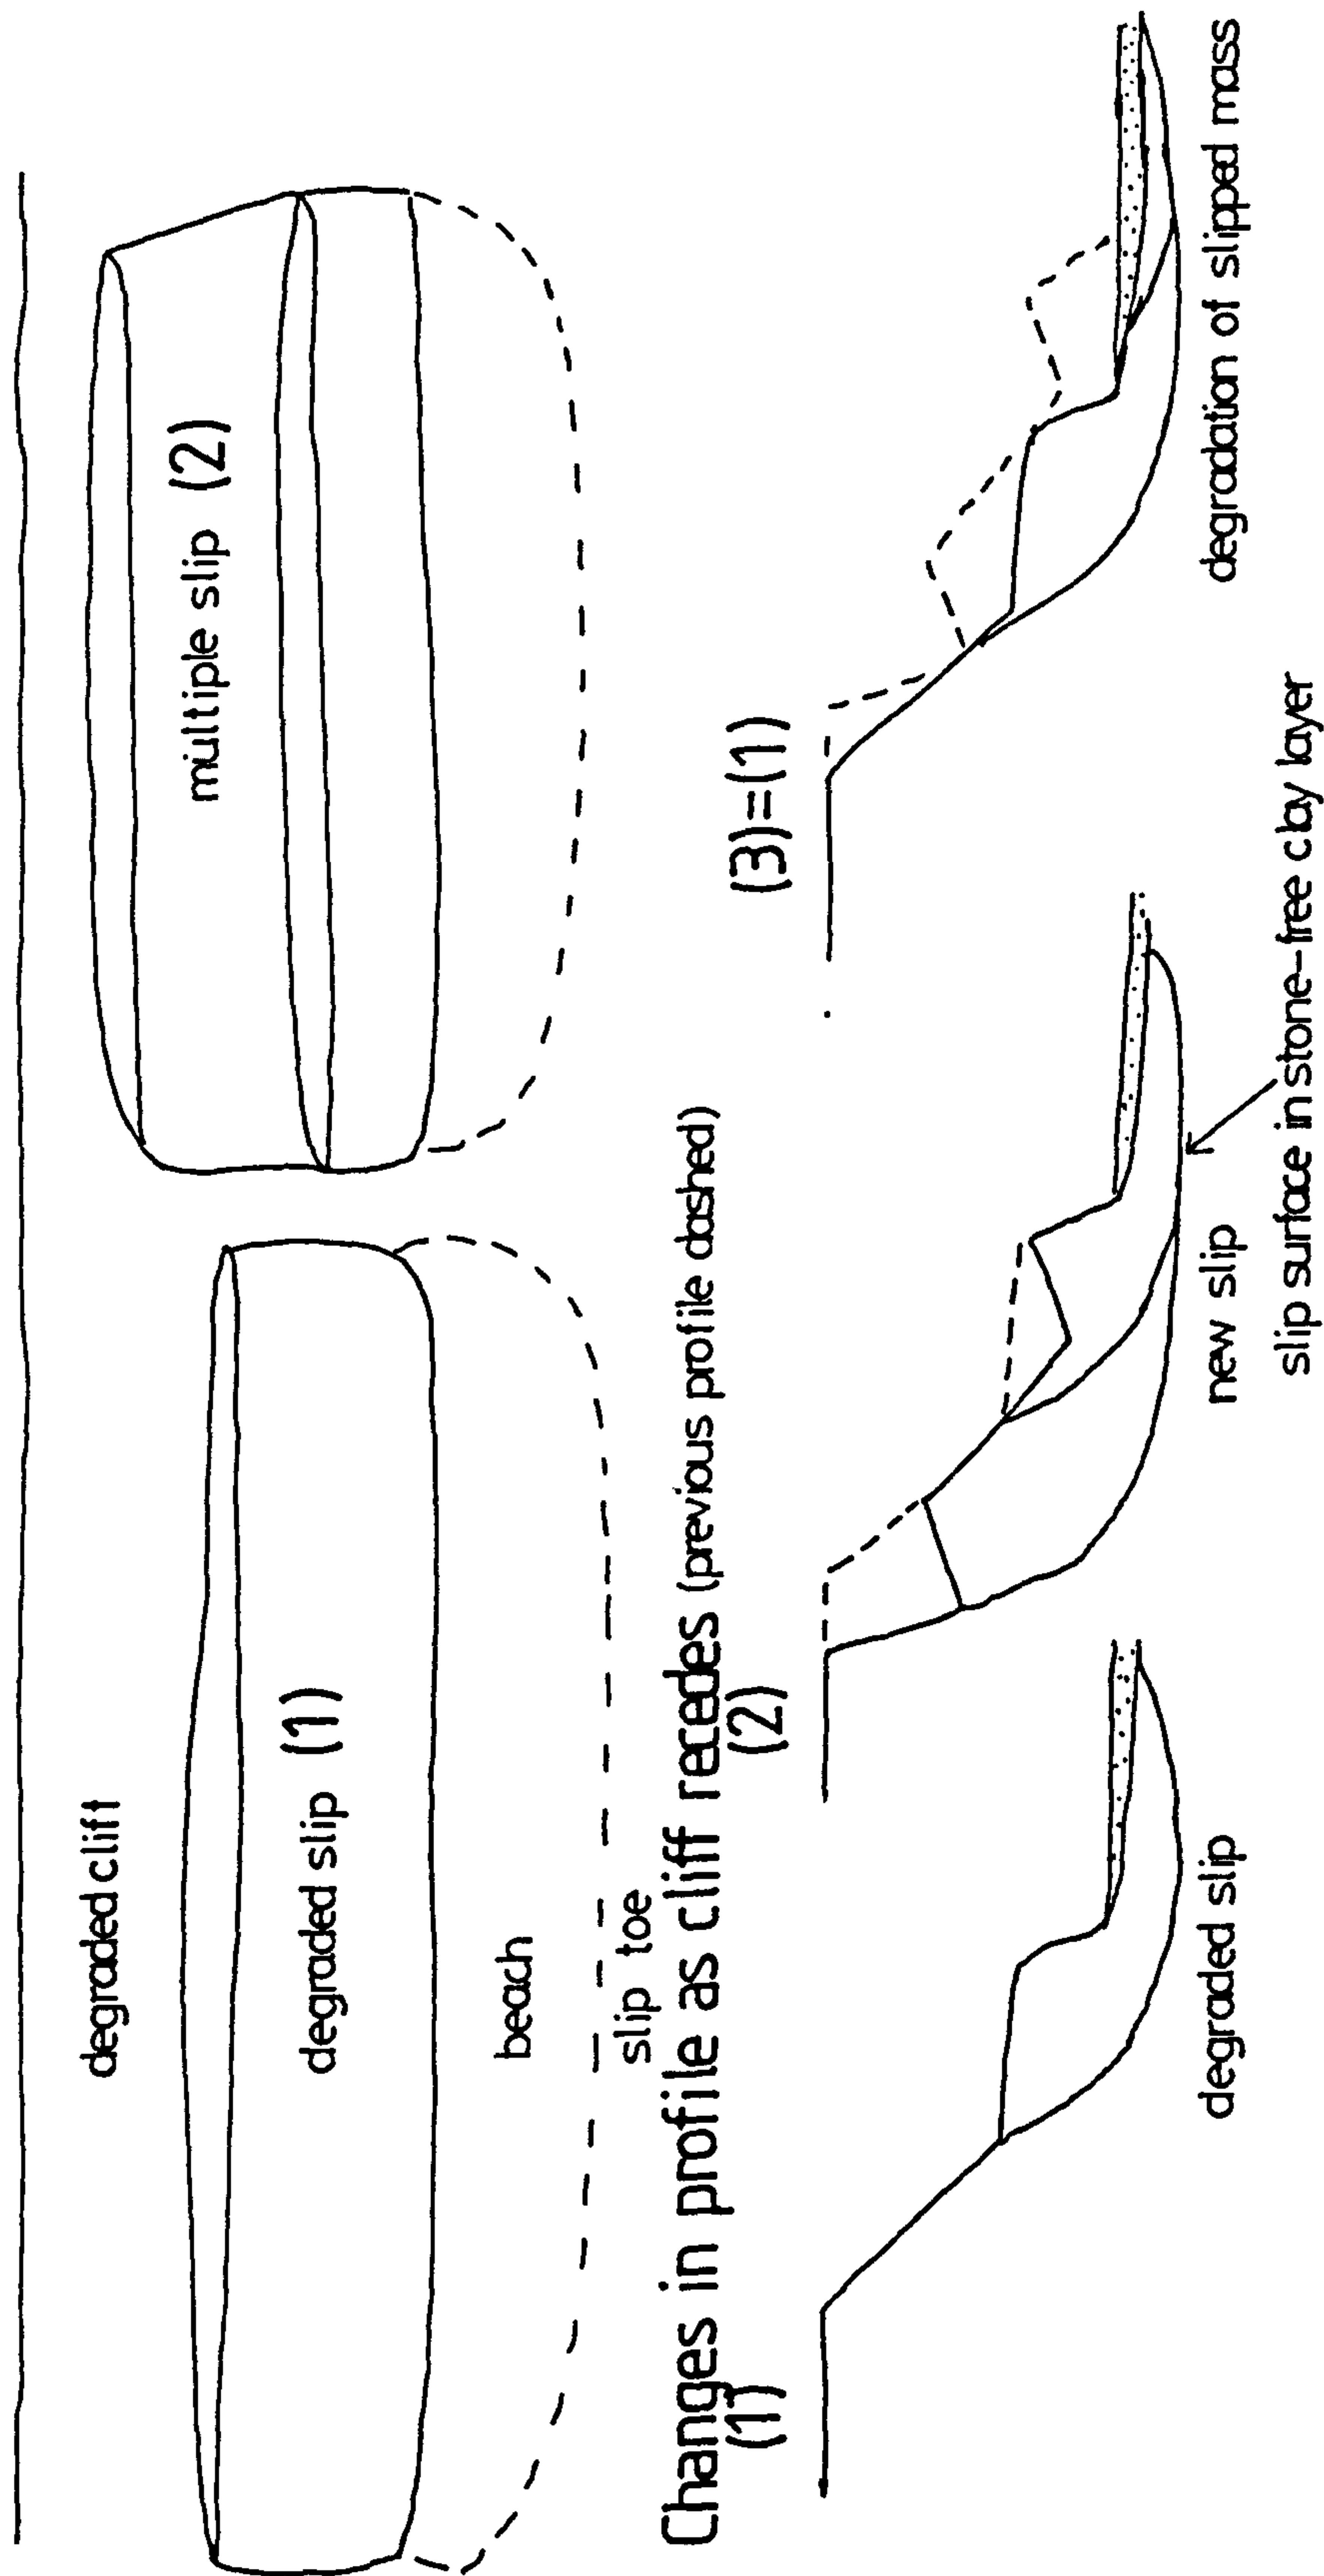
Figure 3.32 not to scale
Cliff morphology and cycle
of recession in zone "C"

"stone-free" silty clays occurring near the cliff foot (see Section 3.2.2). They are non-circular rotational or complex base failures. The cliff morphology is shown in Figure 3.8, and the cycle of failure is illustrated in Figure 3.32. The cliff morphology of long degraded slips and degraded cliffs remains near constant as the cliff recedes. A new slip may occur before the previous slip is entirely removed, resulting in a multiple failure. The slope angle is low throughout the cycle, alternating between 20° (profile 2) and 40° (profile 1). The correlation of zone "C" sections with high values of "total slips" and high "degraded slips" is shown in Figure 3.26, and is confirmed by the statistics in Figure 3.27. The occurrence of zone "C" sections between Cowden and Grimston explains the absence of any zone "B" sections here.

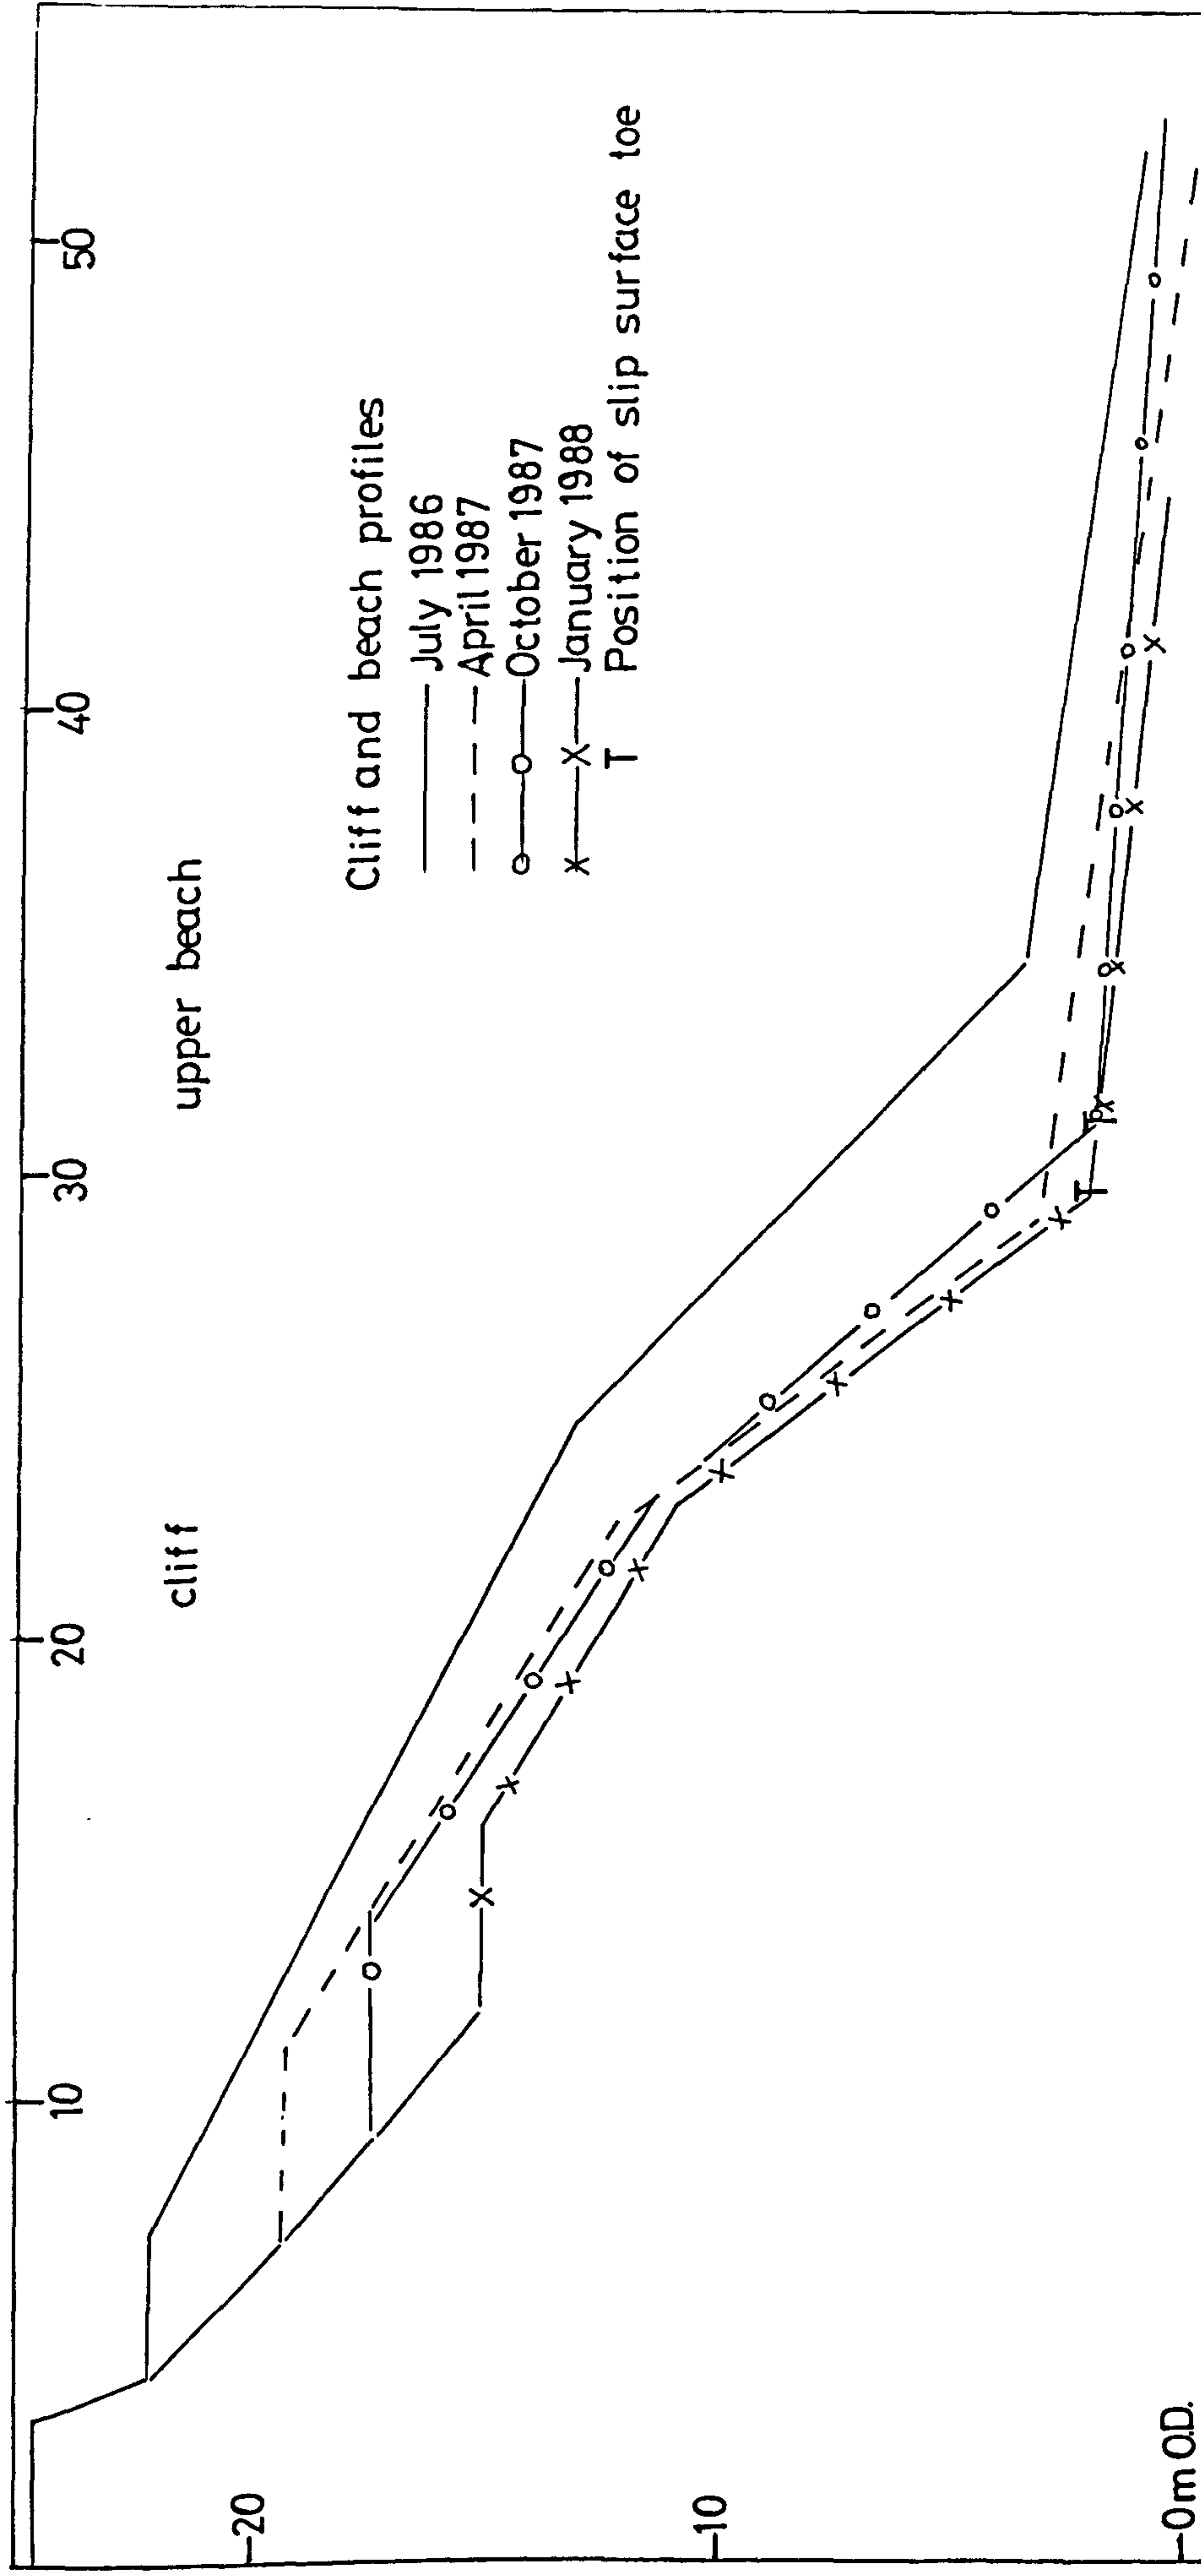
Figure 4:28
Changes in cliff profile for
slip'D' at Grimston
Scale 1:200

The two slipped soil masses at Grimston were degraded and moved downslope during the study, although no new slips occurred. A geomorphological map of the area made during 1981 (Williams, 1982) shows the presence of the two slipped soil masses at the same location. These are probably from the previous cycle of slipping, indicating a cycle time of 4-5 years. Falls of weathered till from the backscarp resulted in a recession of the clifftop by 1-2m, and loaded the slipped soil masses. Erosion of the cliff foot steadily removed till by large falls and corrasion. The rate of erosion was deduced to be equal to the rate at which the slips moved downslope, because the position of the cliff foot did not change during the study. Mudslides activated by seepage from sand layers eroded the till cliff between the slips during the winter months. The beach was lowered during the Summer and Autumn of 1987 by the passing of an "ord". The changes in cliff profile with time are shown in Figures 4.28 and 4.29.

profile of slip "D" (see Figure 4.28) may need a greater amount of toe erosion to activate movement. Also, erosion of the toe of slip "F" was more severe than slip "D".

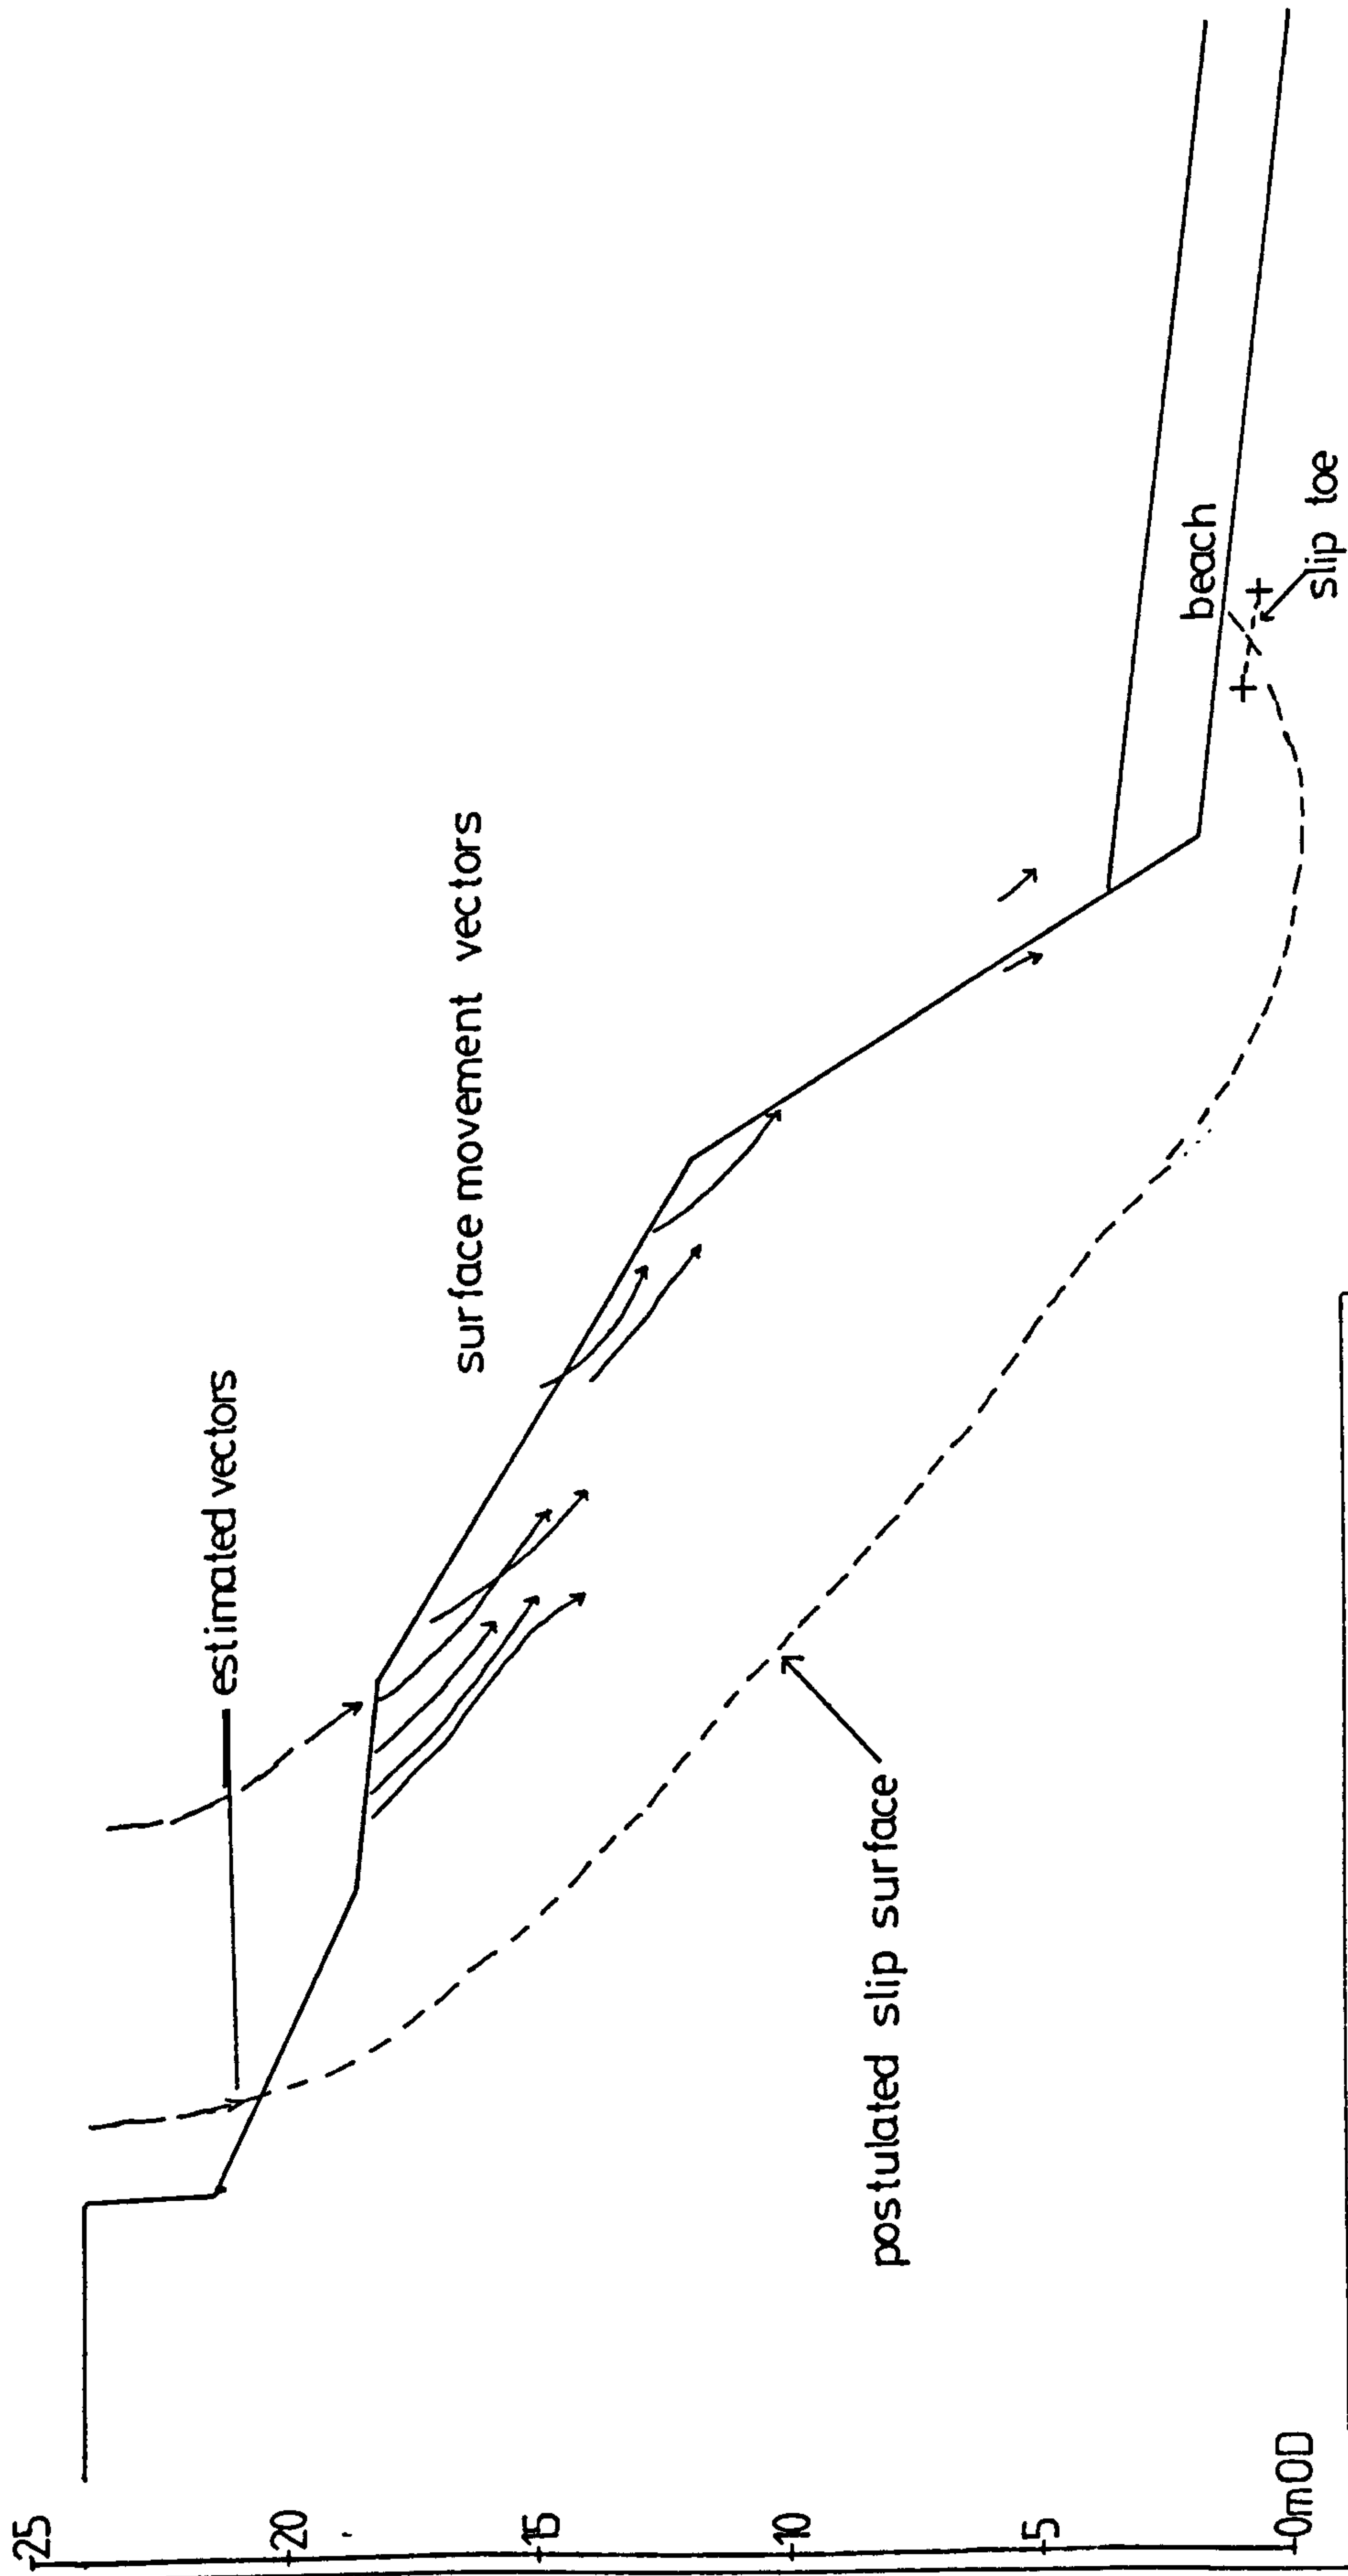
FIGURE 4:30
SURFACE MOVEMENT VECTORS GRIMSTON SLIP 'D'
SCALE 1:200 APRIL 1987 - MARCH 1988

used the assumption that surface movements were parallel to the slip surface. Tangents and normals to the surface movement vectors were drawn and considering the overall geometry of the slope, the slip surfaces were estimated. Because no definite measurements of the depth to the slip surface were made, these estimates could not be checked. Therefore in stability analyses a 'band' of slip surfaces which included the estimated one were examined.

The estimated slip surfaces comprise an approximately linear central portion with two circular portions at the head and toe. A circular failure surface could not be fitted with the observed ground movements, or be made to agree with the inclination of surfaces exposed and measured in other nearby slips. Although the slip toe was hidden by the beach during the survey, its position could be estimated between the limits shown, from exposure of different parts of the till shore platform on several visits. The rear scarp is near vertical, although its profile may have been modified by falls, and would not then represent the original slip surface.
