Erosion and Stability of Till Cliffs
on the Holderness Coast

This thesis is submitted in fulfilment of the requirements
for the Degree of Doctor of Philosophy
in Geotechnical Engineering

Iain Robertson

University of Newcastle upon Tyne
Geotechnical Engineering

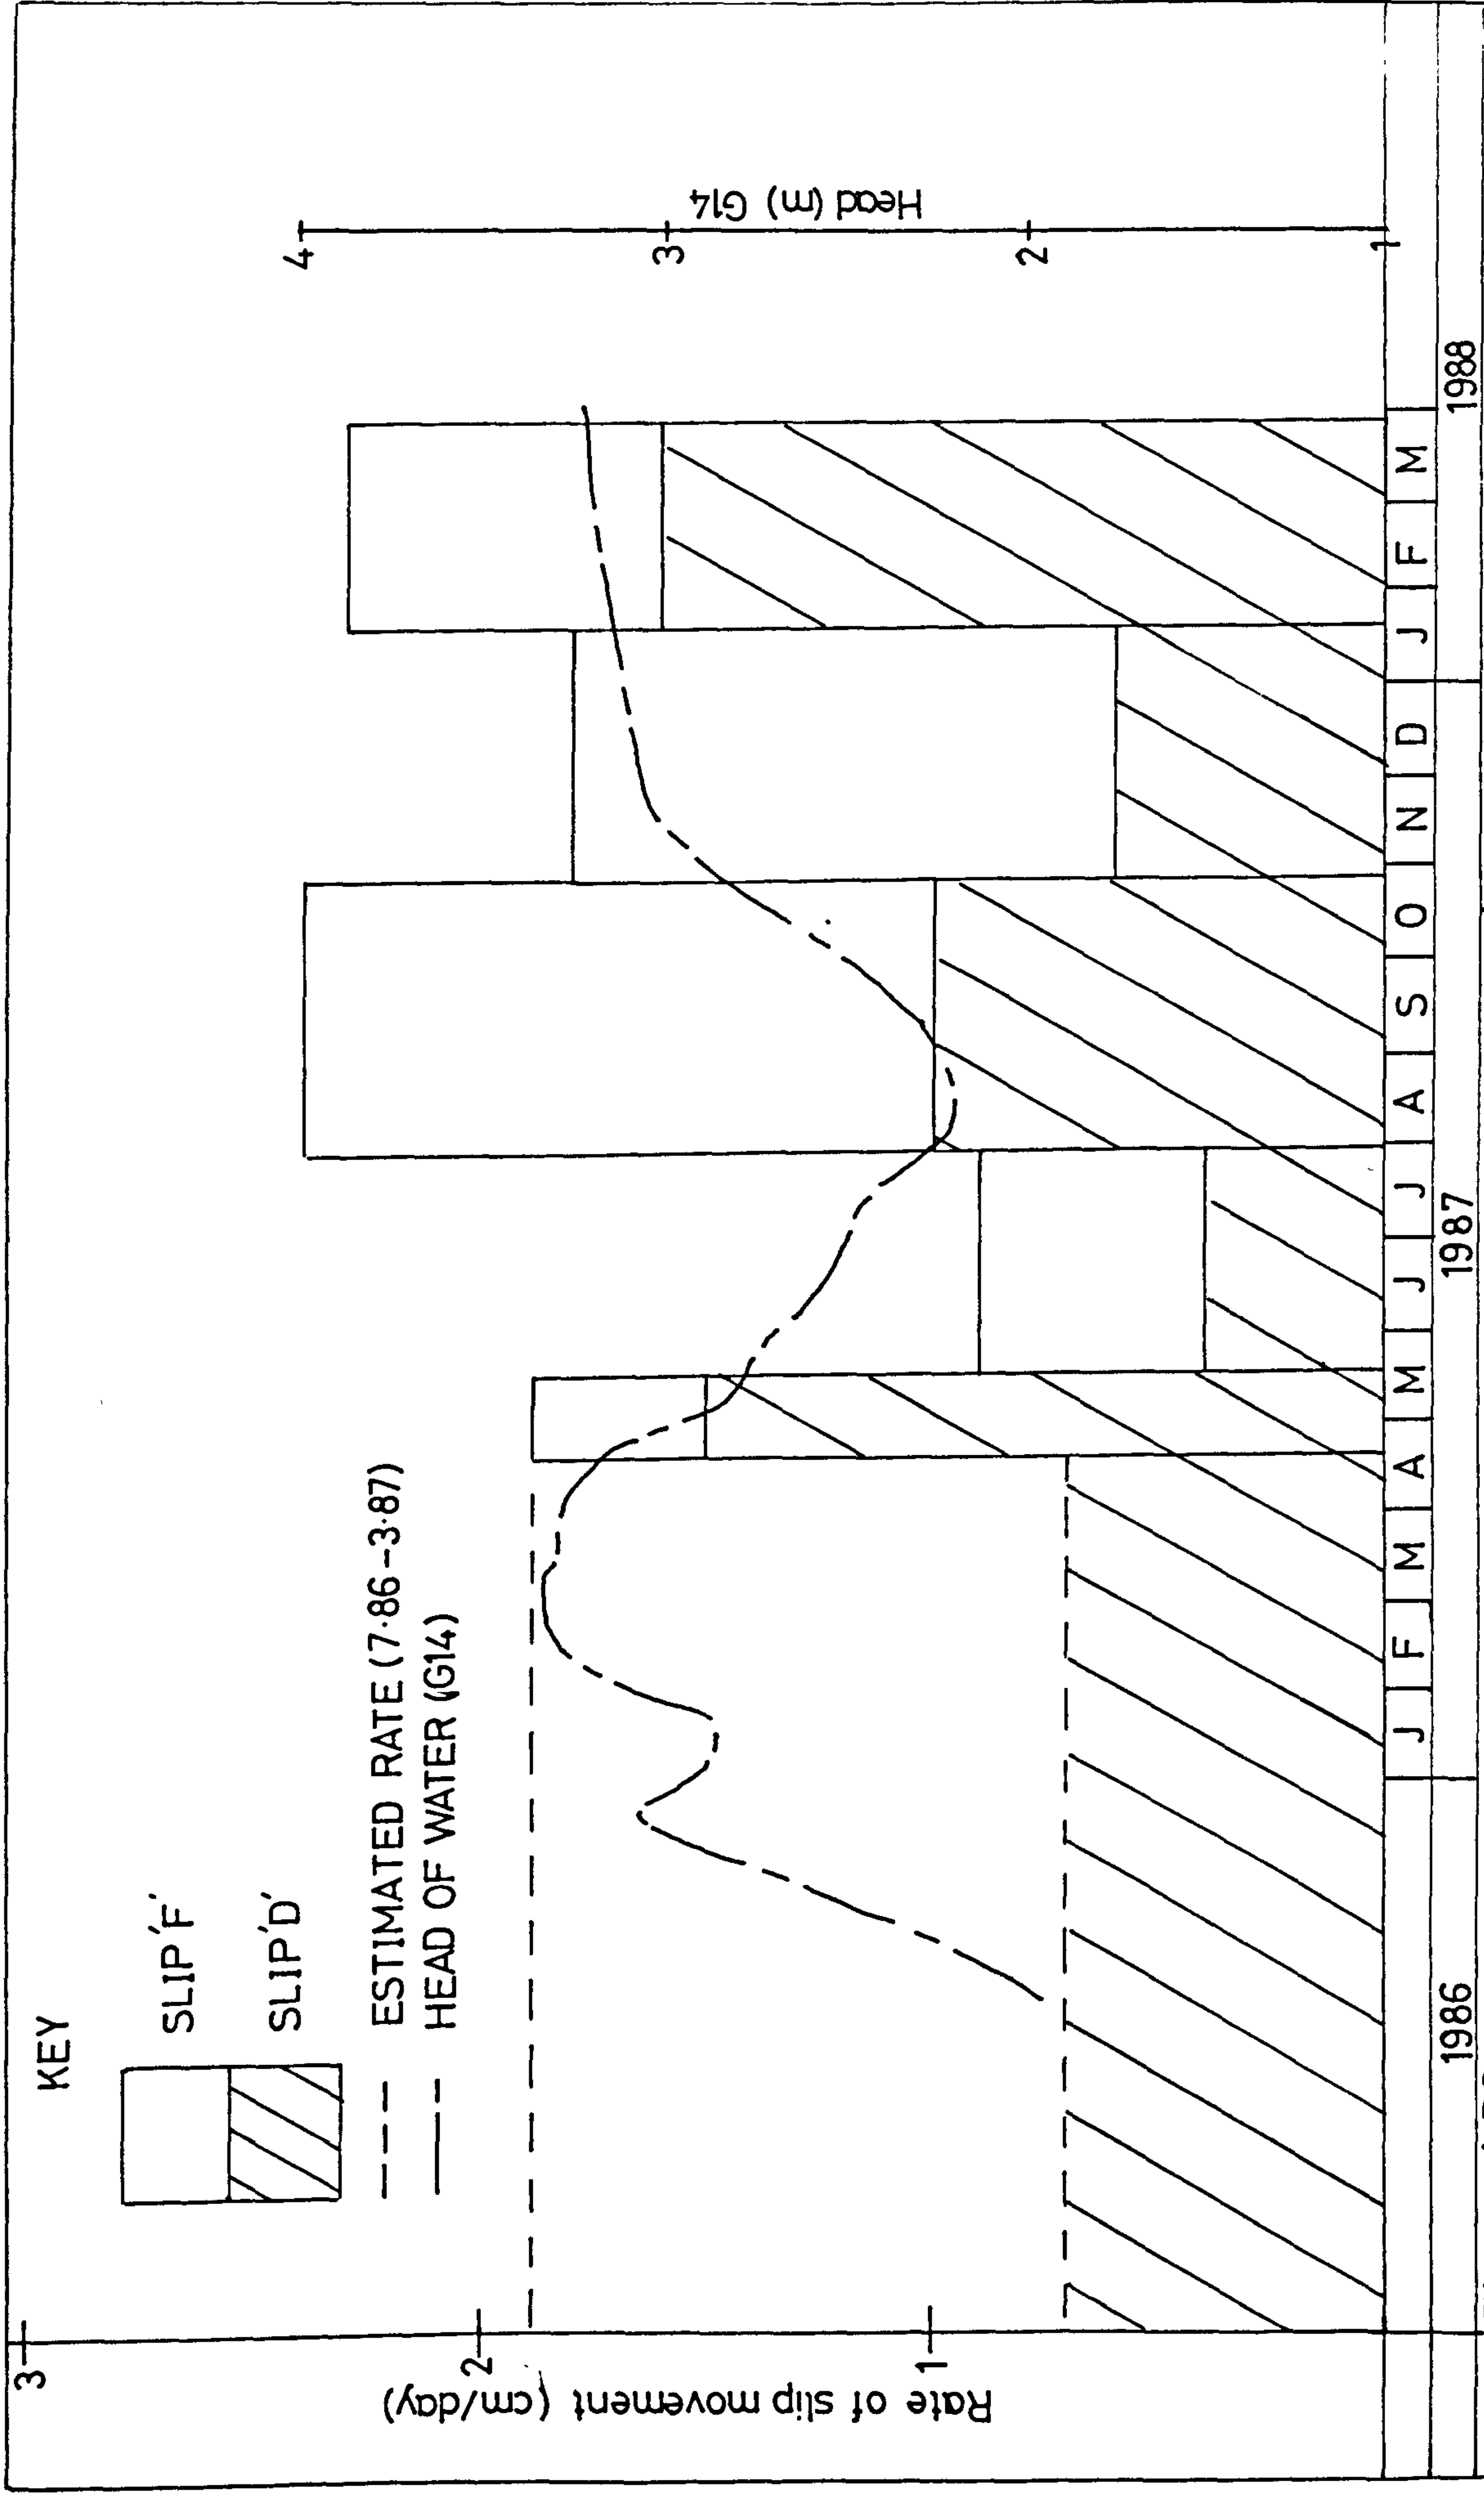
Figure 4:32
Histogram to show rate of movement of slips D and F at Grimston

The rate of movement of the two slipped soil masses at Grimston was calculated for the periods between surveys. The results are plotted as a histogram in Figure 4.32. Slip "F" has consistently moved at a faster rate than slip "D" throughout the period July 1986 to March 1988, probably because of the difference in size of the slips. Slip "D" is 70m long and 11m wide, compared with 30m and 5m for slip "F". The higher

profile of slip "D" (see Figure 4.28) may need a greater amount of toe erosion to activate movement. Also, erosion of the toe of slip "F" was more severe than slip "D".

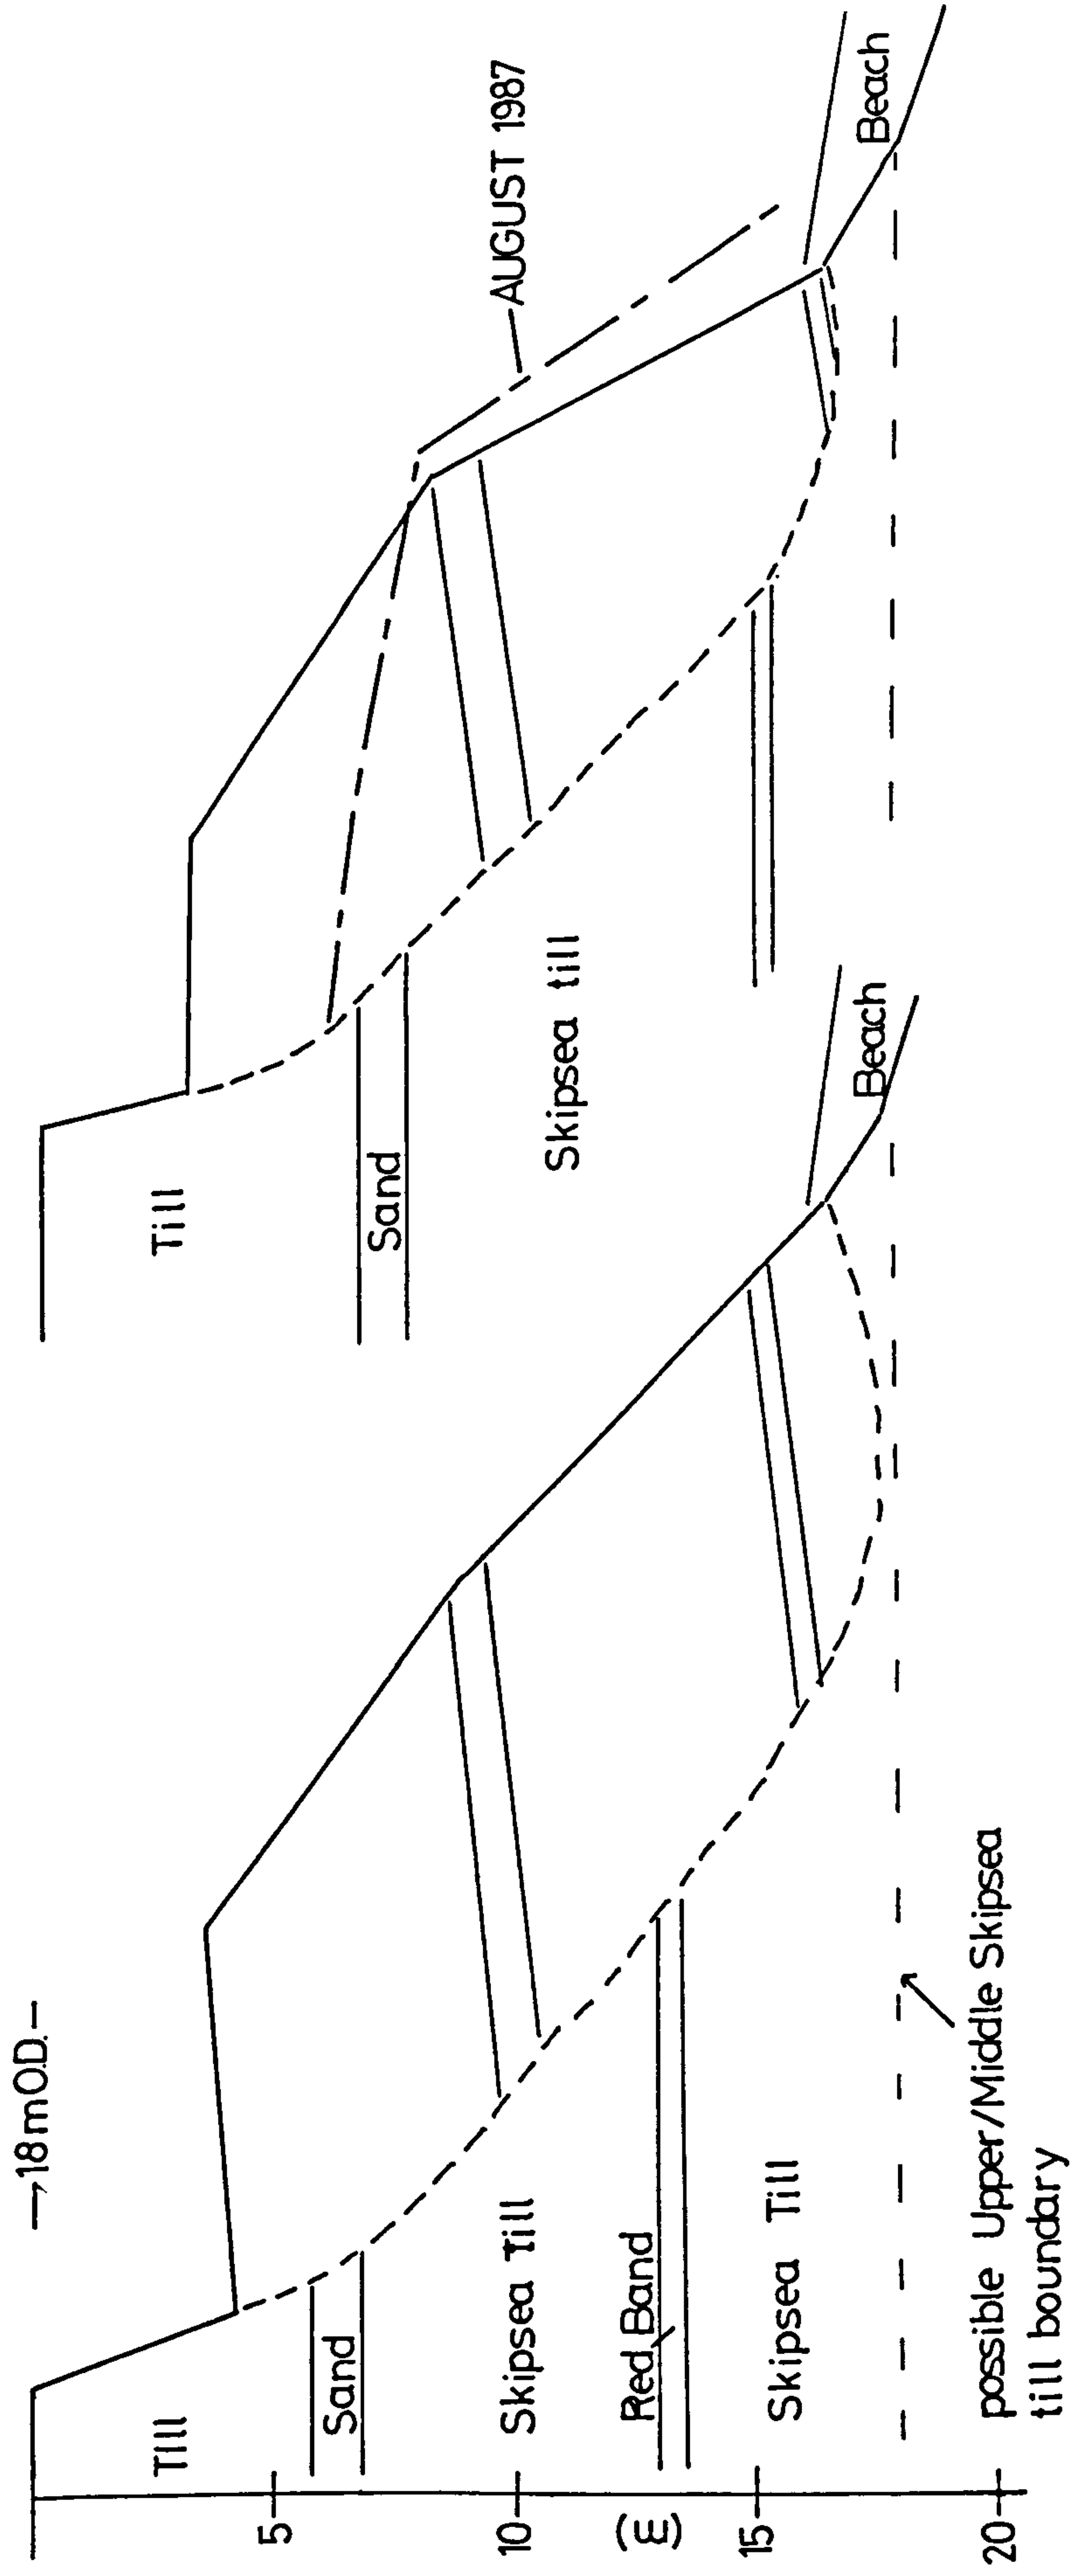
FIGURE 4.35
ROLSTON SLIP PROFILES
SCALE 1:200

The slipped soil masses at Rolston were broken up quickly by the toe erosion, thus it was impossible to measure their movements. Two of the four major slips were surveyed soon after their occurrence. The profiles are shown in Figure 4.35, together with the estimated slip surface. The shape of the slip surface could not be found precisely owing to the lack of slip movement measurements. However it was probably similar to the Grimston slips, from examination of exposed slip surfaces nearby. Also the slipped soil masses are backtilted less than would be expected for a circular slip. The position of the toe was not influenced by the unusual red clay layer near the cliff foot.

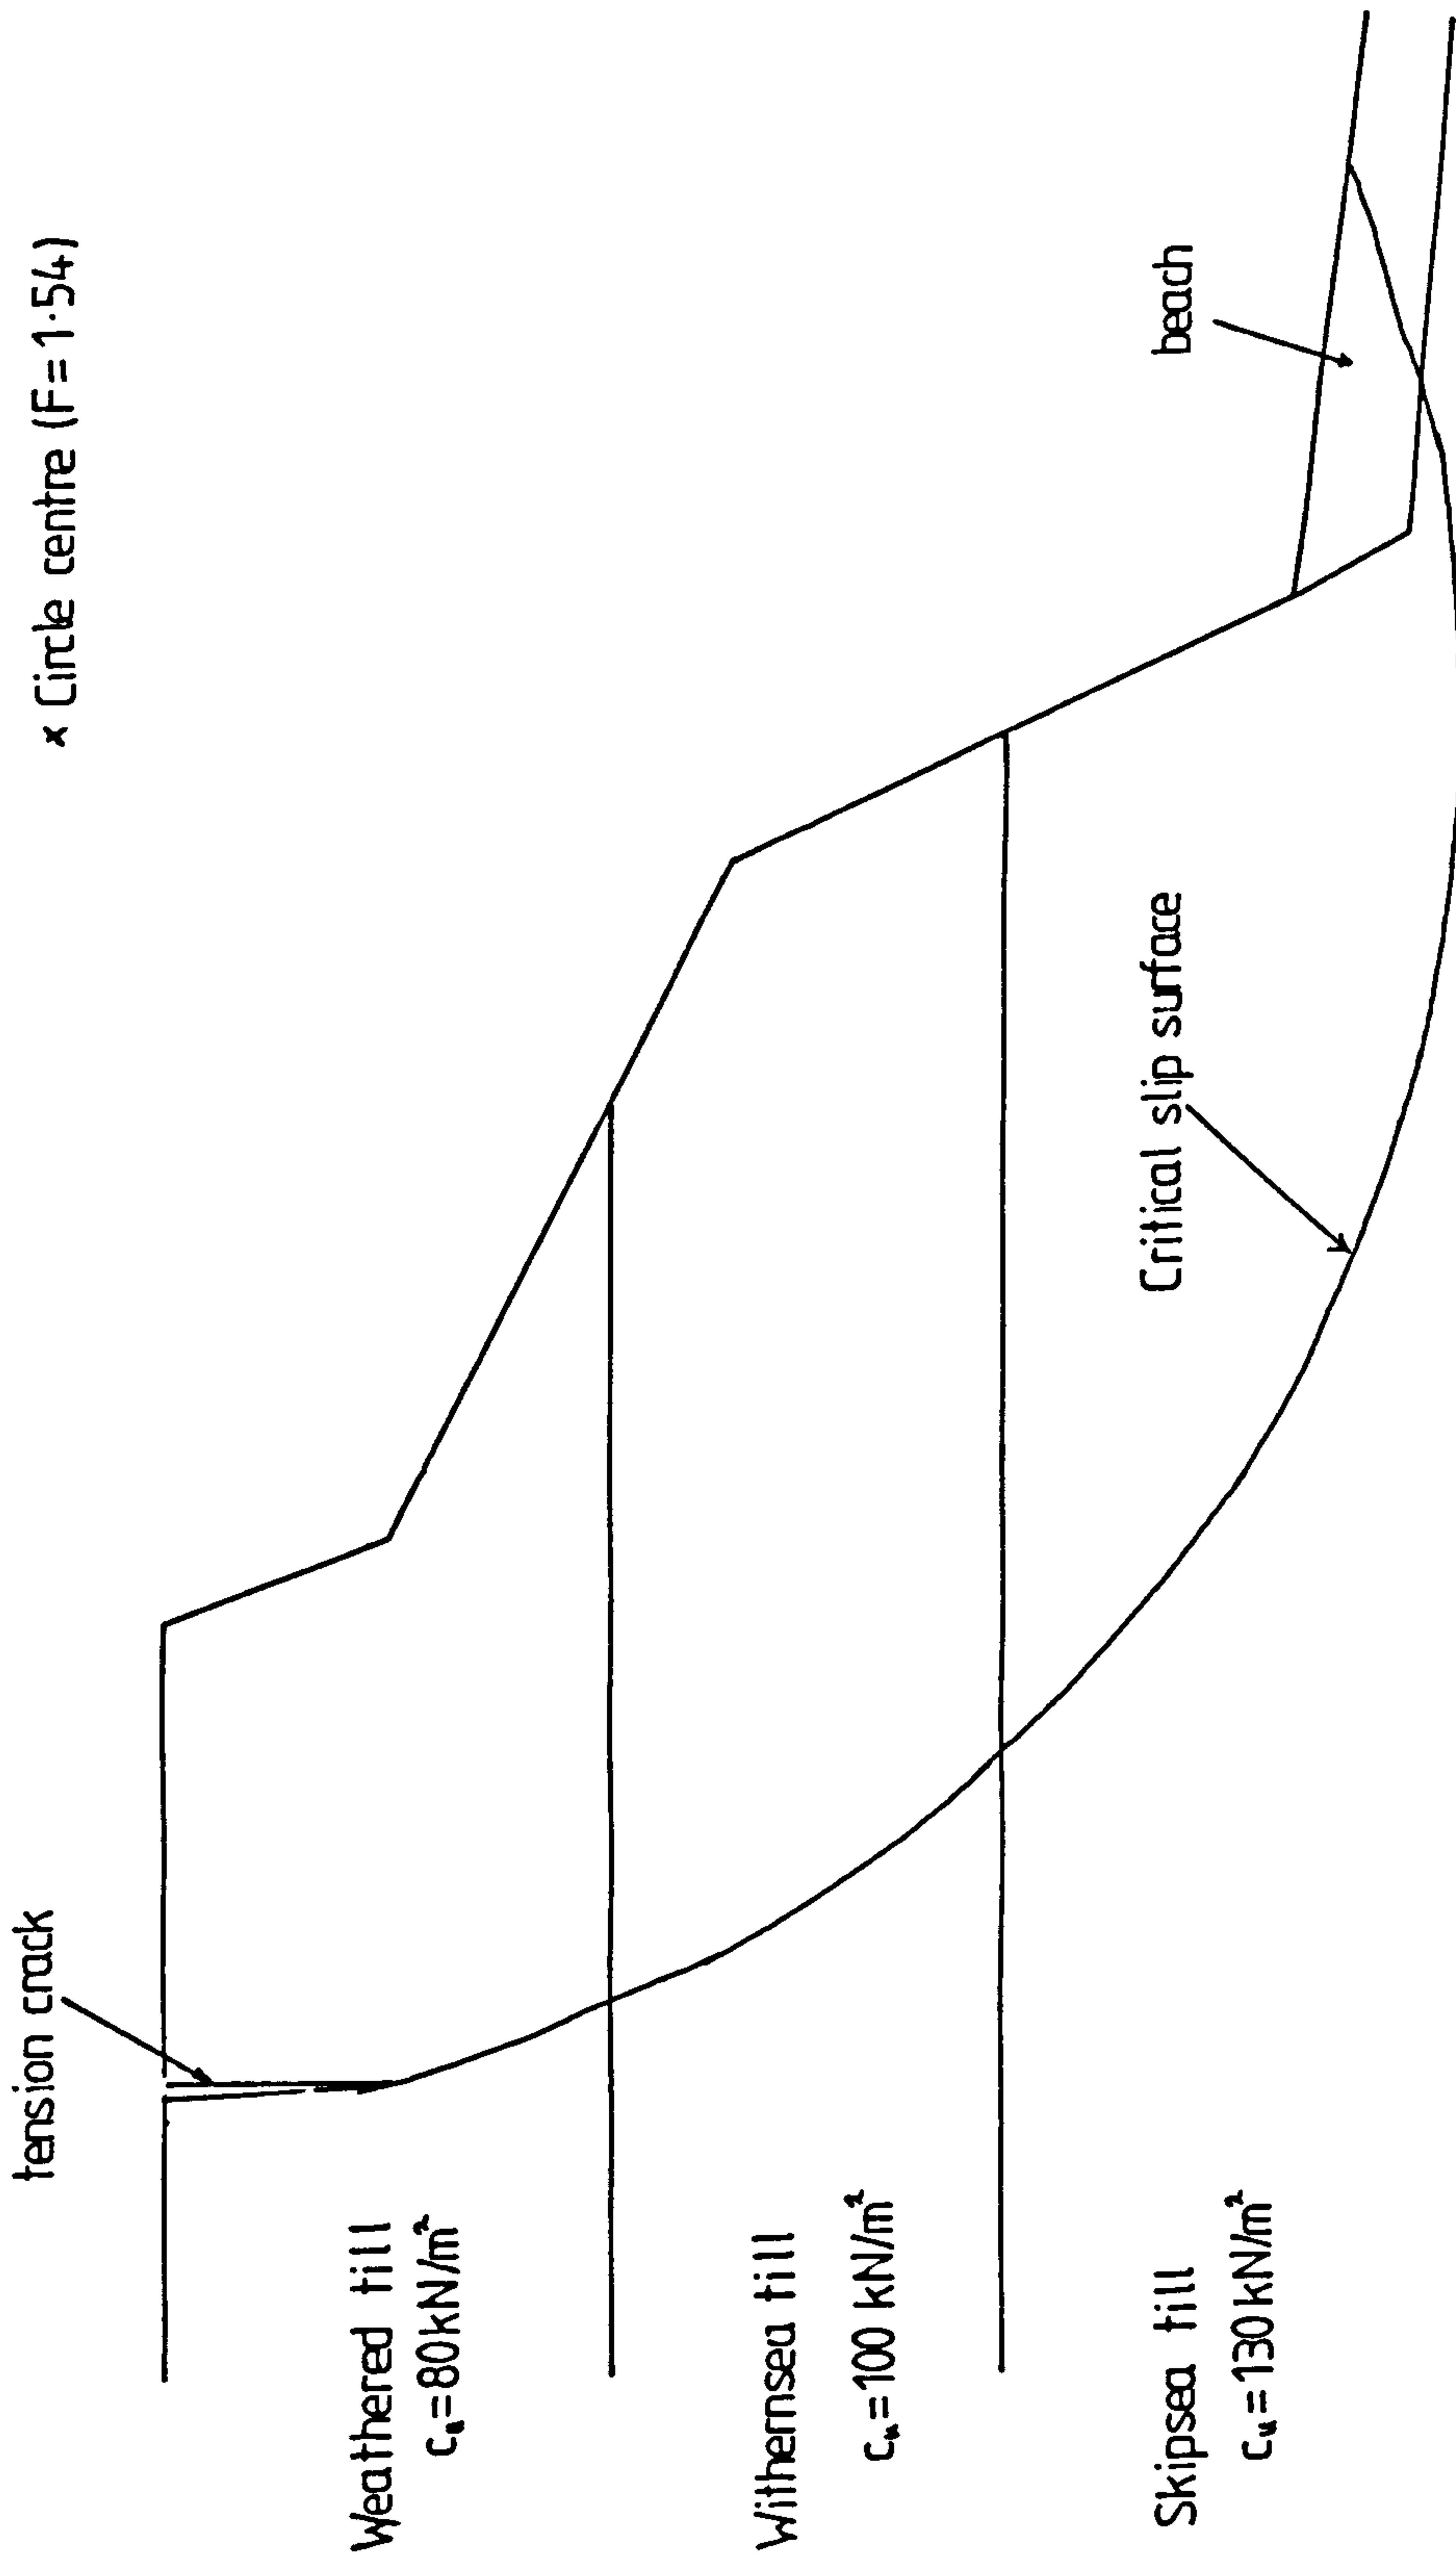
Figure 5.15	Scale 1:200
Critical slip circle for total stress $\phi_u = 0$ method

A search was made for the critical slip circle which is shown in Figure 5.15. A 4m deep tension crack was included at the head of the slip. Tension cracks of about this depth were often observed behind cliff failures. The toe of the slip surface was constrained to emerge in the foreshore, as observed in the actual failure. The factor of safety obtained was 1.54.

To obtain a factor of safety of unity it was necessary to decrease the undrained shear strength by about a third. Some of this difference may be attributed to the differing undrained stress paths followed in cone tests and in the cliff. However the majority of it is probably due to swelling and softening of the till in response to stress relief, prior to failure.

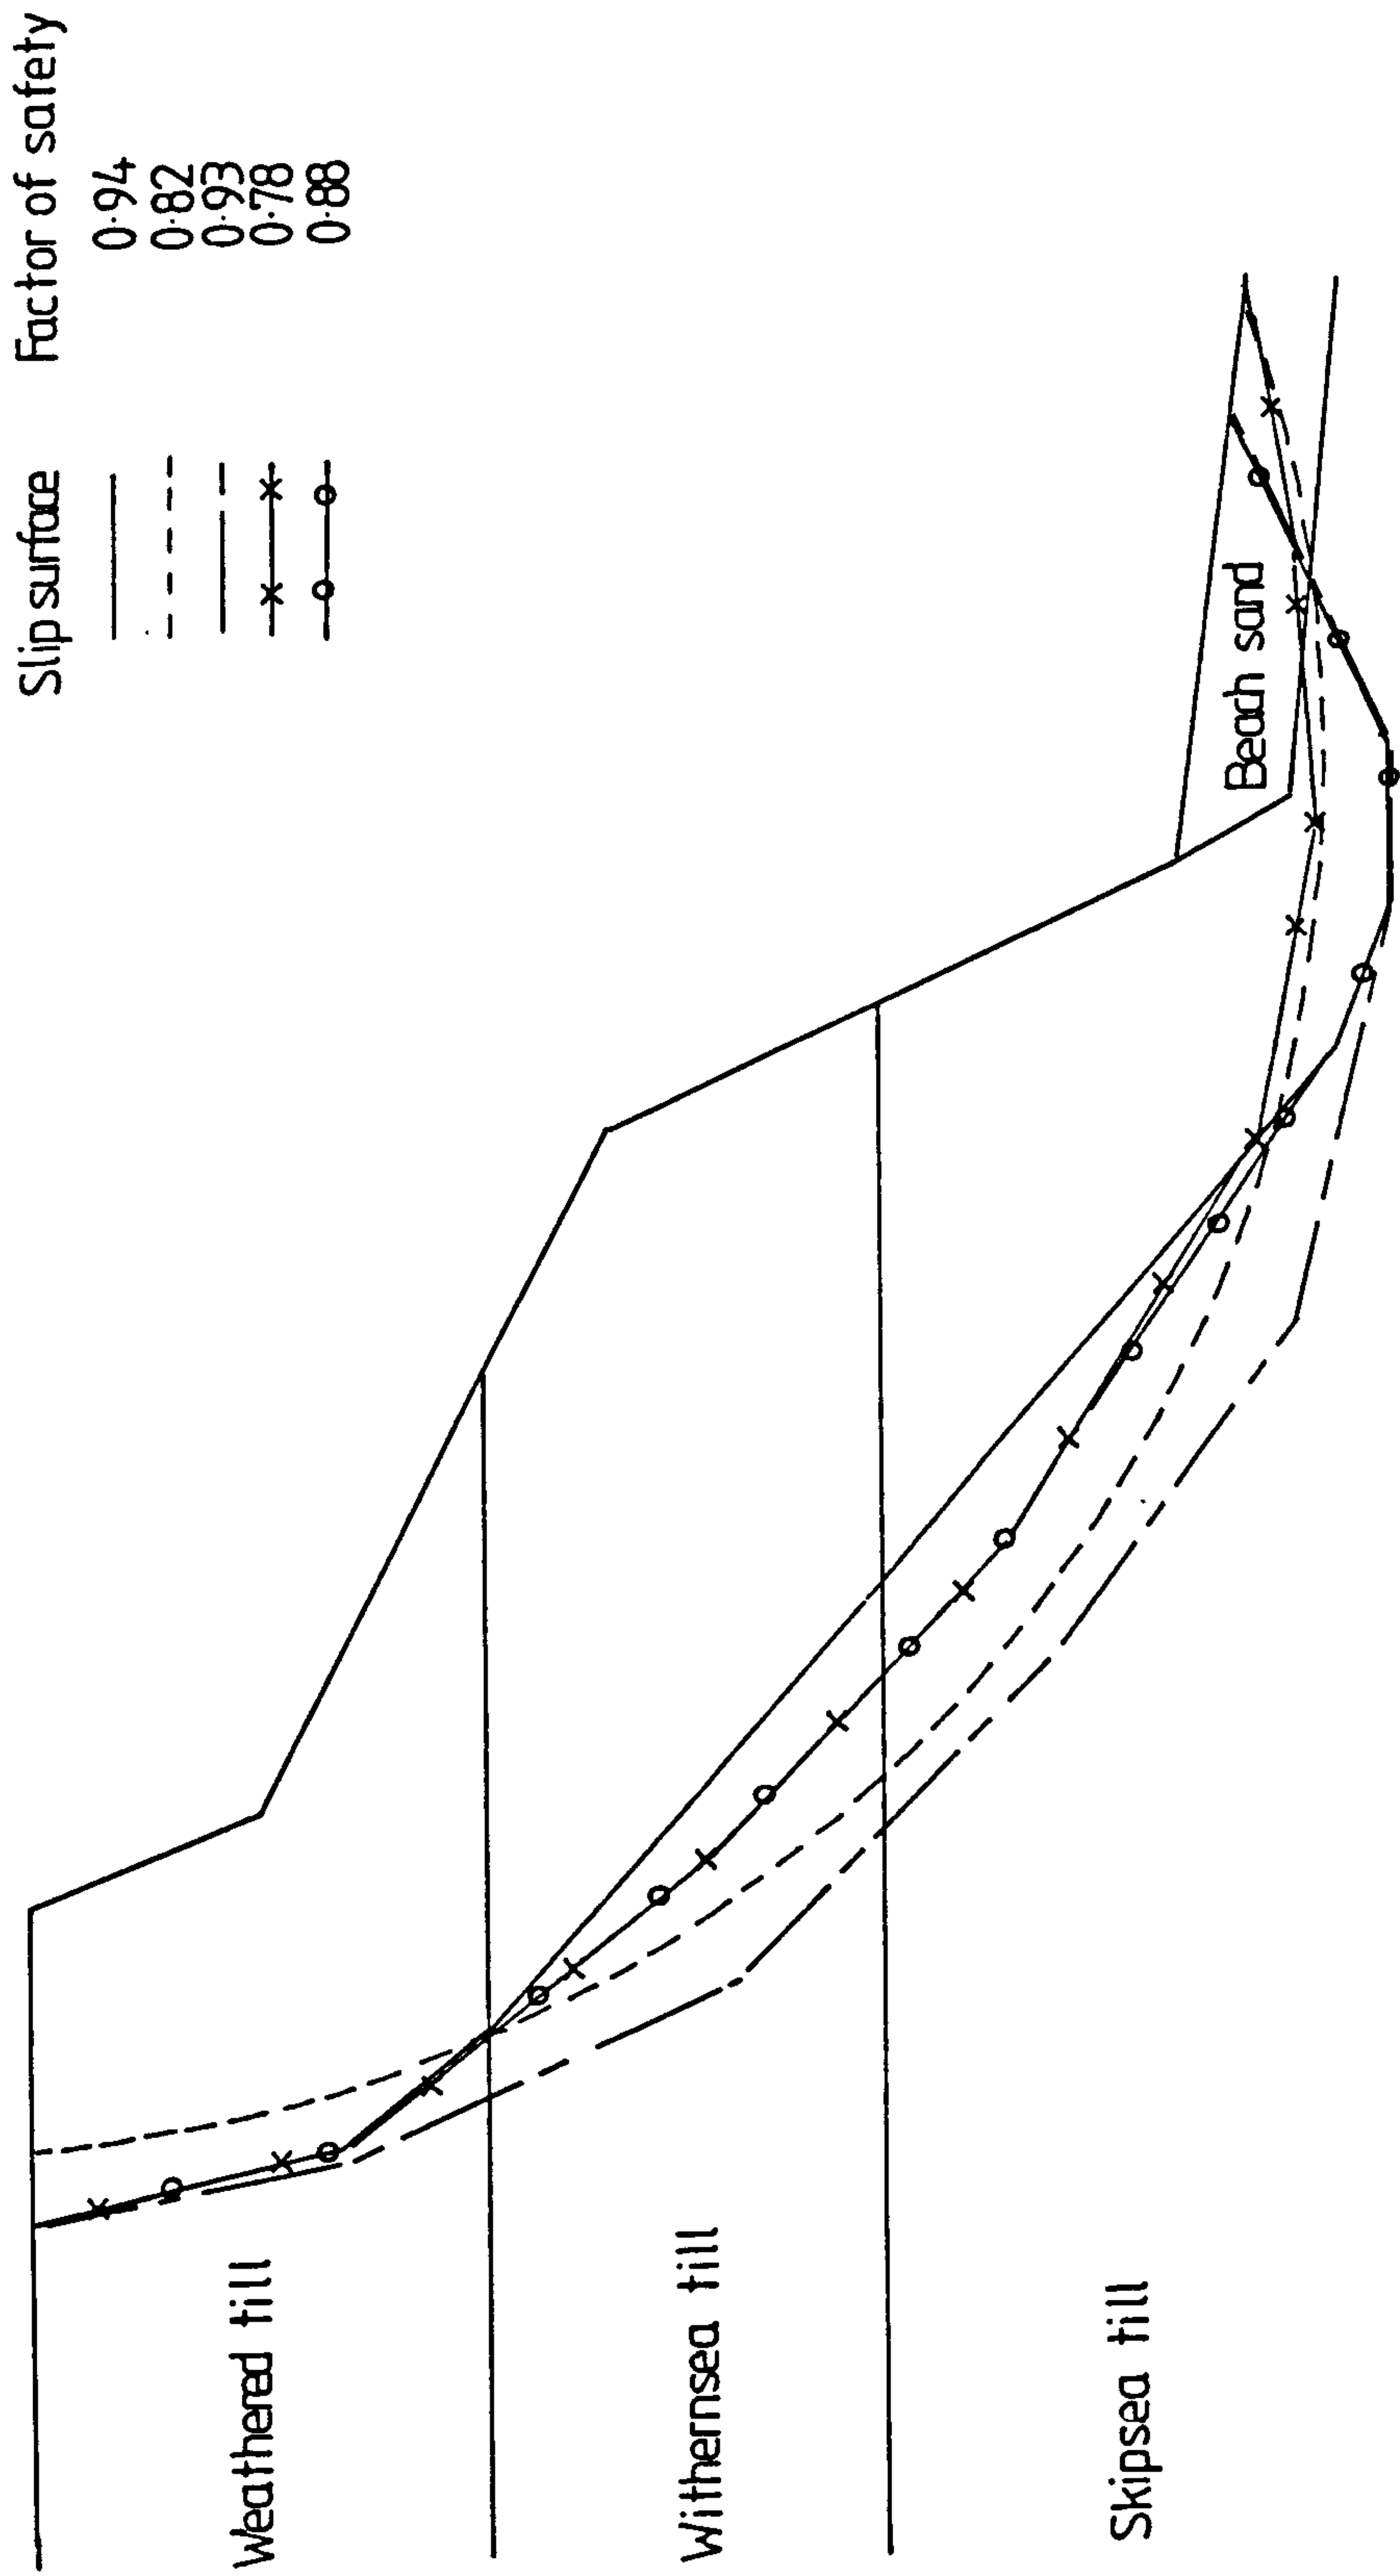
FIGURE 5.16 Scale 1:200

In the initial analyses a full beach, constant pore pressure ratio of 0.2 and peak strength parameters from "standard" triaxial tests were used. The slope profile, slip surfaces and factors of safety obtained are given in Figure 5.16.

The most critical surface found was a non-circular surface at moderate depth with a factor of safety of 0.78. As the profile is a pre-failure one, a factor of safety of 1 or greater would be expected. The three most probable reasons for this discrepancy are:

1. neglect of the effects of lateral variation in slope profile and end effects;
2. pore water pressures on the slip surface may be lower than than those used in the analyses;
