Erosion and Stability of Till Cliffs
on the Holderness Coast

This thesis is submitted in fulfilment of the requirements
for the Degree of Doctor of Philosophy
in Geotechnical Engineering

Iain Robertson

University of Newcastle upon Tyne
Geotechnical Engineering

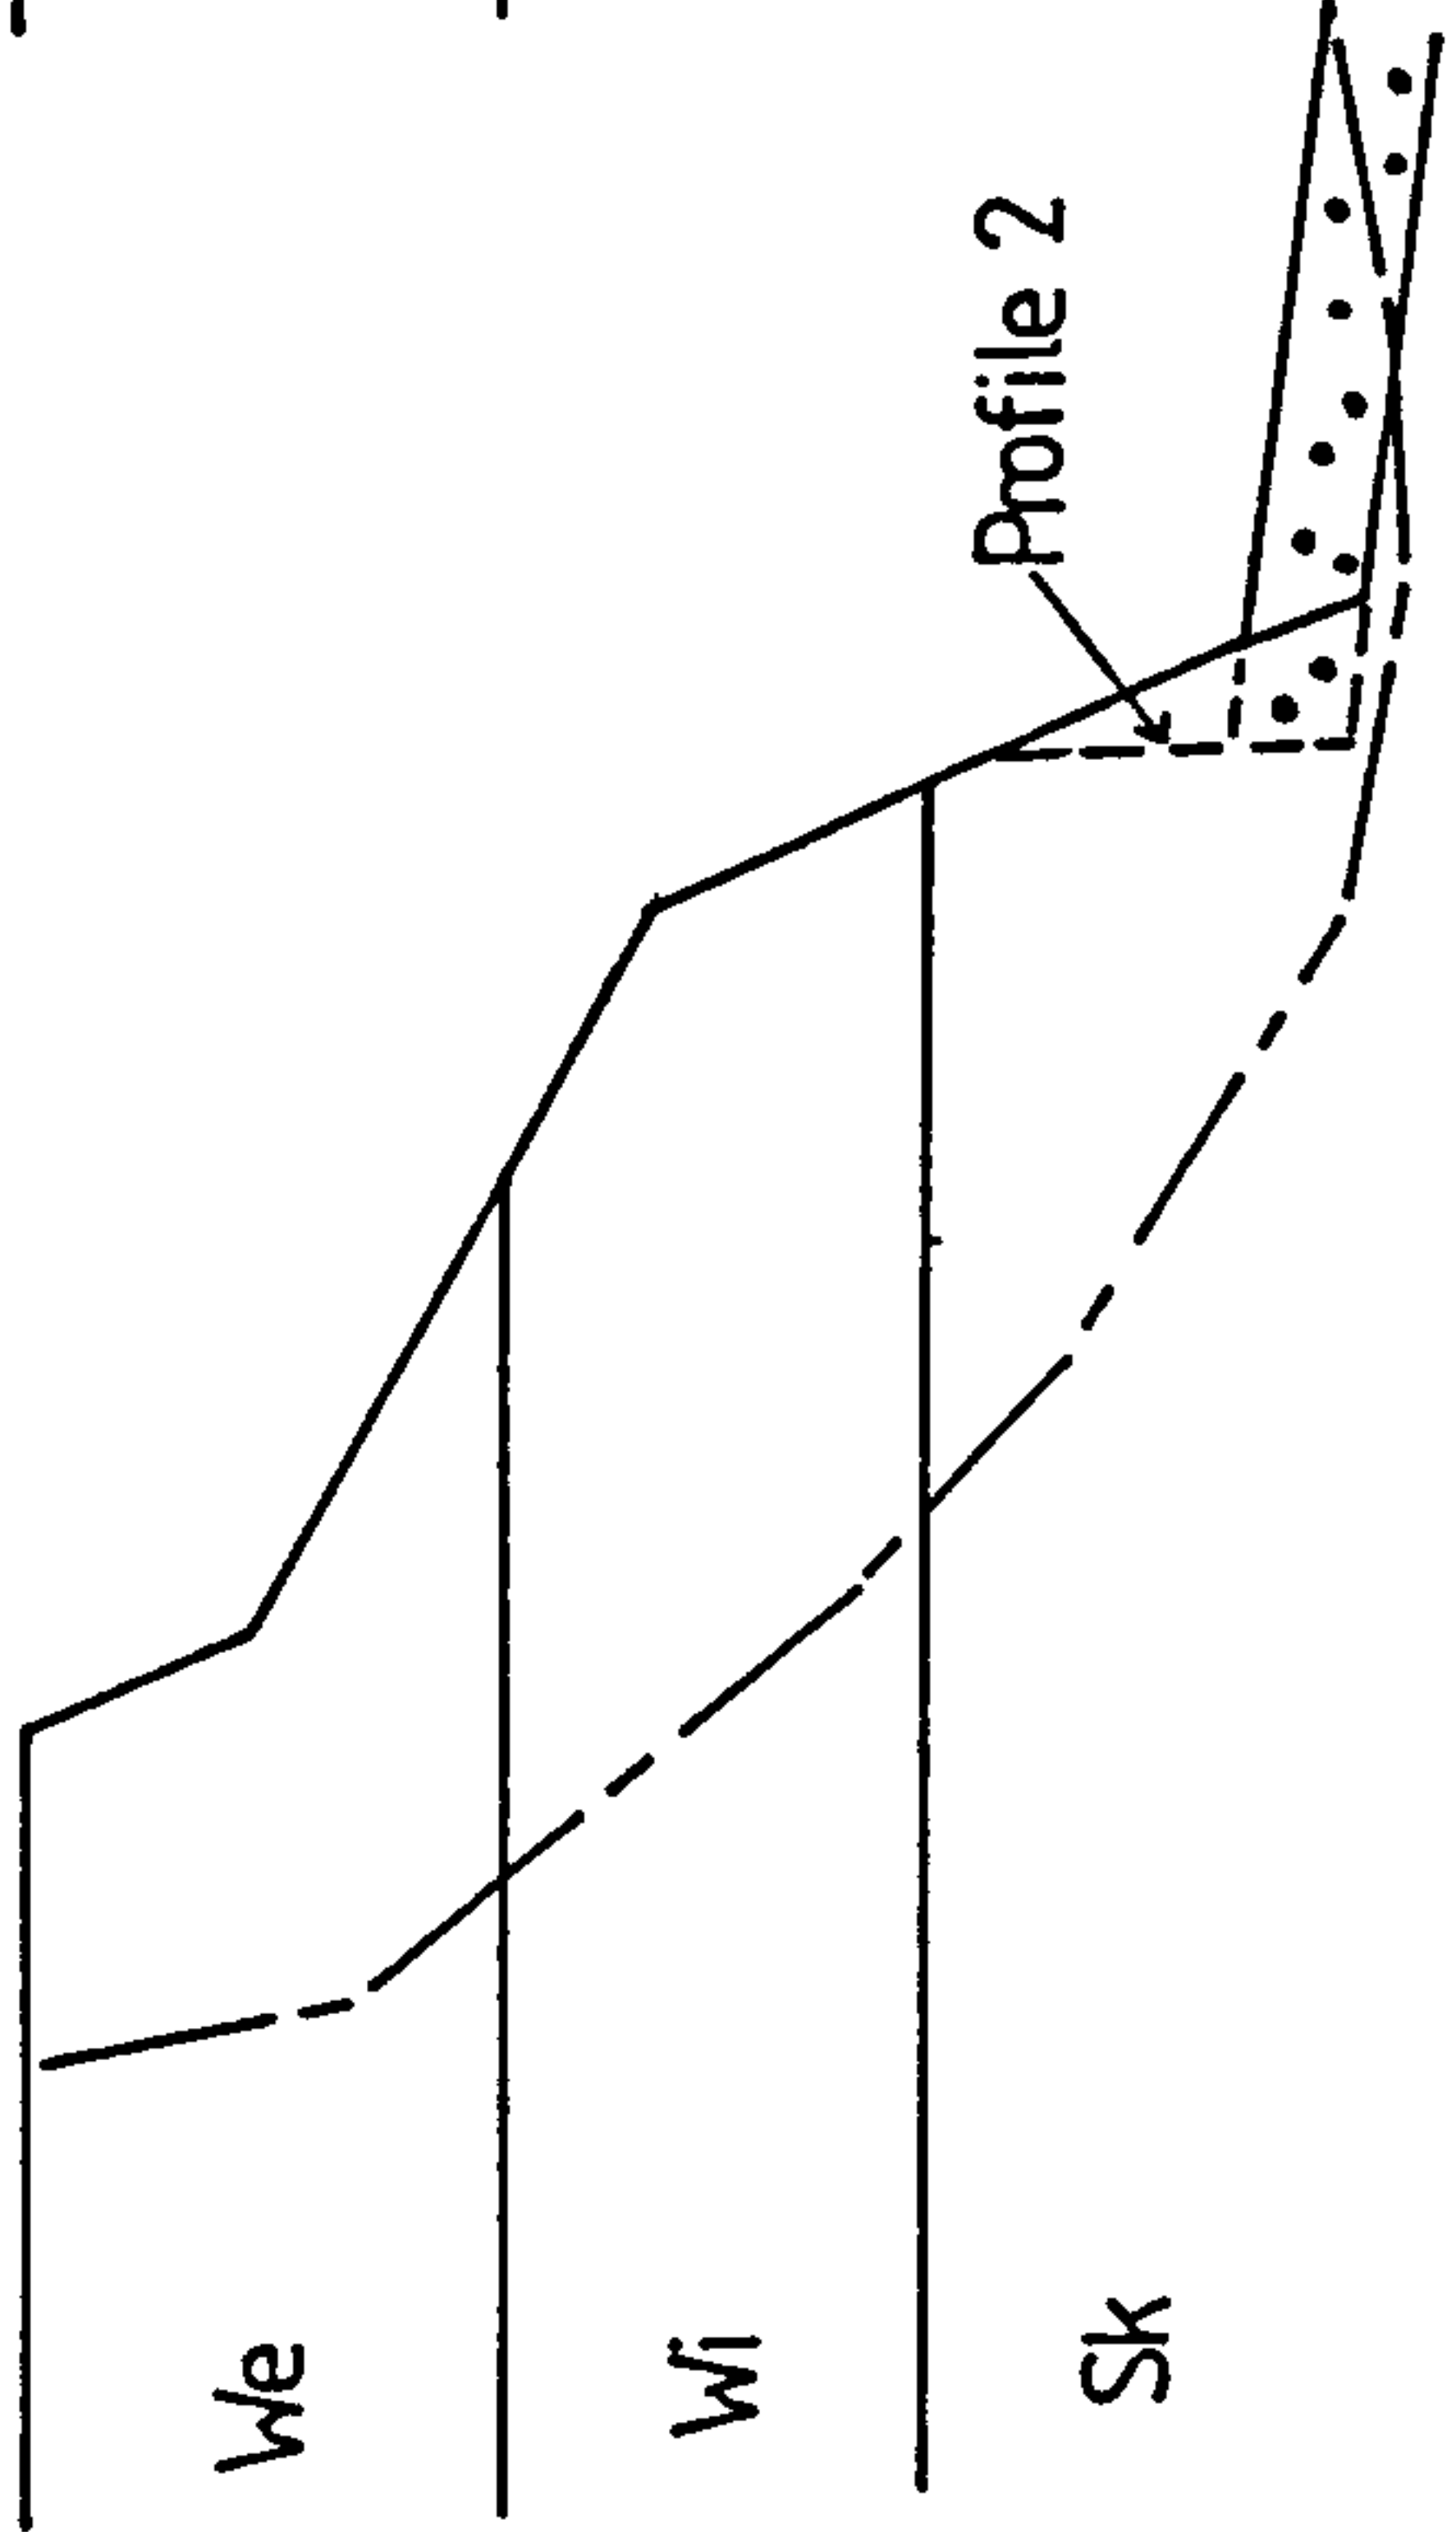
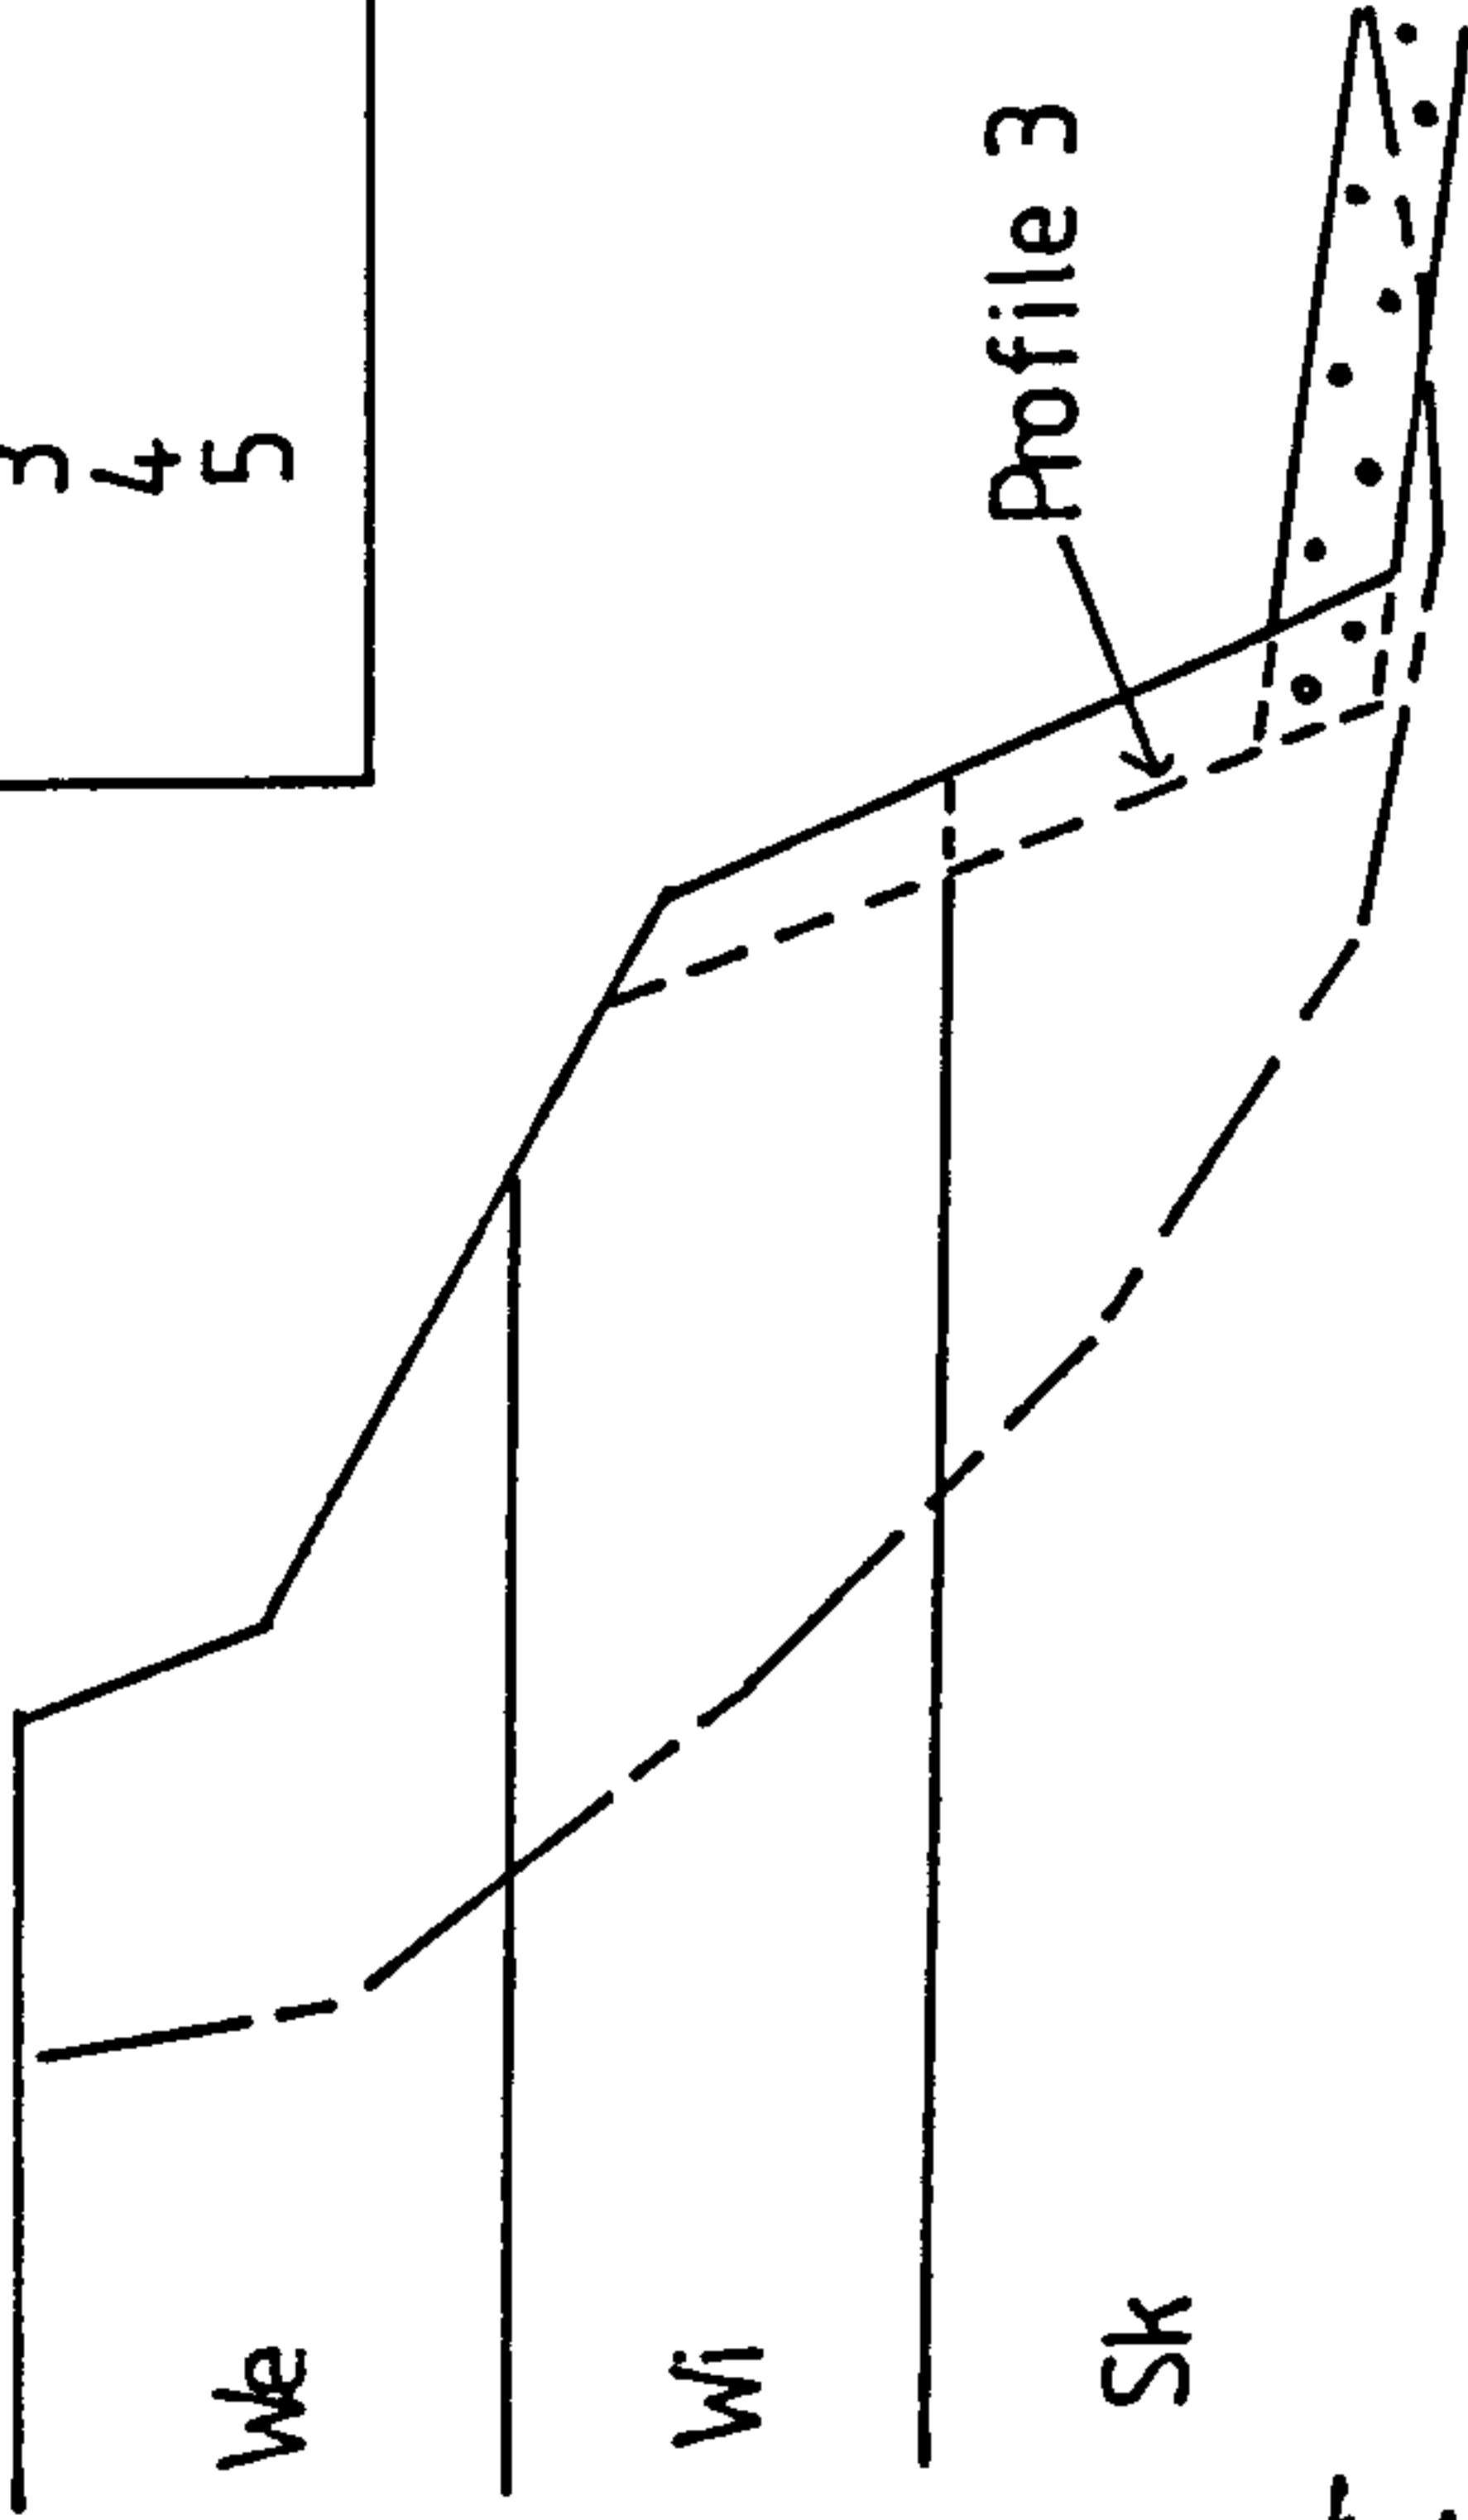
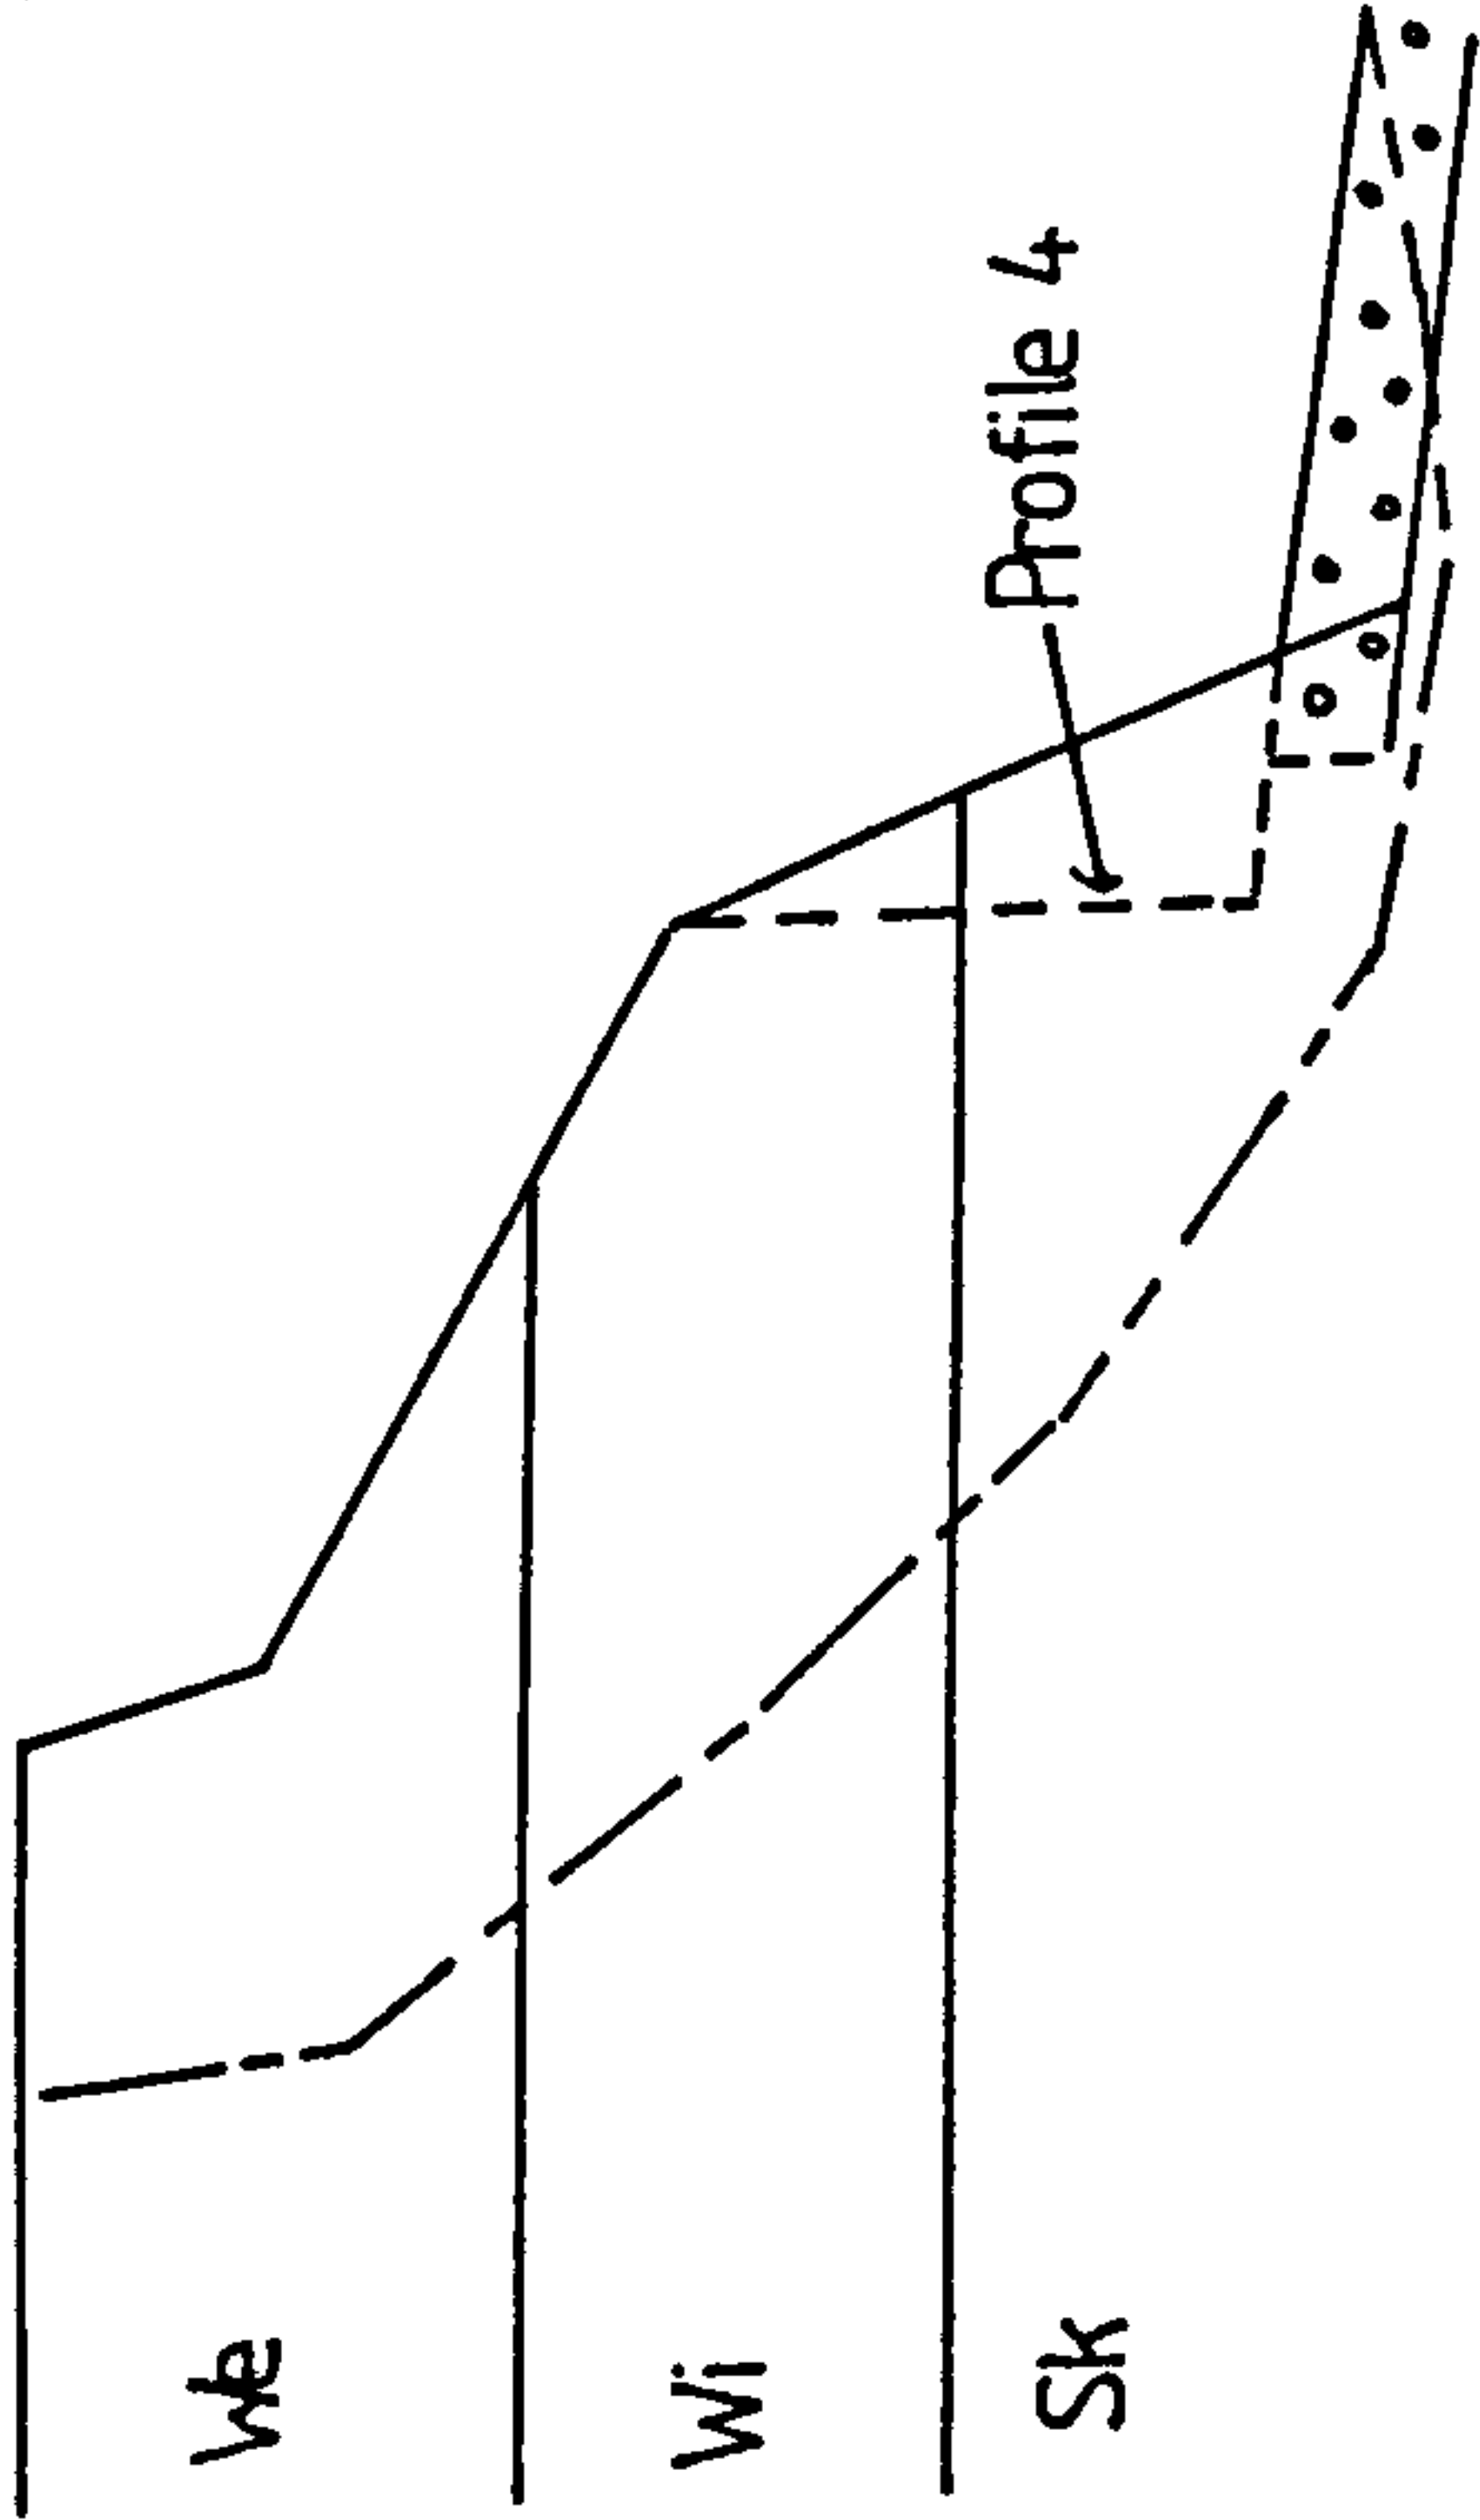
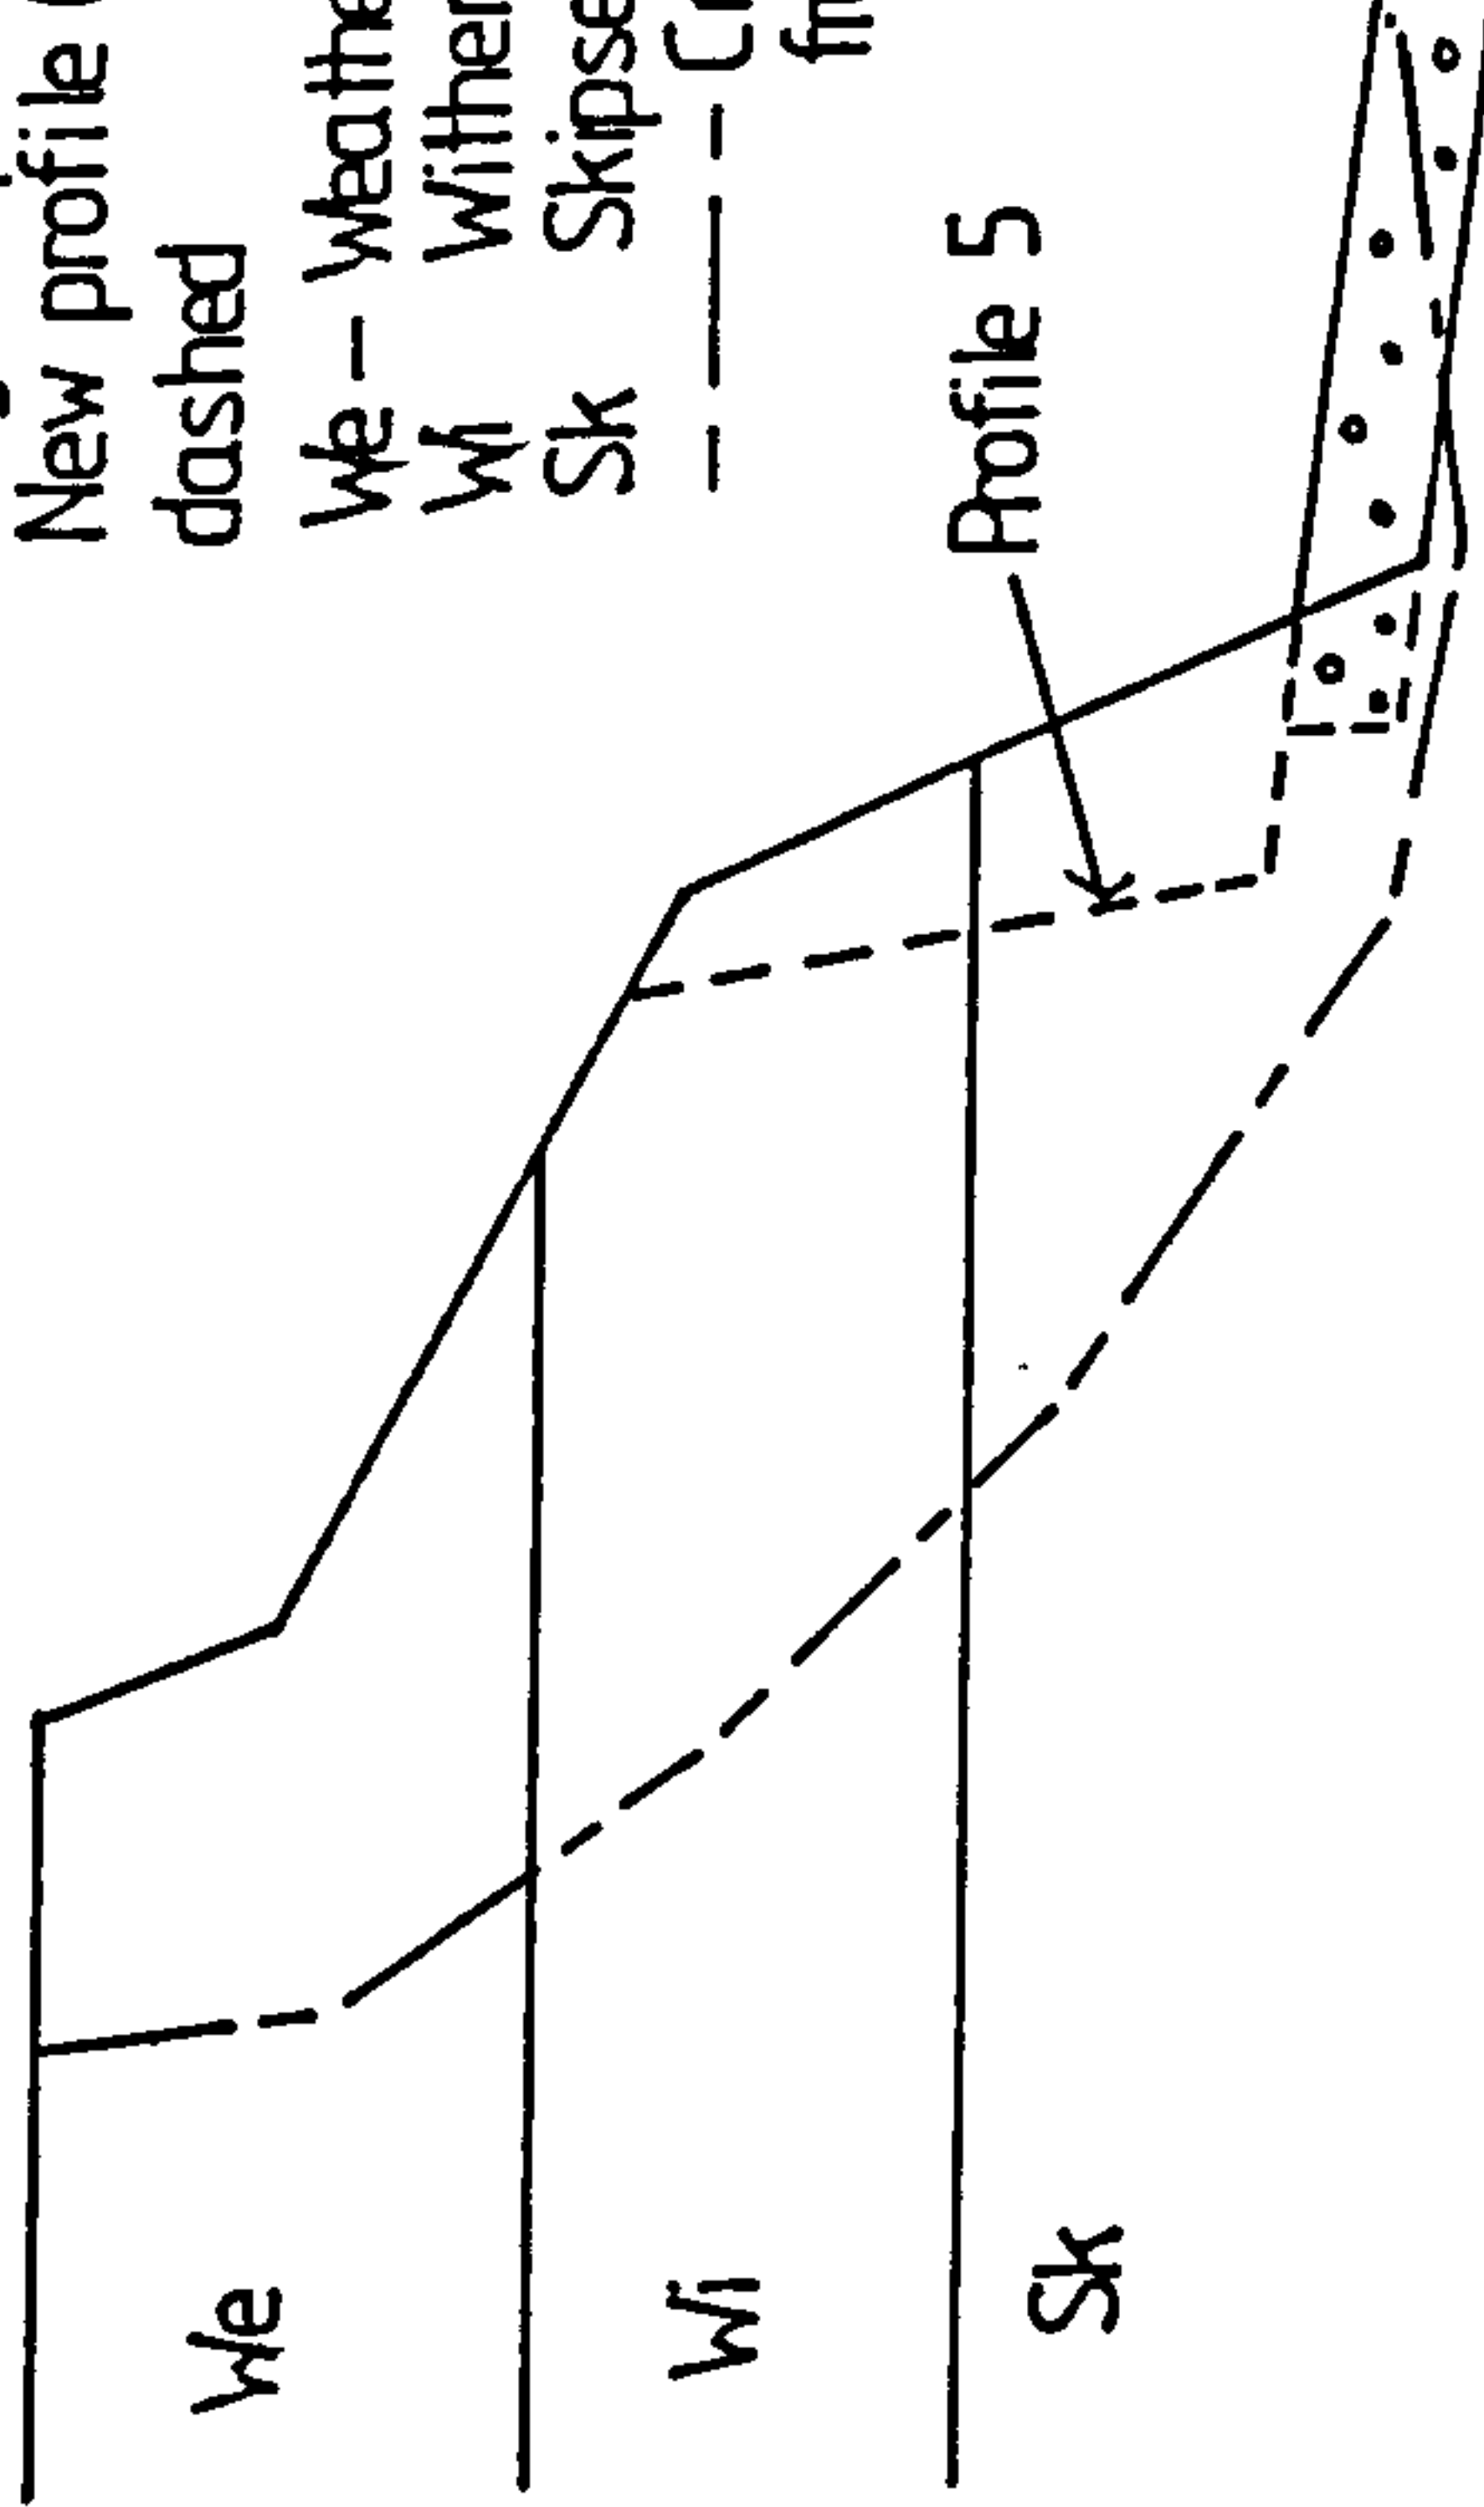
Figure 5.20 | Scale 1:400 | Changes in profile of slip 'F0' and corresponding factors of safety

The study shows that toe erosion can be an important factor in reducing stability of the cliff, with nearly as much influence as lowering of the beach. The two processes are linked, as

lowering of the beach will cause an increase in toe erosion through the greater amount of wave energy reaching the toe.

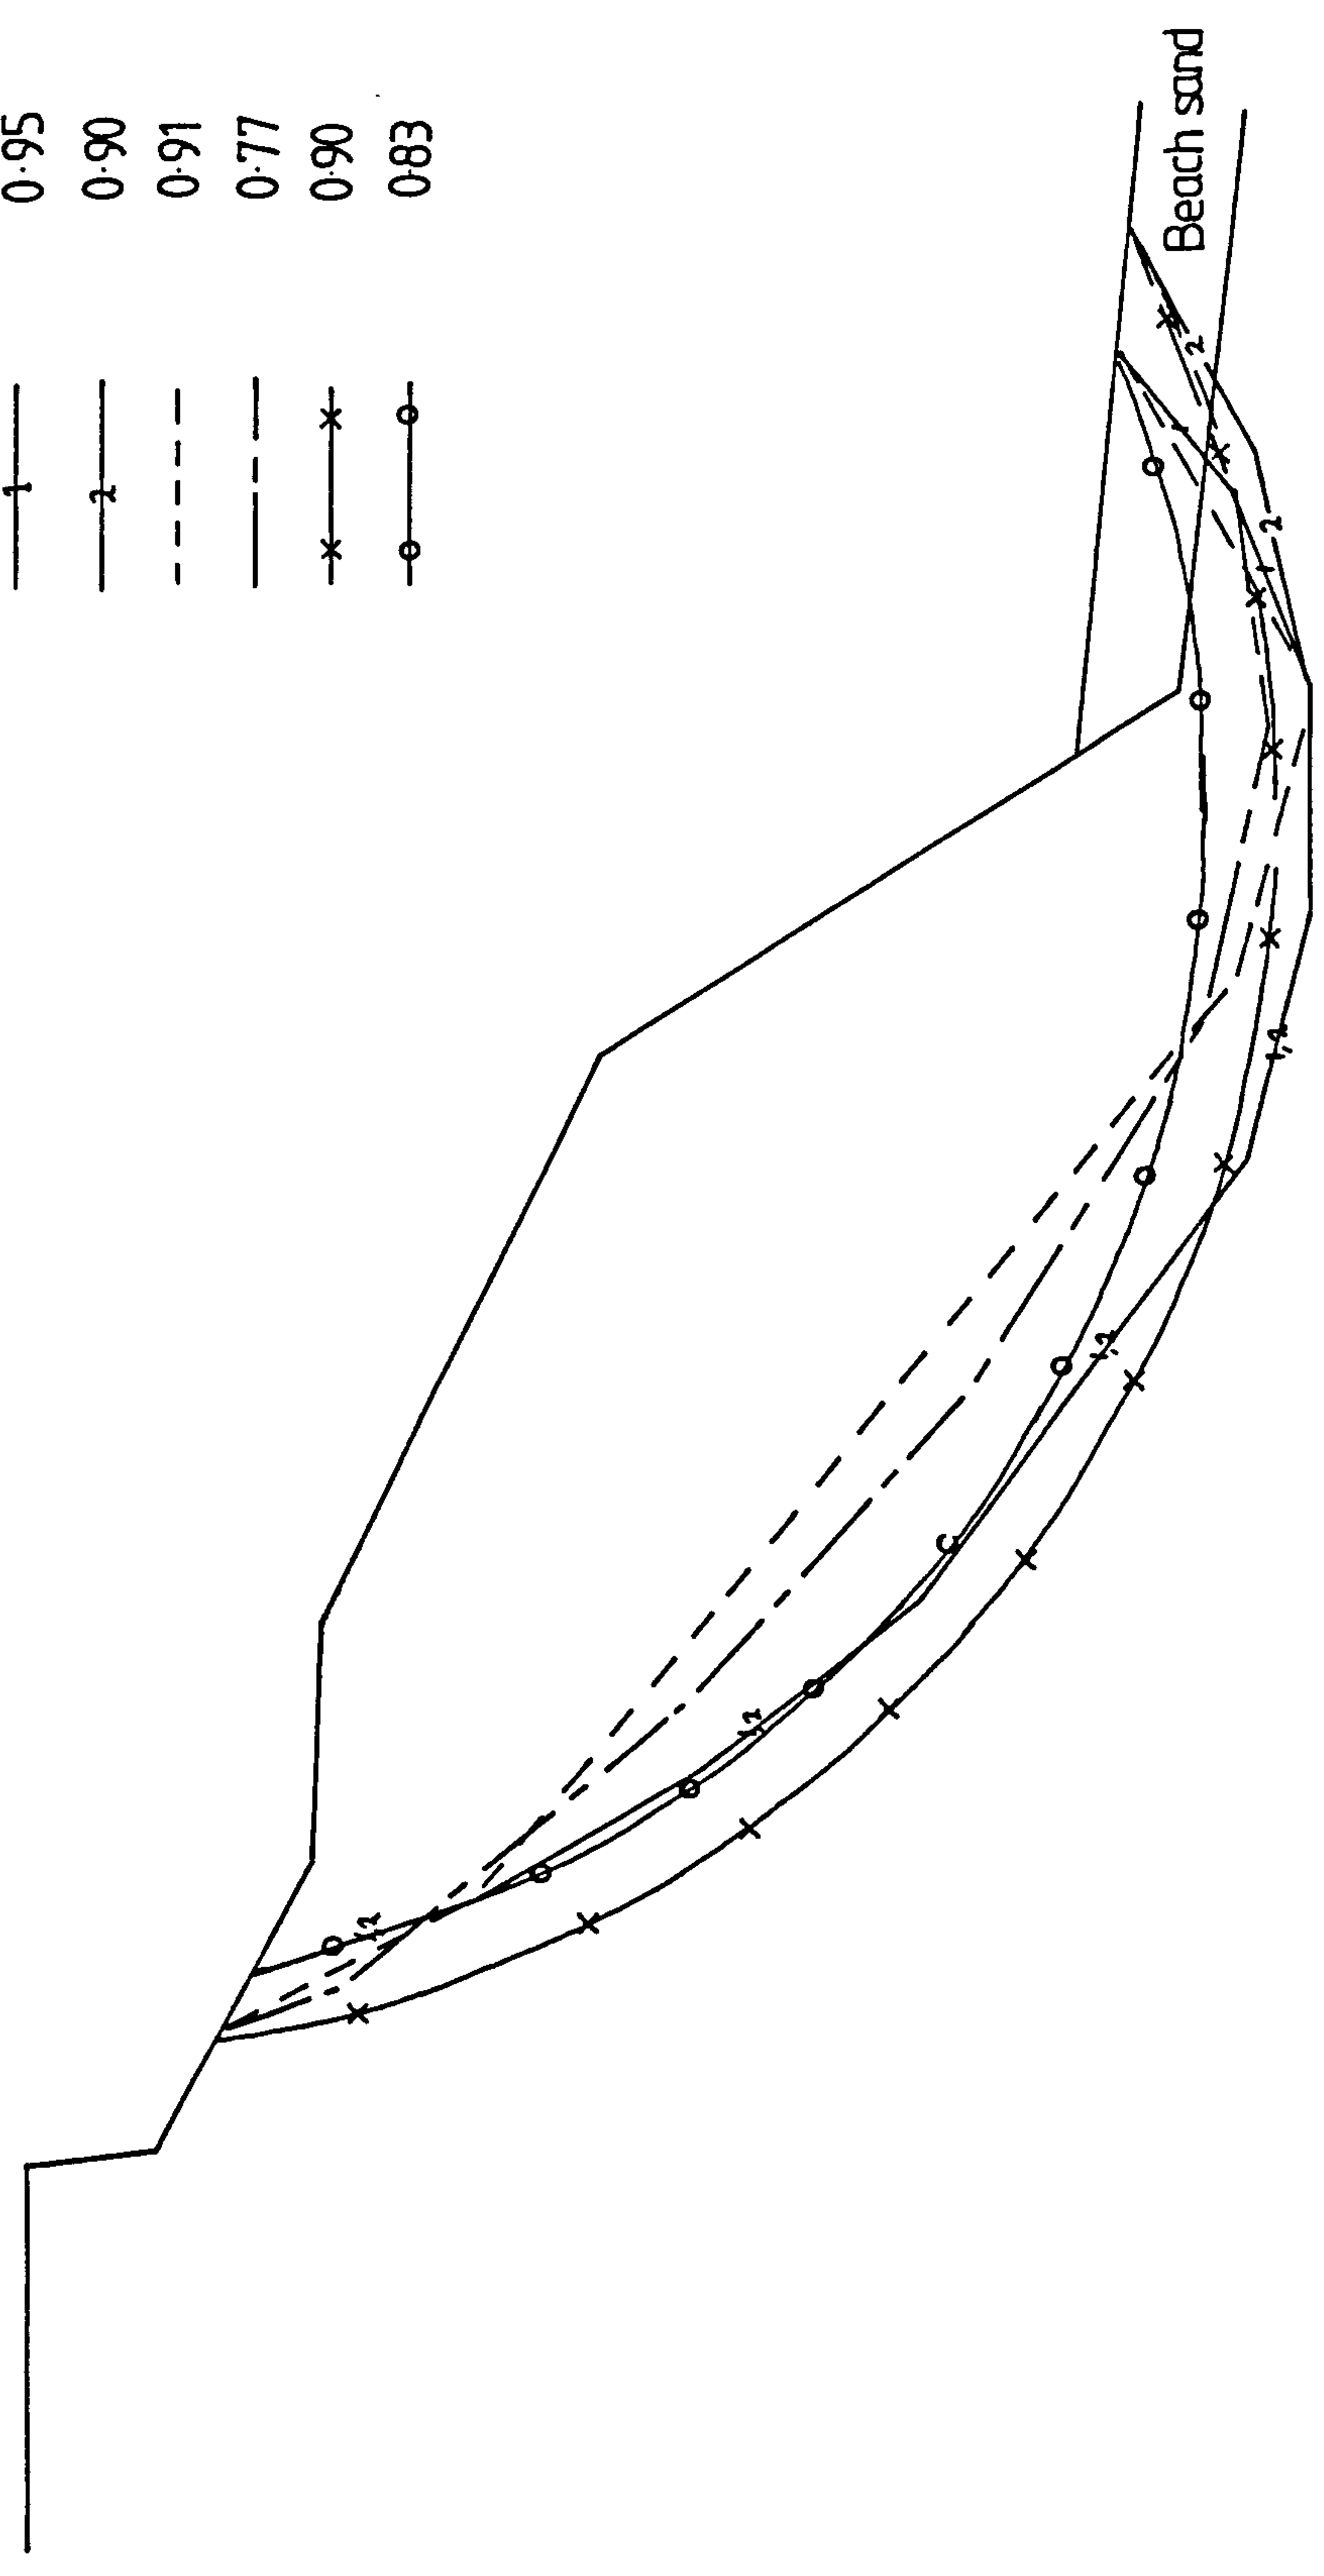
Figure 5.21 | Scale 1:200
 Profile 'FA' at Grimston with slip surfaces analysed and factors of safety obtained

The band of slip surfaces analysed for profile 'FA' and the associated factors of safety are shown in Figure 5.21. The most critical surface found had a factor of safety of 0.77. A parametric study was then carried out and the results given in Figure 5.22.

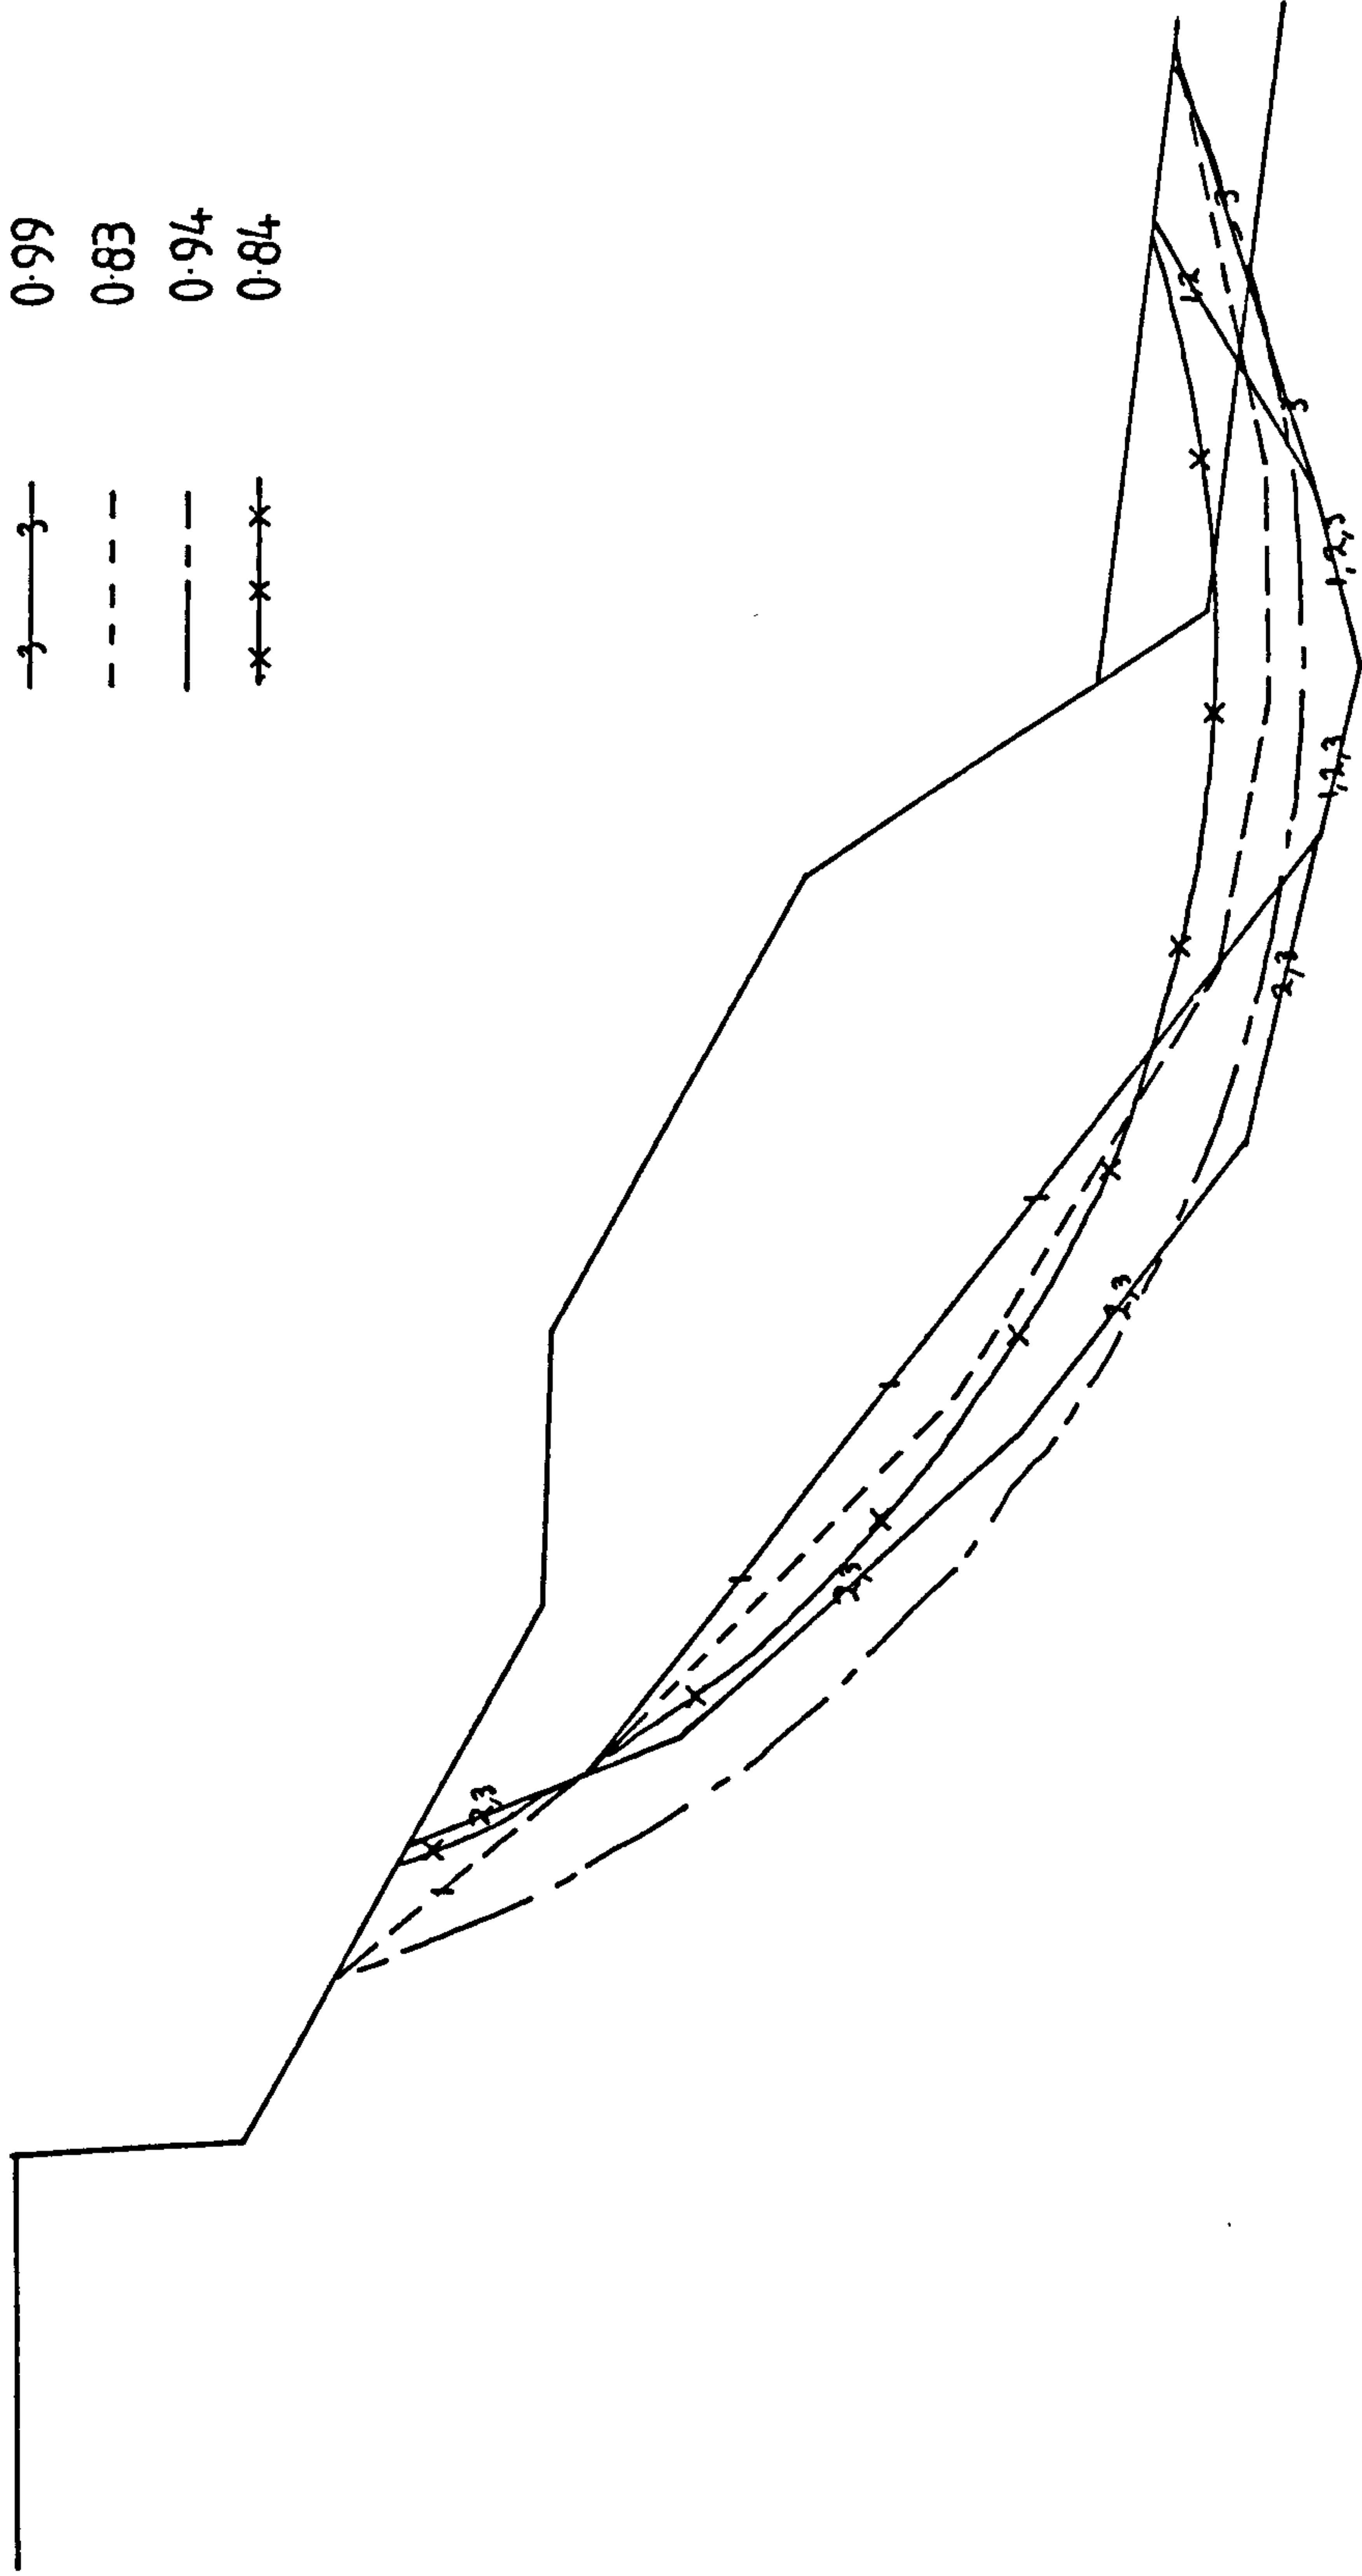
Figure 5.23 | Scale 1:200
Profile 'FJ' at Grimston with slip surfaces analysed and factors of safety obtained

The band of slip surfaces analysed is shown in Figure 5.23, together with the factors of safety obtained. With a full beach, an r_u of 0.2 and residual strength parameters, the lowest factor of safety obtained was 0.83.
