Erosion and Stability of Till Cliffs
on the Holderness Coast

This thesis is submitted in fulfilment of the requirements
for the Degree of Doctor of Philosophy
in Geotechnical Engineering

Iain Robertson

University of Newcastle upon Tyne
Geotechnical Engineering

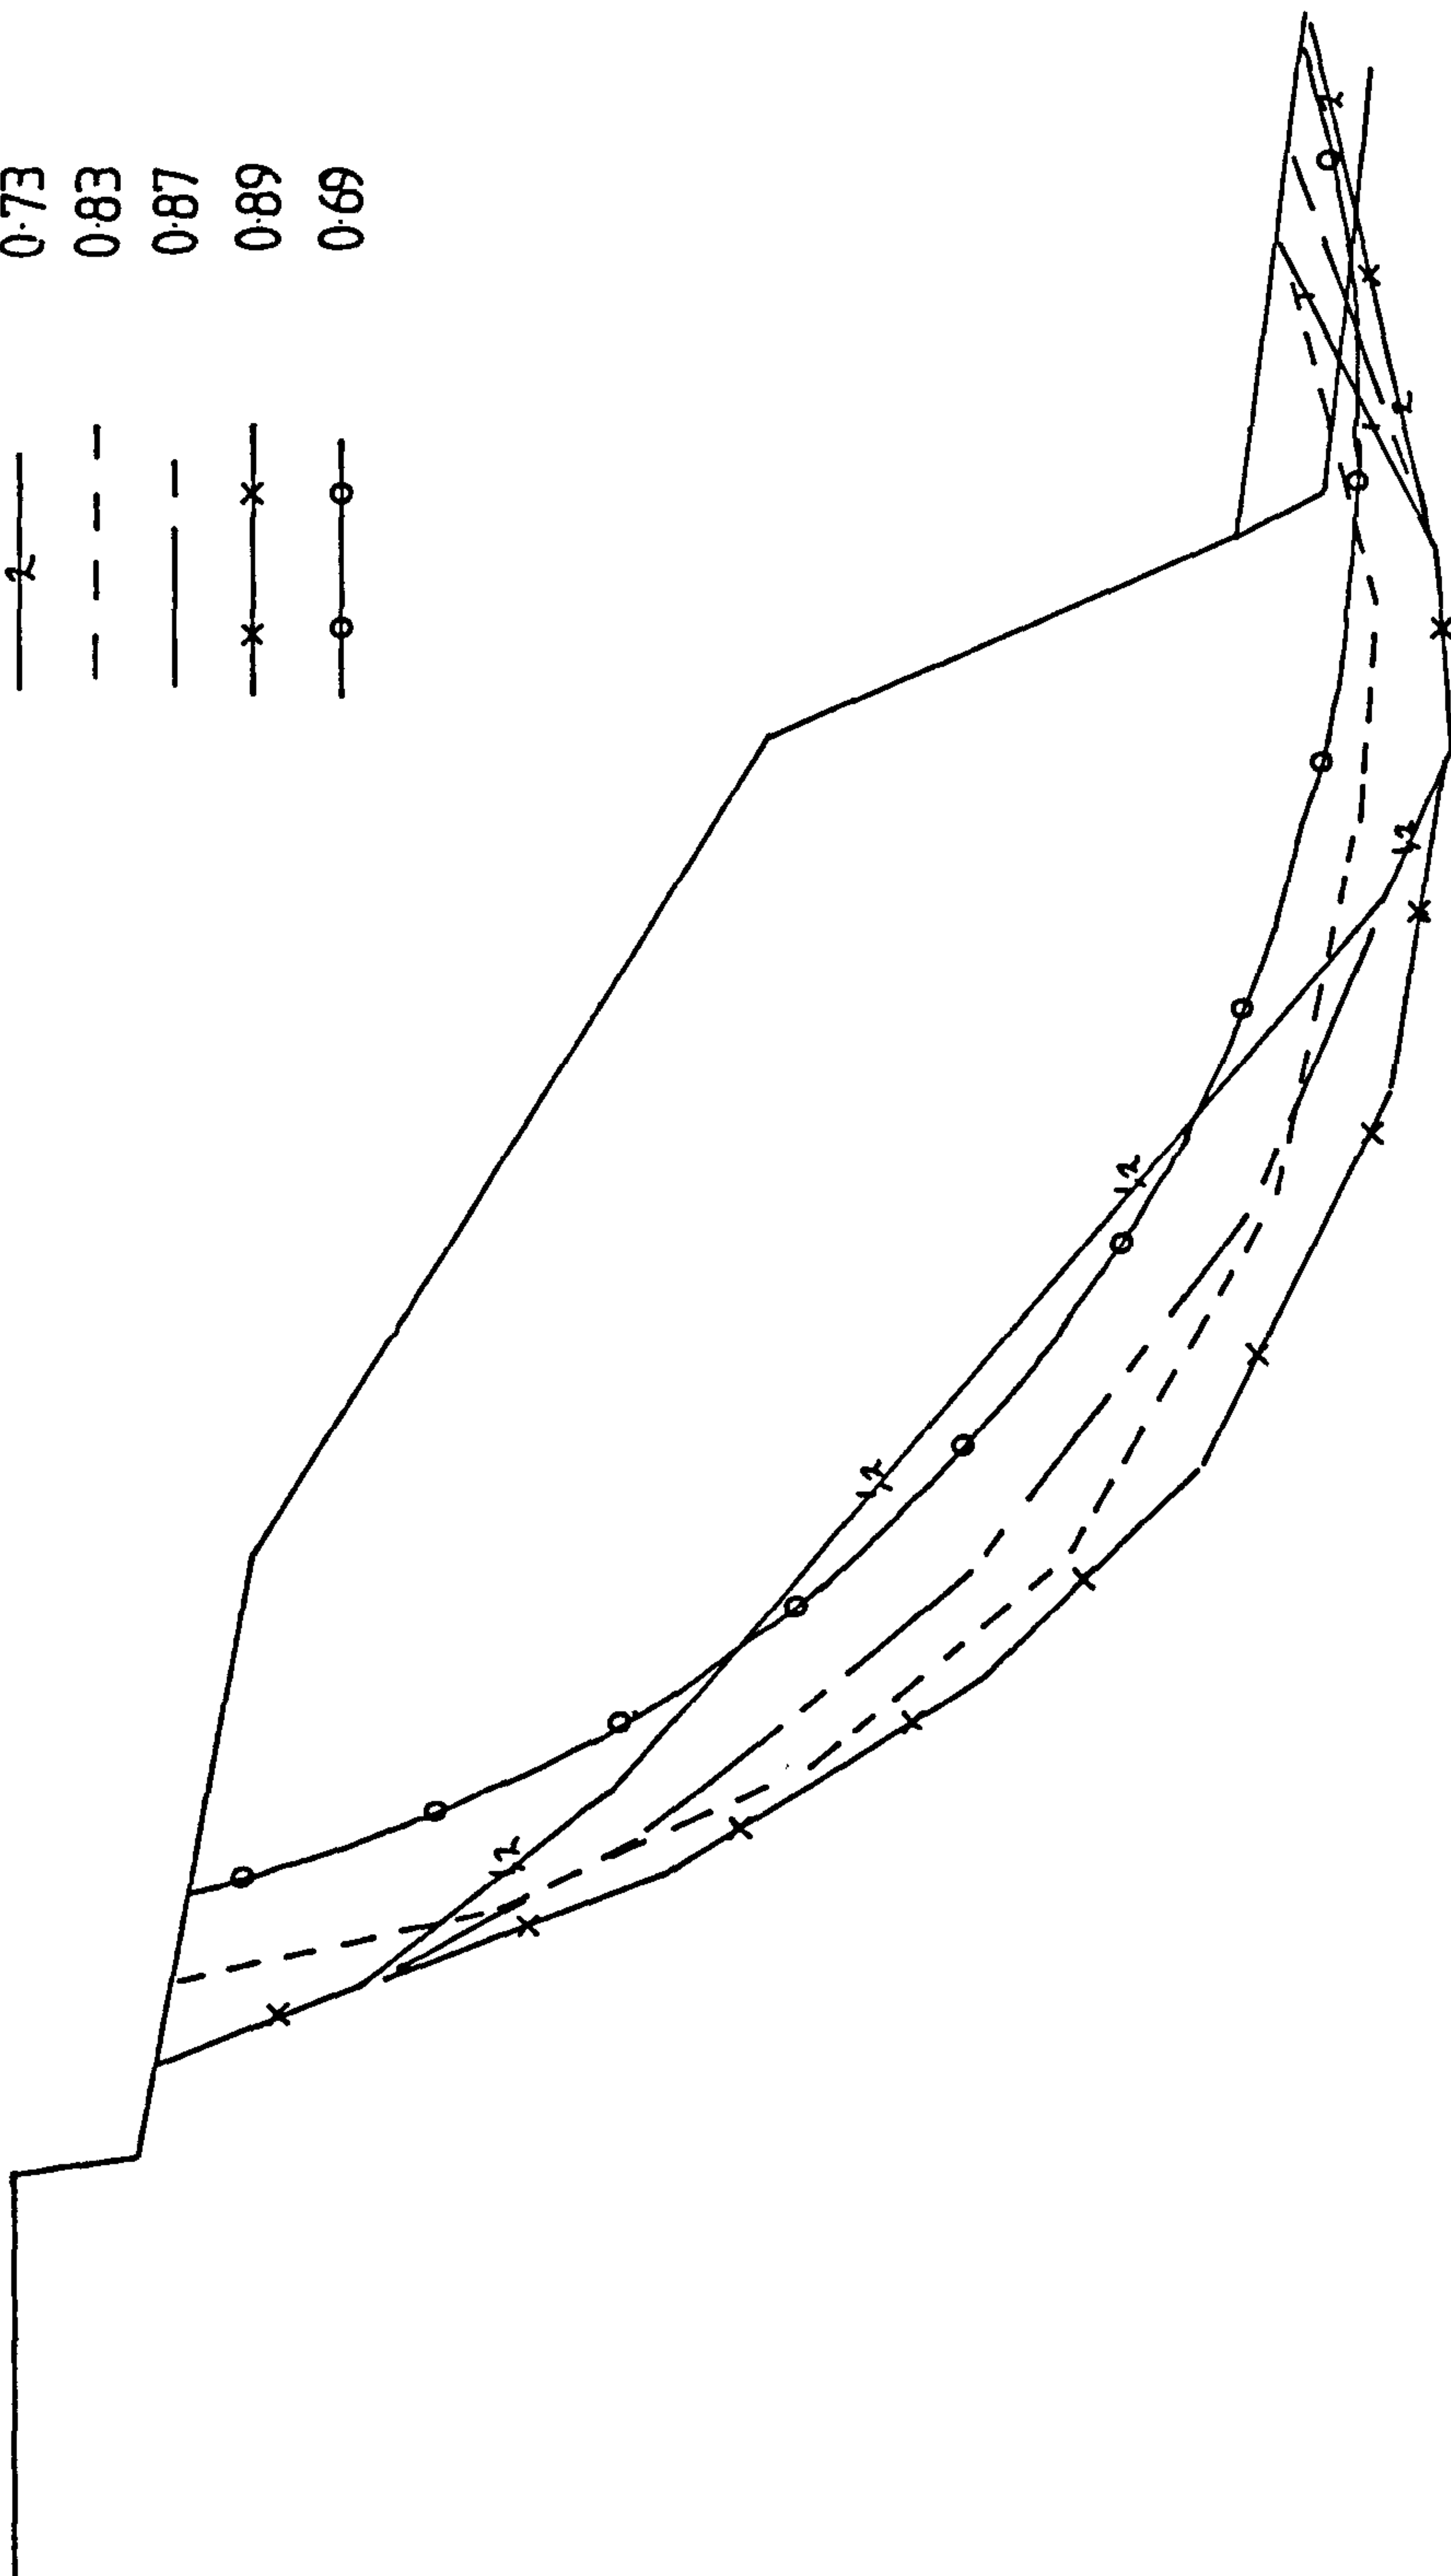
Figure 5.25 Scale 1:200

The profile of slip 'D' at April 1987 was analysed. A 'band' of slip surfaces was analysed initially with a full beach and r_u of 0.2 and residual shear strength parameters. These are shown in Figure 5.25, with the factors of safety obtained. The lowest factor of safety of 0.69 was for a circular slip surface.

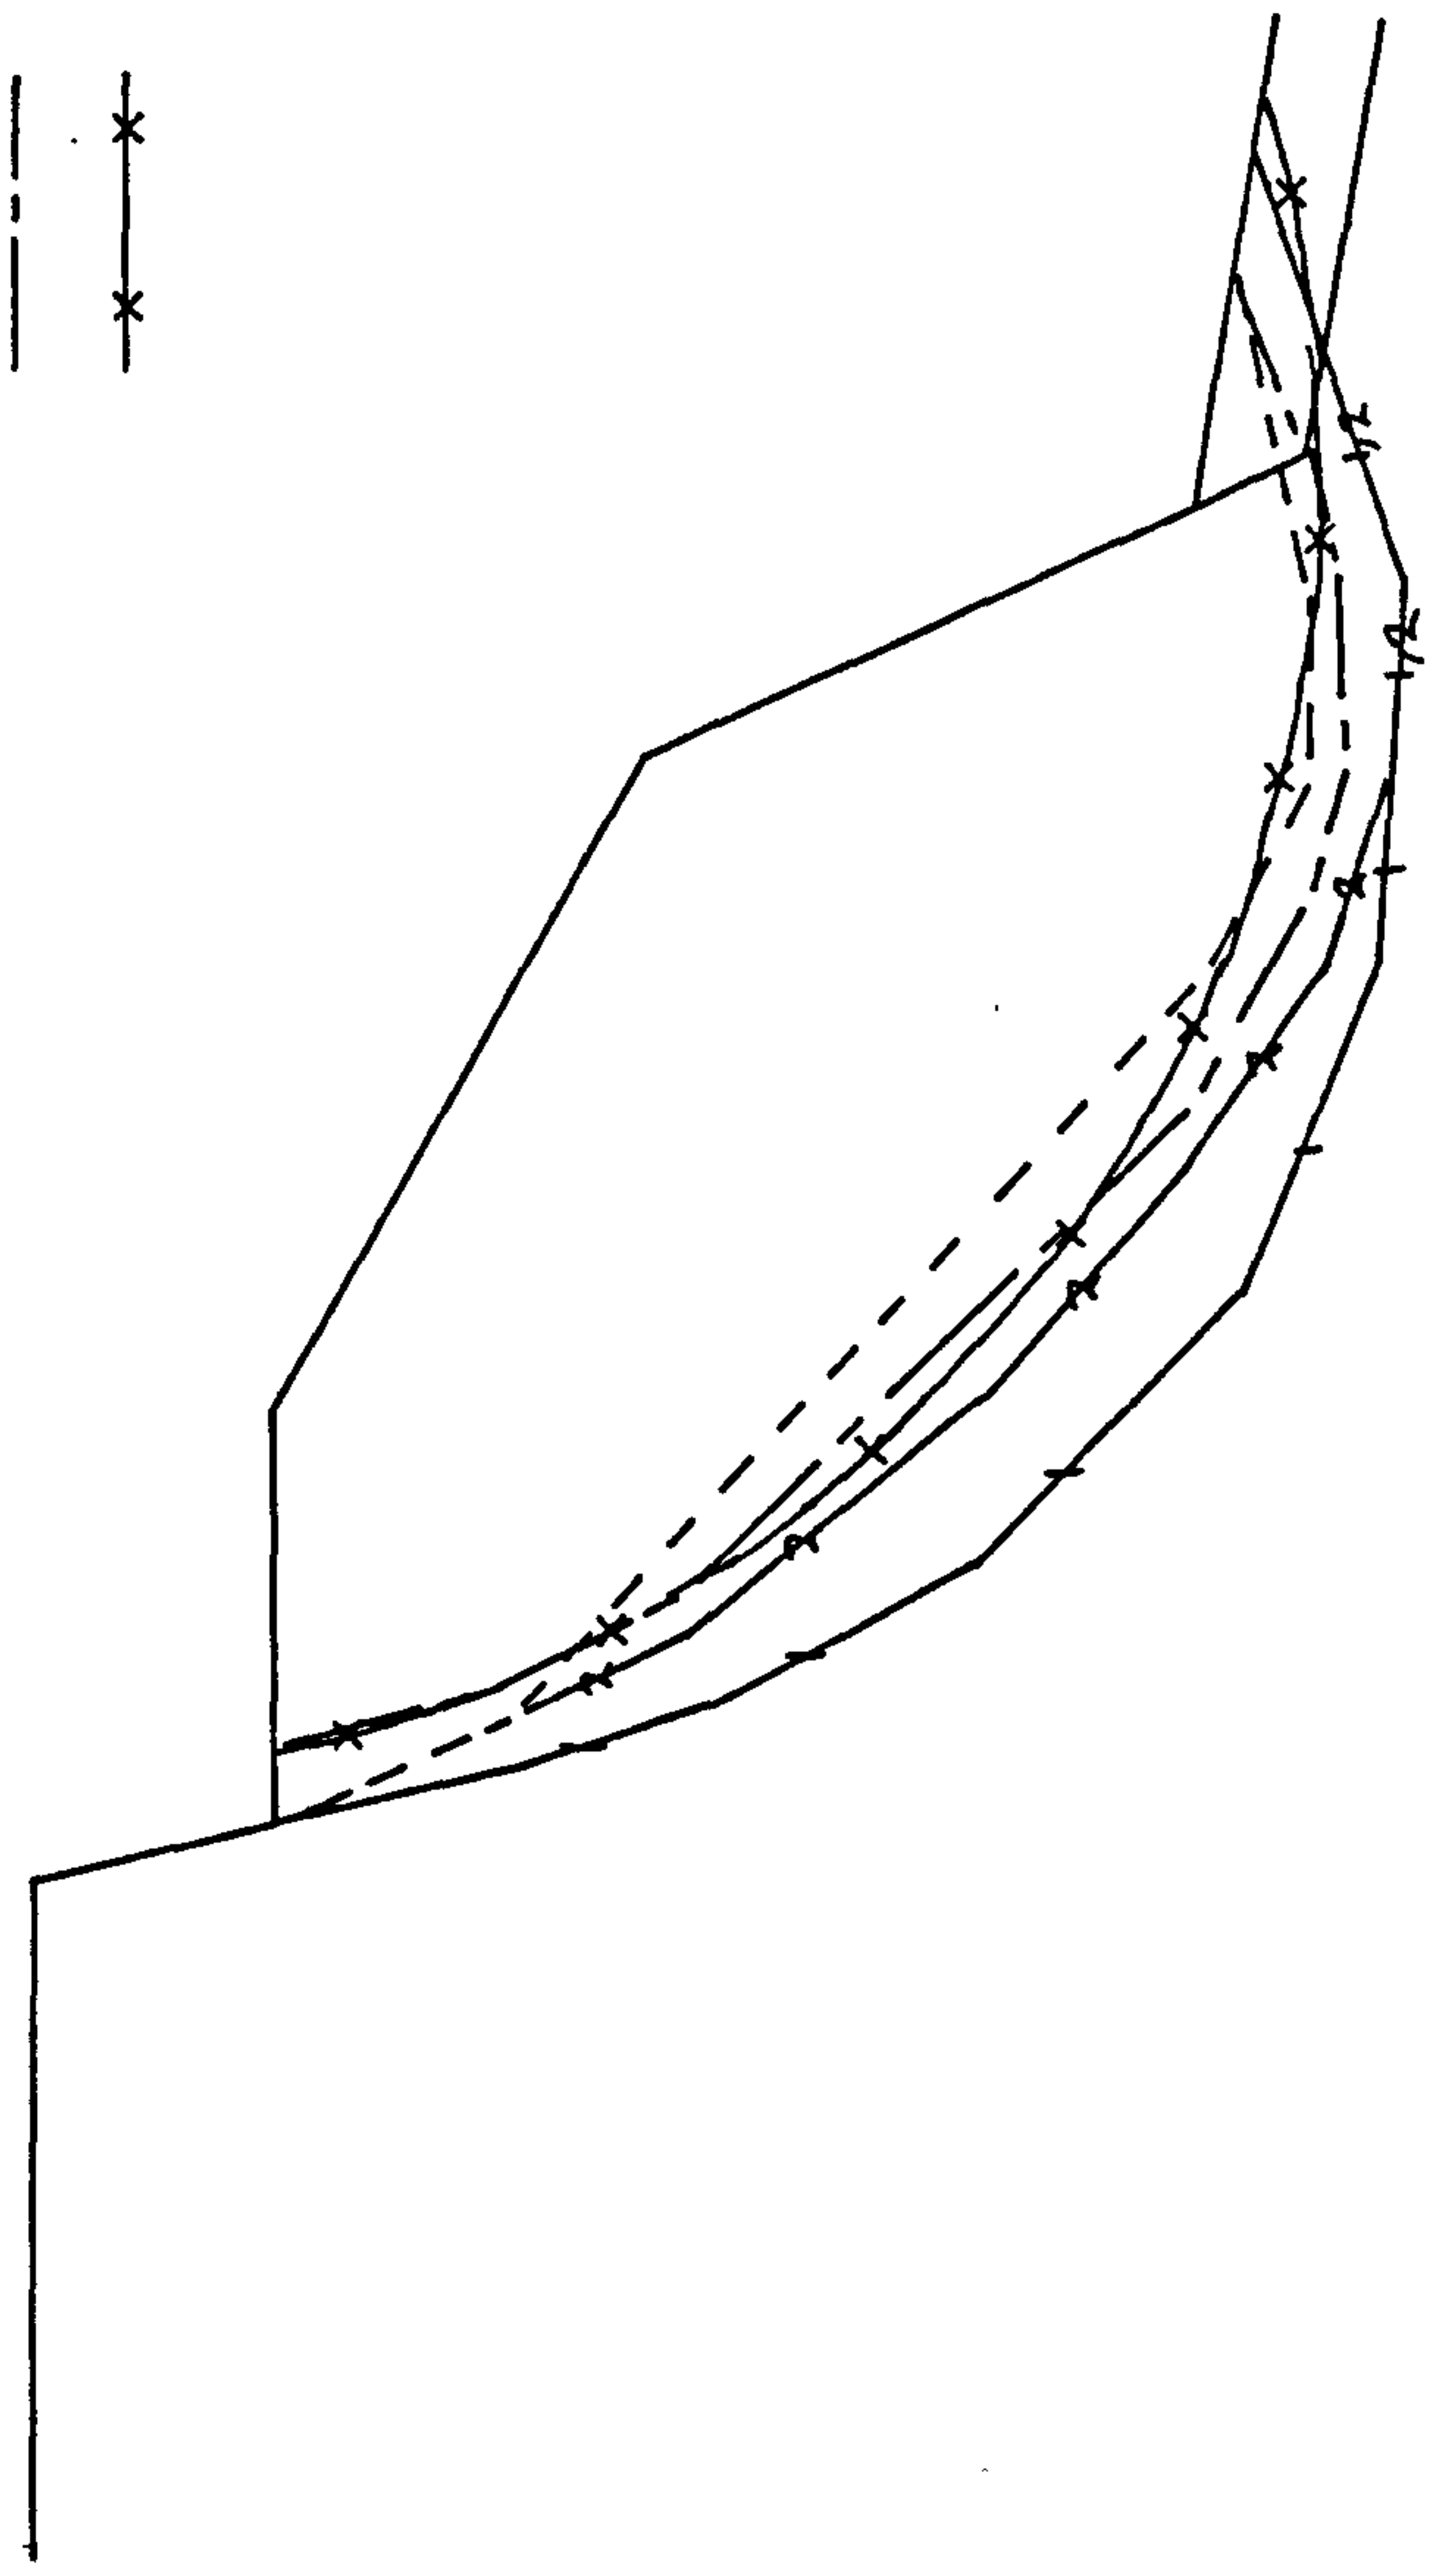
Figure 5.27	Scale 1:200
Profile B at Rolston with slip surfaces analysed and factors of safety obtained

The band of slip surfaces analysed is shown in Figure 5.27. The lowest factor of safety obtained with $r_u=0.12$ and residual shear strength parameters of $c'_r = 0\text{kN/m}^2$ and $\phi'_r = 25^\circ$ was 0.78 for a circular slip surface.

The results show that to obtain a factor of safety approaching unity, an r_u of zero or less is required, or the inclusion of a small cohesion.

If the beach is removed the factor of safety is reduced by an average of 8%, and the factor of safety is well below 1, unless both an r_u of zero and a small cohesion are taken.

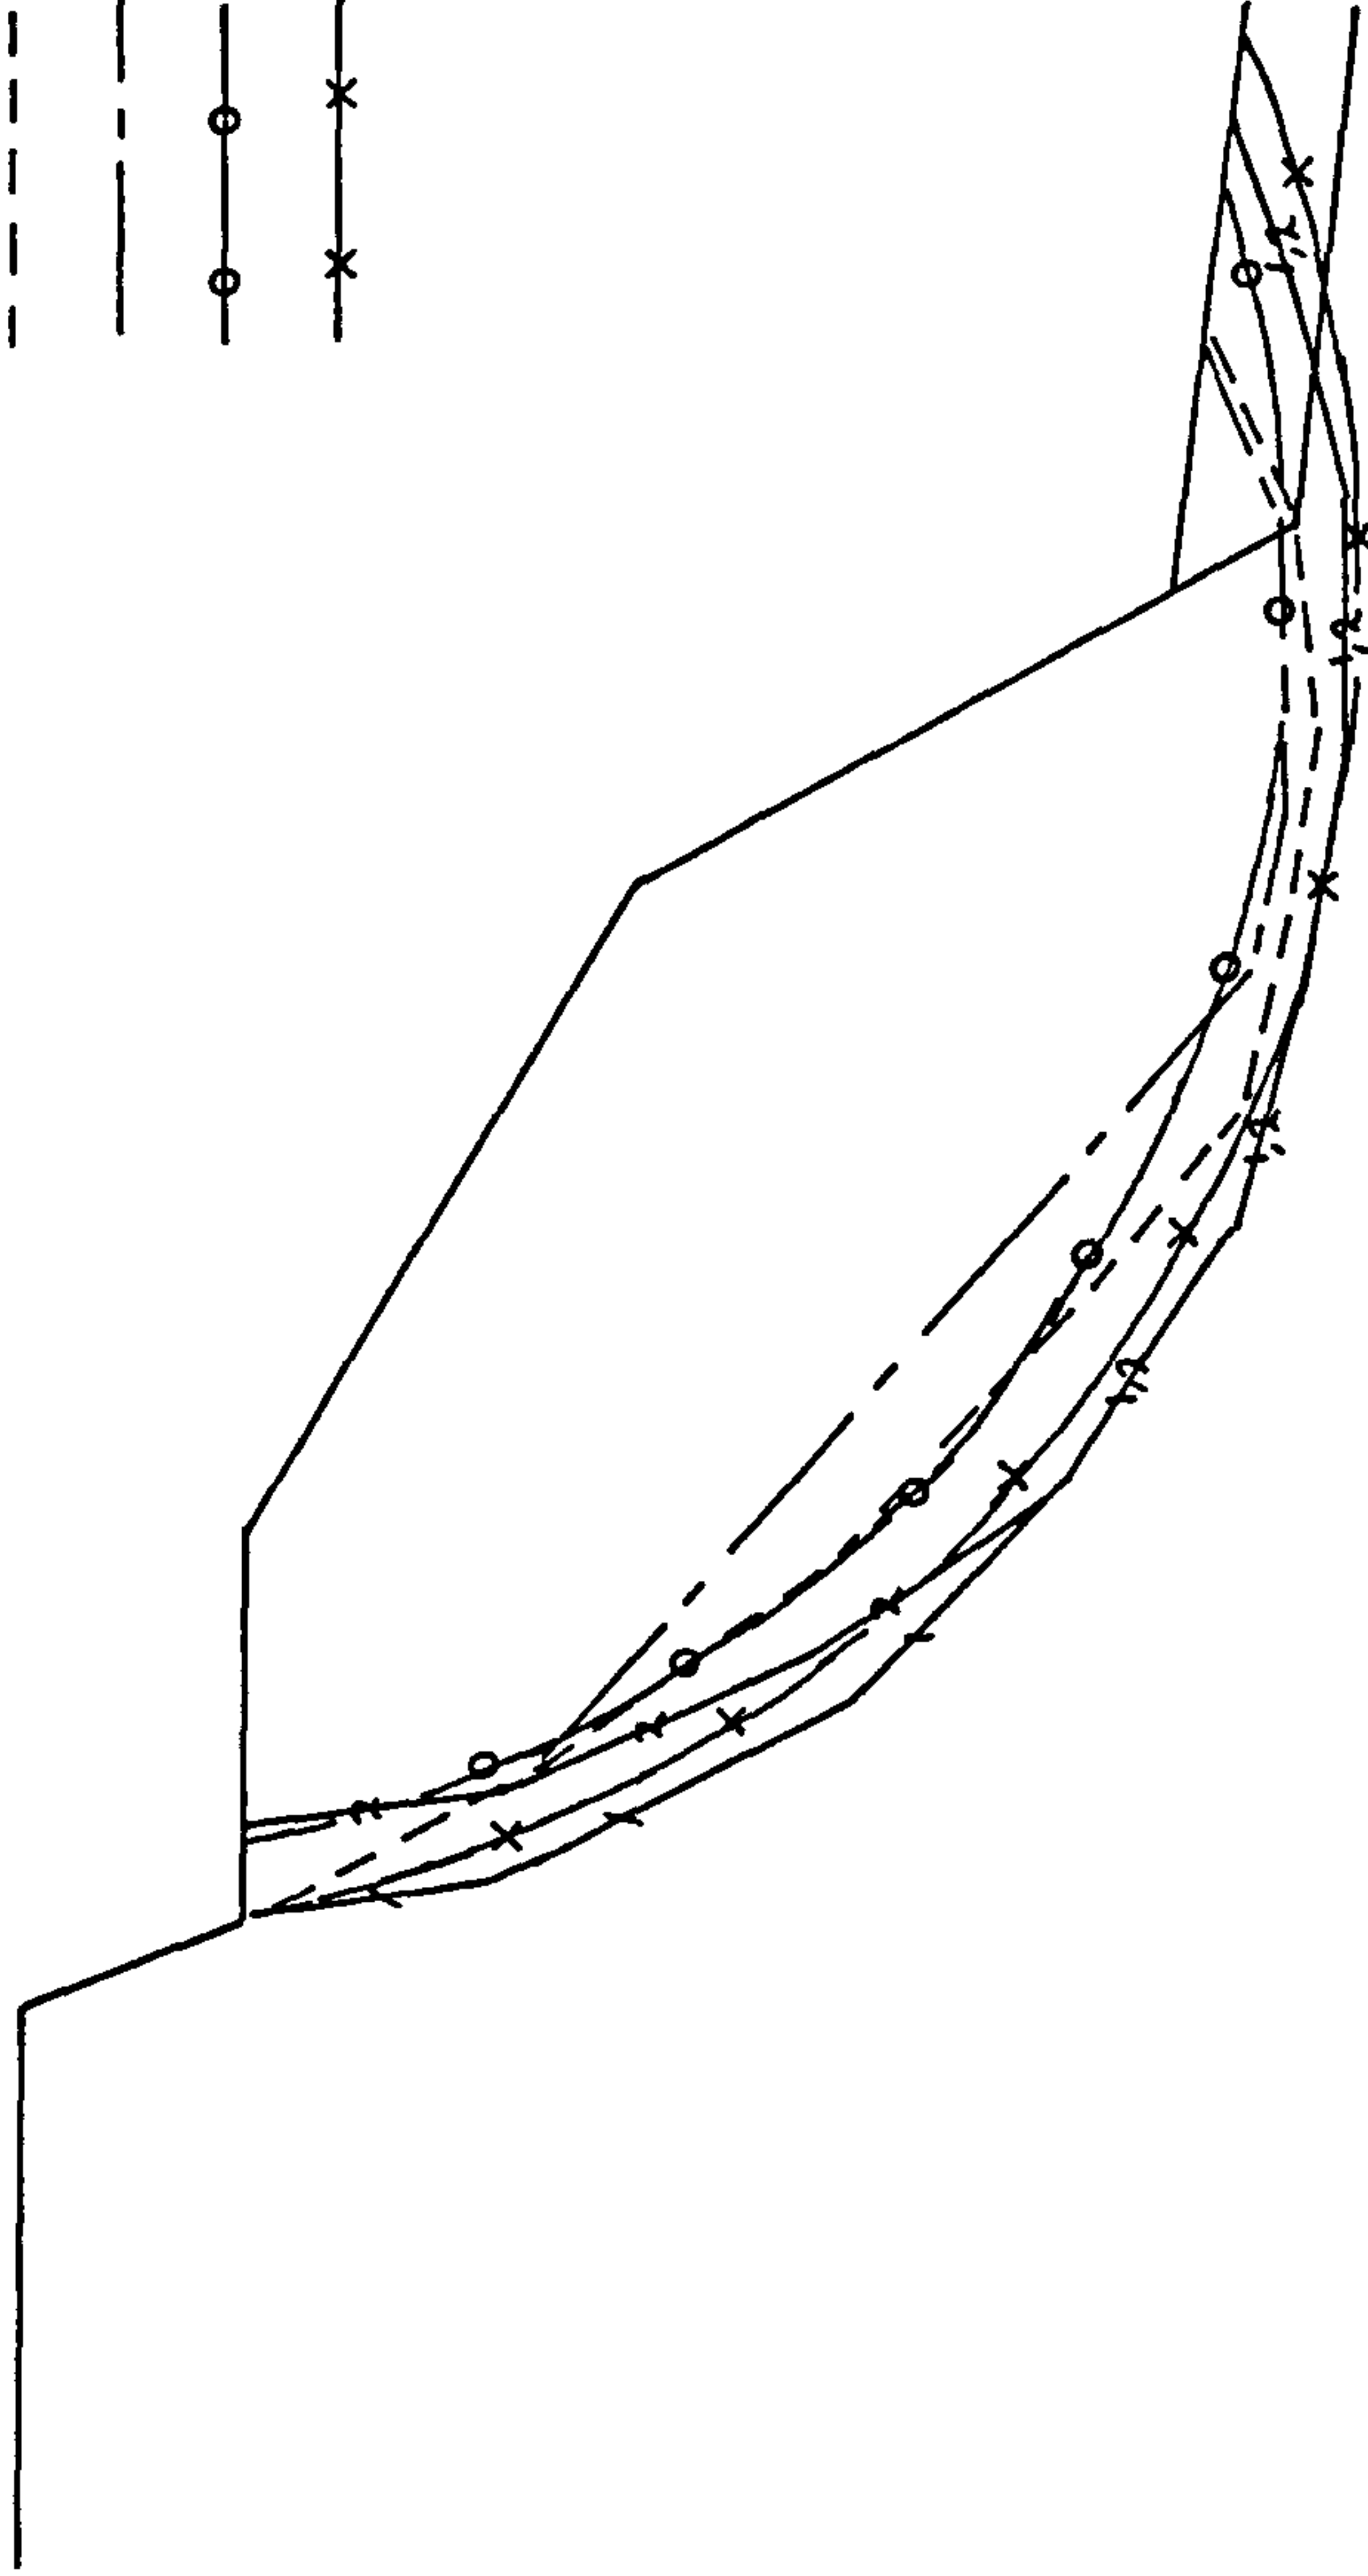
Figure 5.29	Scale 1:200
Profile 'R' at Rolston with slip surfaces analysed and factors of safety obtained

The band of slip surfaces analysed and the factors of safety obtained are shown in Figure 5.29. The most critical slip surface was circular with a factor of safety of 0.75 with an r_u of 0.2 and 0.83 with an r_u of 0.12. A parametric study was carried out and the results are given in Figure 5.30.

The factors of safety obtained are similar to those for slip 'B', although slightly higher. An r_u of zero or the inclusion of a small cohesion is necessary to achieve a factor of safety

approaching 1. Removal of the beach results in a reduction in factor of safety of about 10%.
