Erosion and Stability of Till Cliffs
on the Holderness Coast

This thesis is submitted in fulfilment of the requirements
for the Degree of Doctor of Philosophy
in Geotechnical Engineering

Iain Robertson

University of Newcastle upon Tyne
Geotechnical Engineering

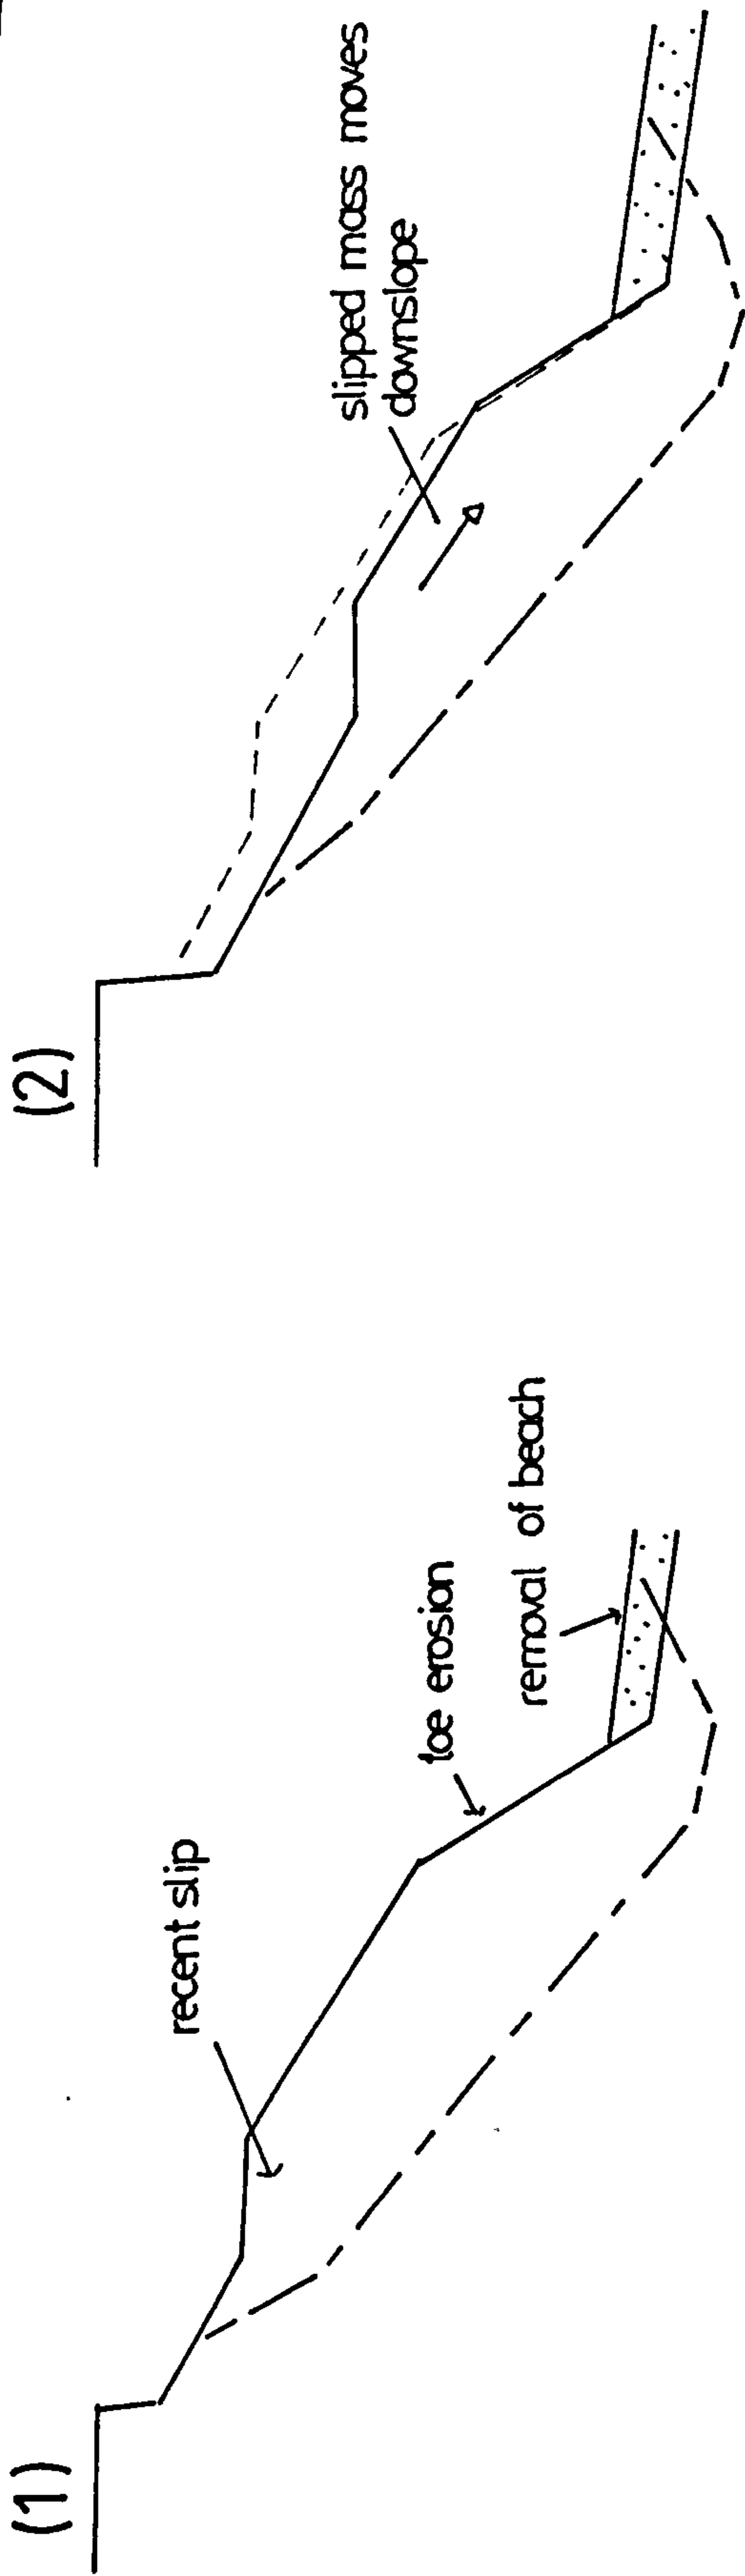
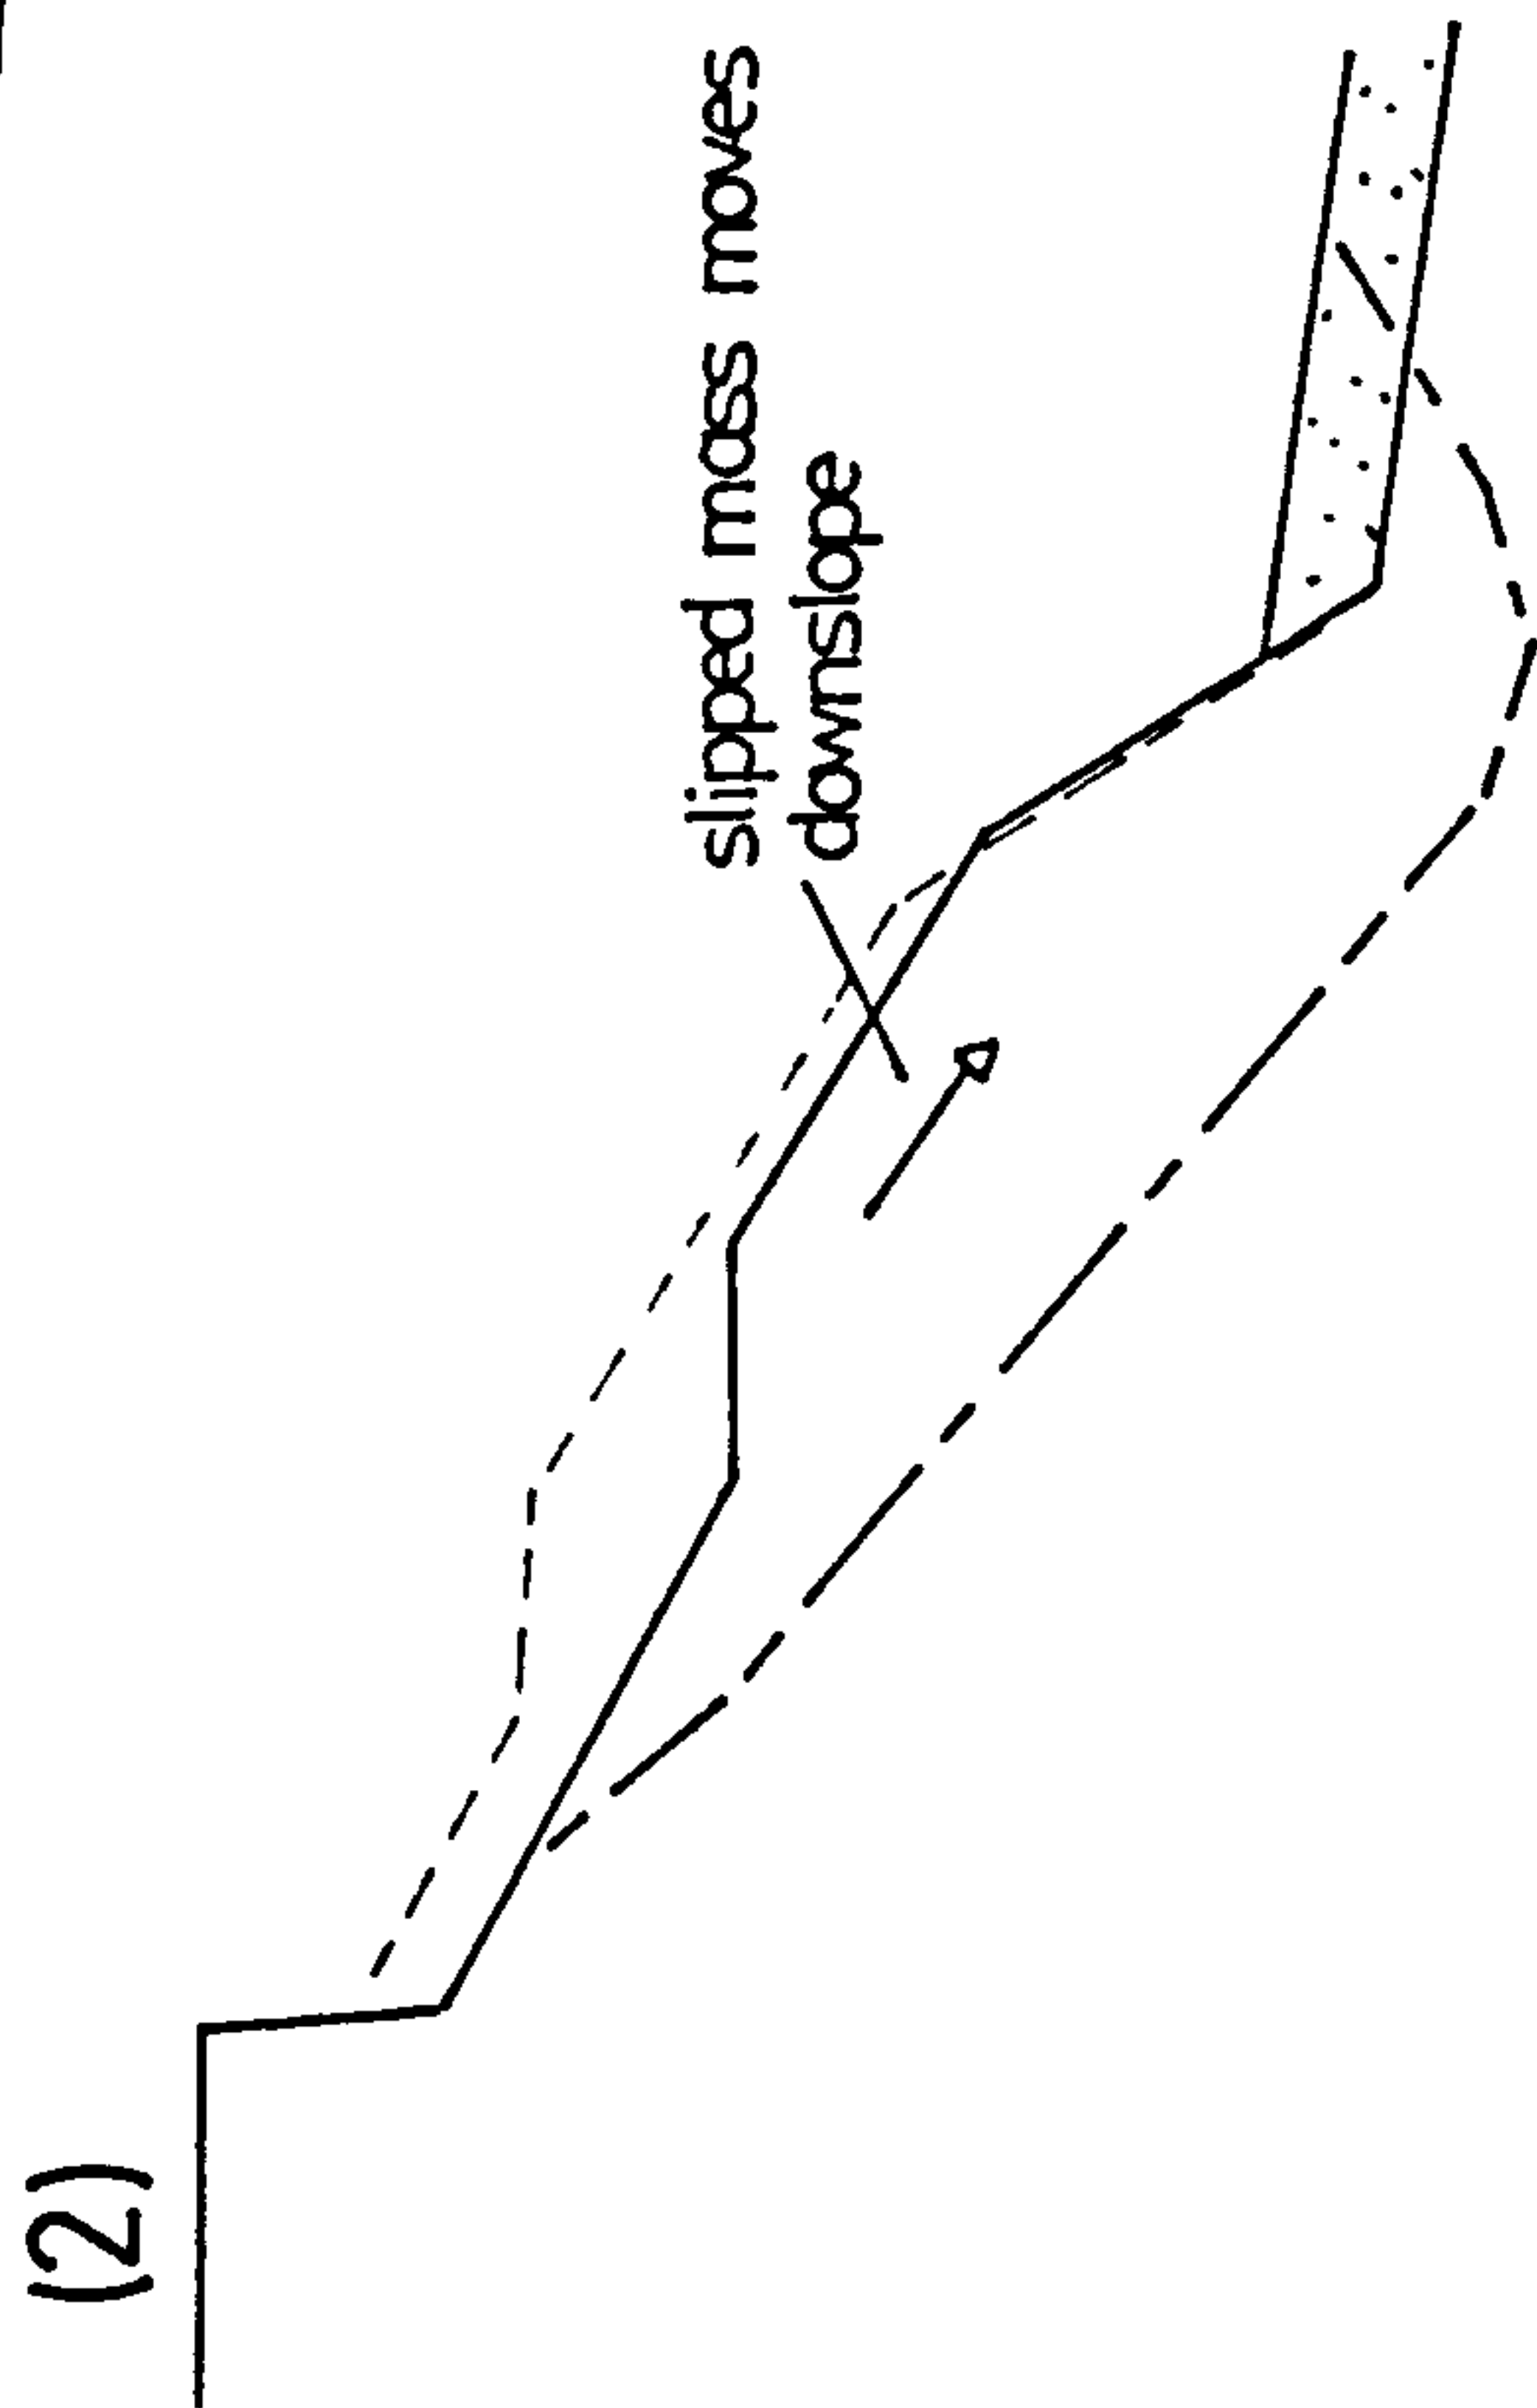
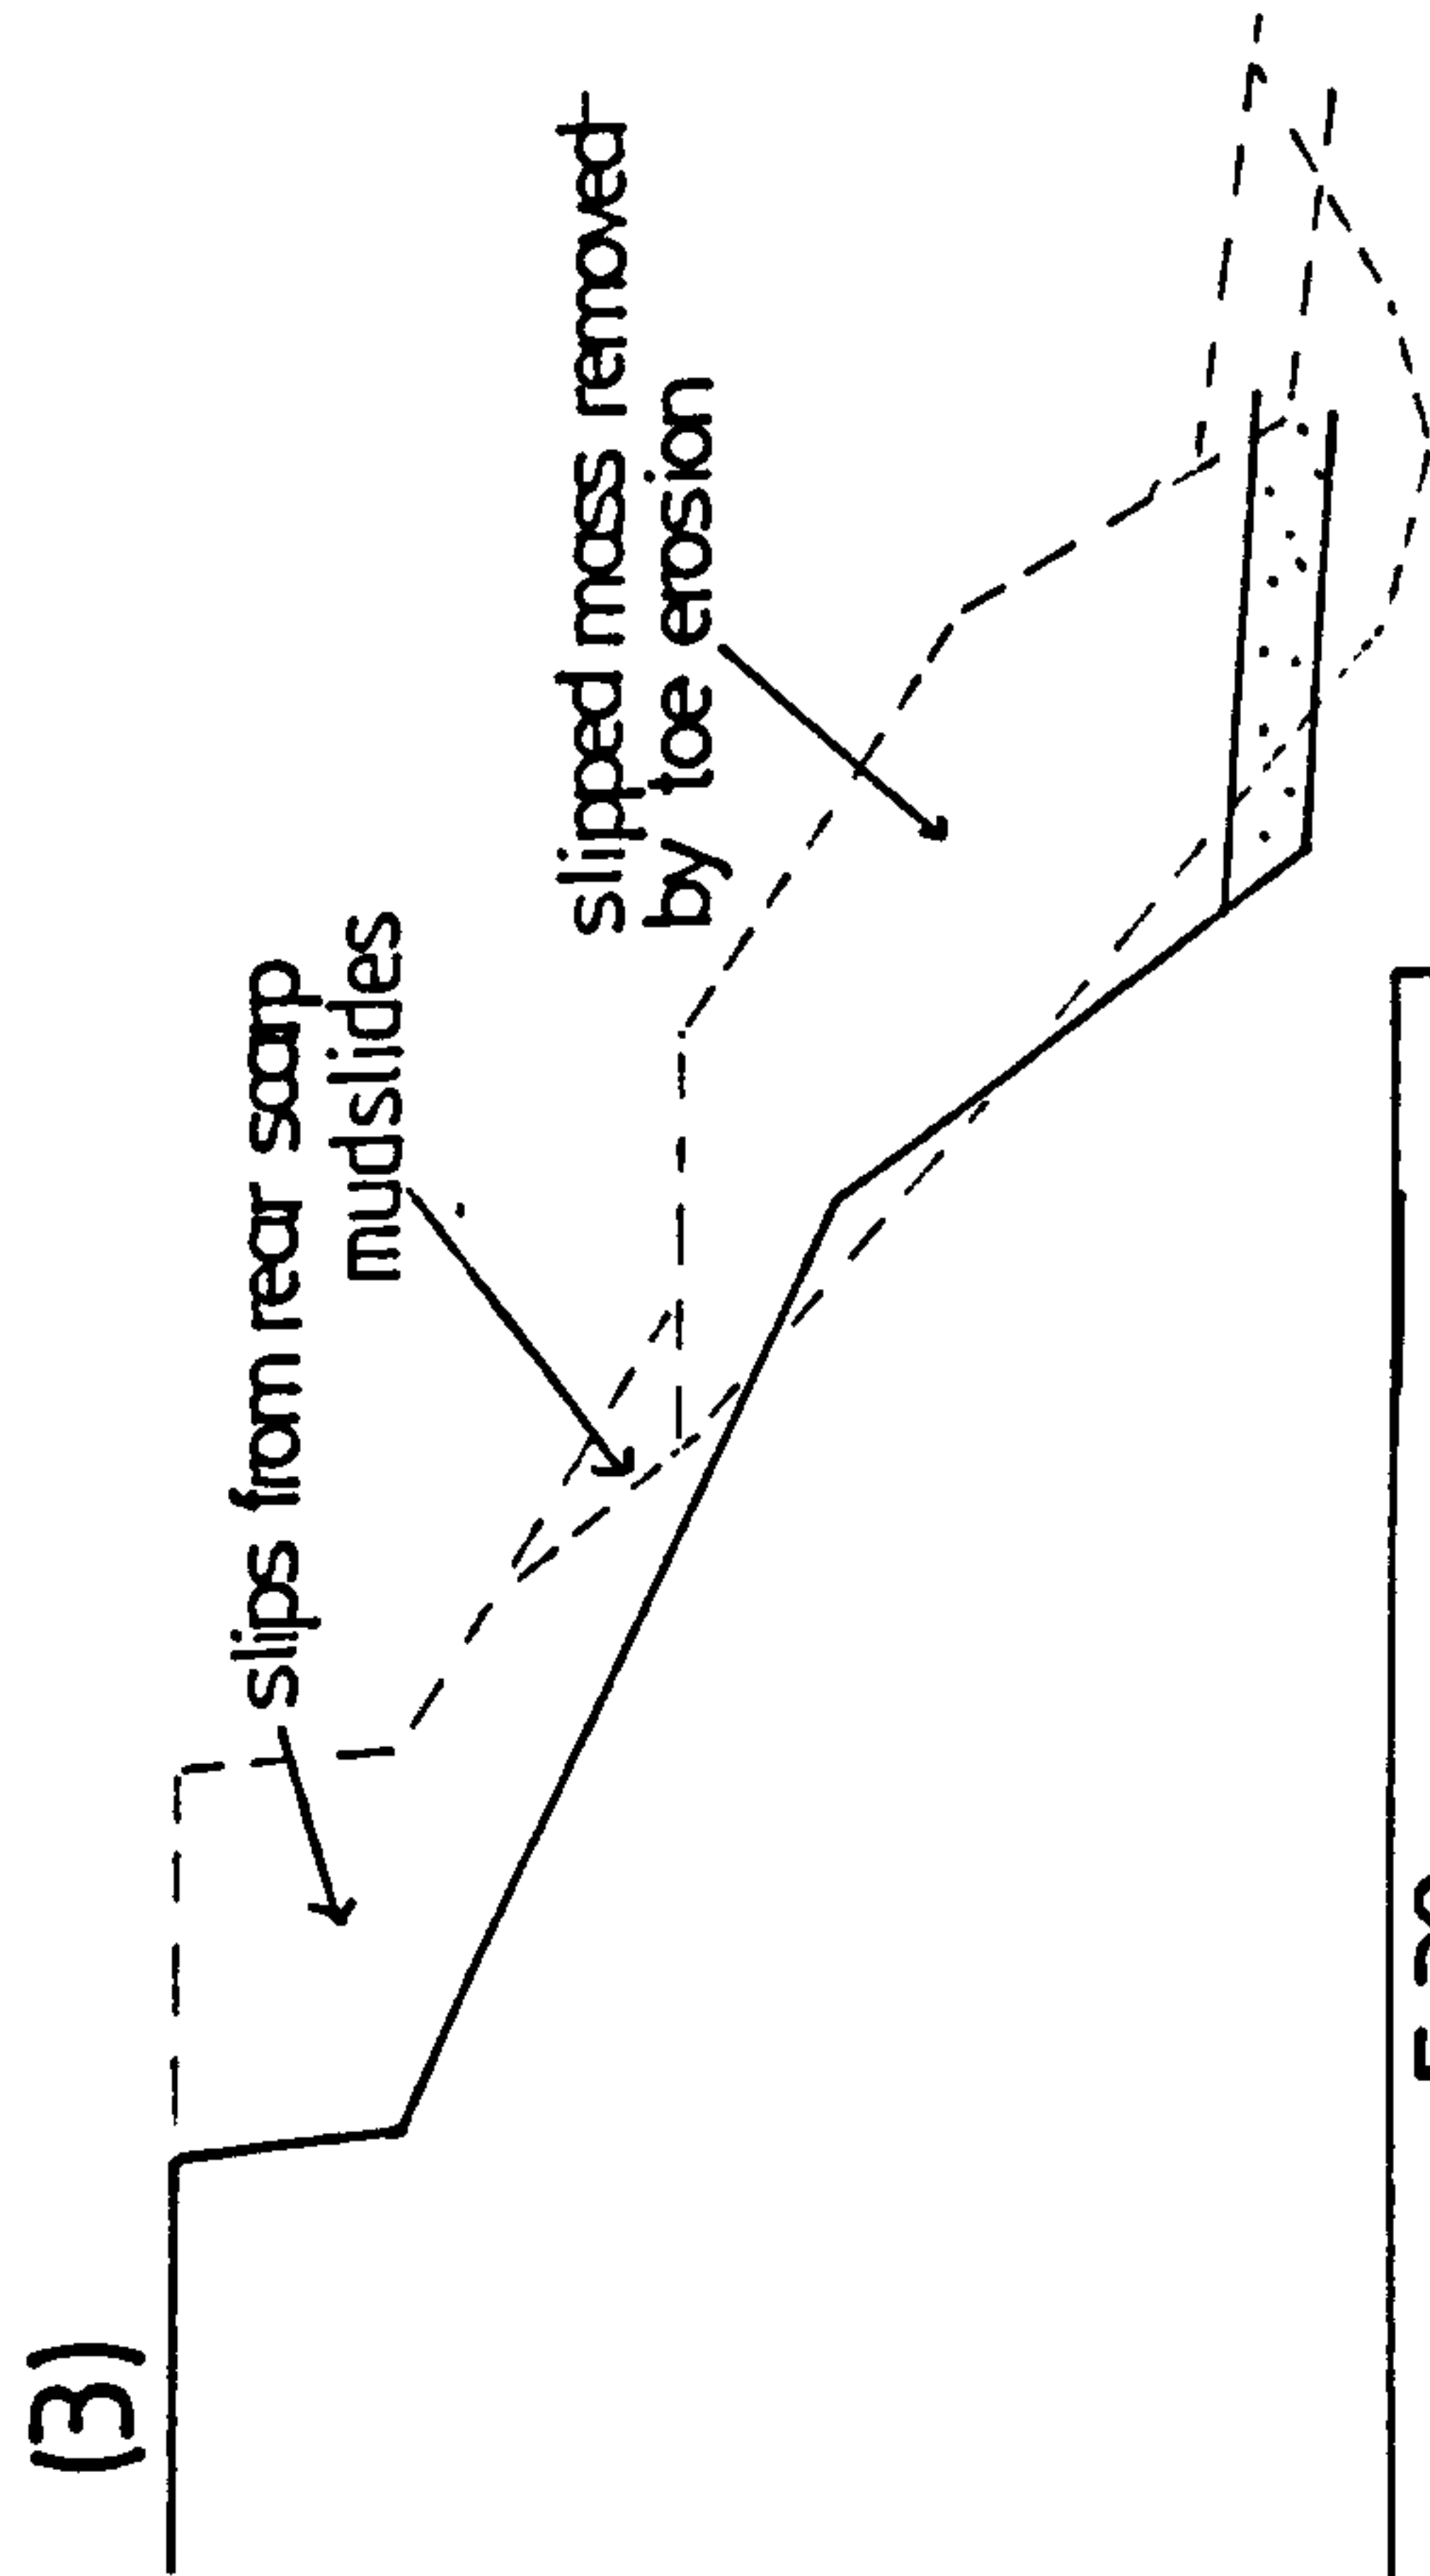
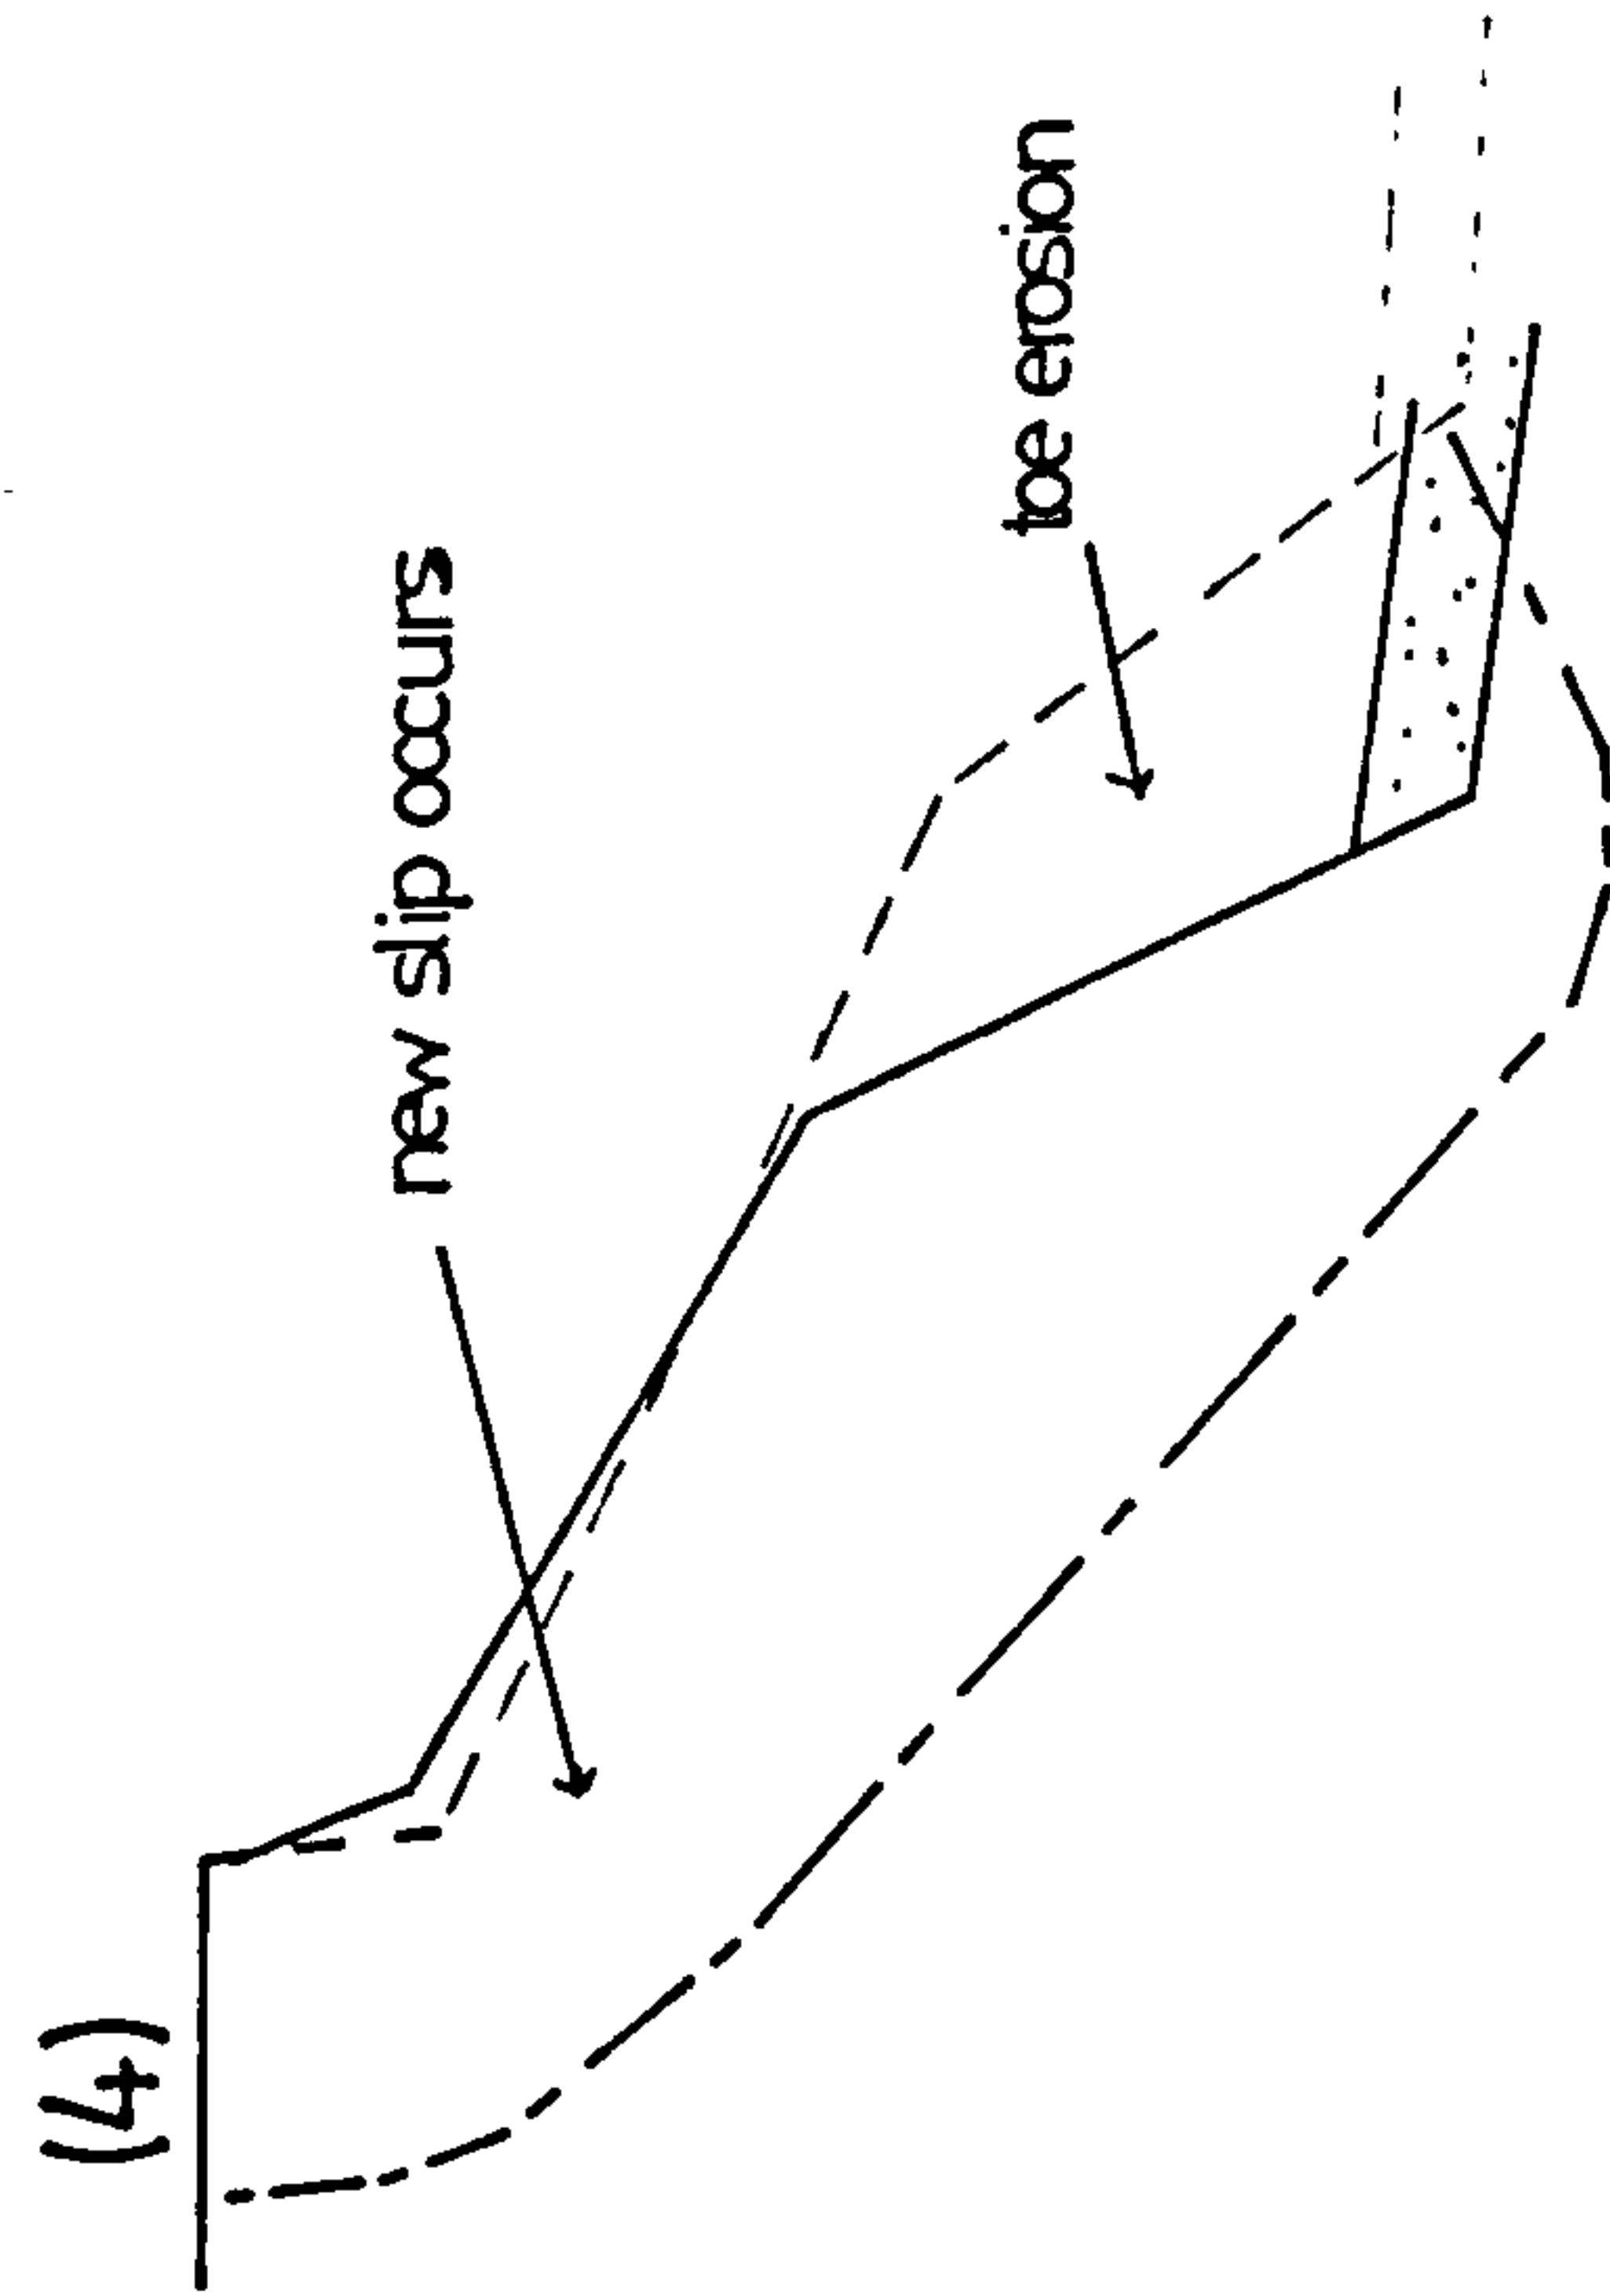
Figure 5:32
Series of cliff profiles showing cycle
of recession at the Grimston site
Scale 1:400

In this Section a hypothetical cycle of recession for the Grimston site is outlined, based on the findings of the site investigation and the earlier sections of this chapter, and from study of other failures in zone "B" at different stages in the cycle. It is then compared with recession of cliffs on the Great Lakes shoreline. Most of the changes described will also apply to other areas in zone "B", and some will also apply to other zones.

The cycle is described with the help of the cliff profiles in Figure 5.32. The first profile (1) shows the situation just after a slip has occurred. The slipped soil mass is slowly moving downslope (at the rate of a few cm/day) and the factor
